ALGORITHM DEVELOPMENT FOR SEWER PIPE SYSTEM CONDITION
ASSESSMENT USING MULTI-SENSOR (MSI) TECHNOLOGY

ALGORITHM DEVELOPMENT FOR SEWER PIPE SYSTEM CONDITION ASSESSMENT USING MULTI-SENSOR (MSI) TECHNOLOGY

This study investigates the performance of all the current large-diameter pipeline system of The City of Arlington (COA) sewer lines of 48 miles (24-inch inner diameter and above for rigid and flexible pipes). Proper inspection and rehabilitation plan for the city sewer pipeline system are better choice for the municipality and tax payers in terms of cost than dealing with pipe damage and collapsing problems when they happen.

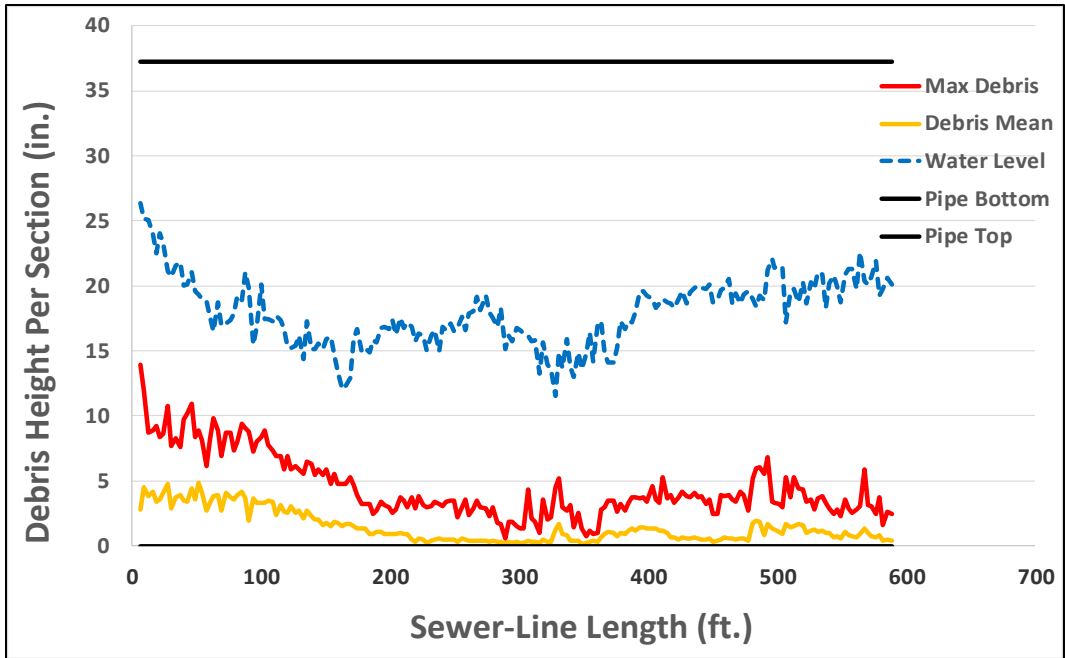
Figure 4-3 Debris level and sewer water level for line 19

Figure 4-3 shows a maximum debris level of almost 14 inches and a maximum mean level of almost 5 inches. Furthermore, the average value of the mean debris height for the whole pipe is 1.44 inch. The latter figure also shows the height of the sewer water level.

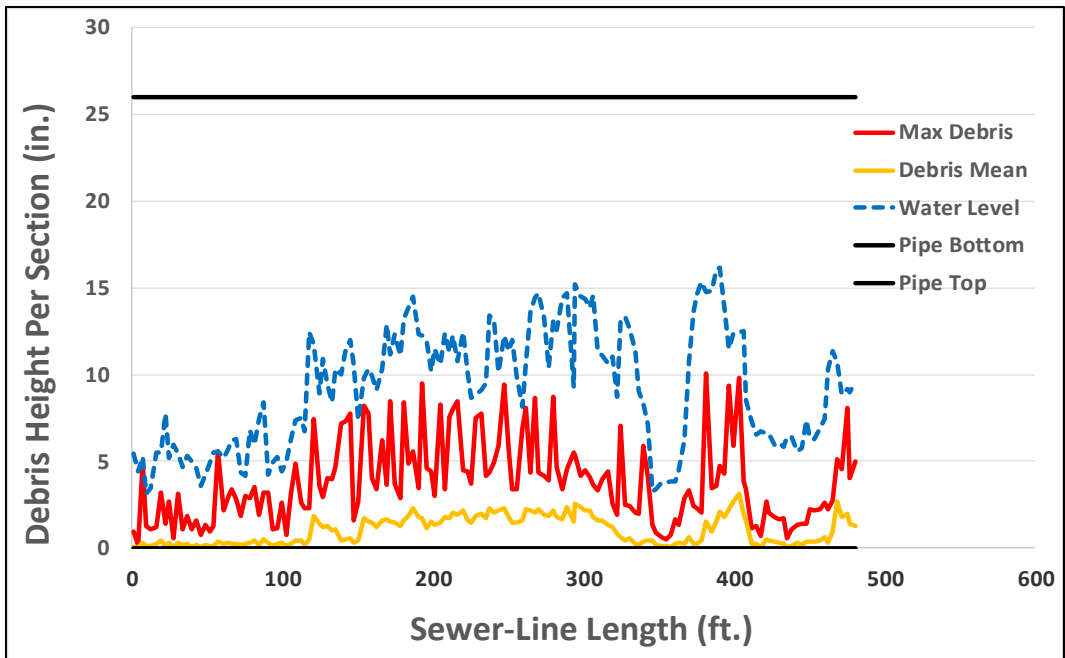
Figure 4-4 Debris level and sewer water level for line 23

Figure 4-4 shows a maximum debris level of a little over 10 inches and a maximum mean level of almost 2.5 inches. Moreover, the average value of the mean debris height for the whole pipe is 1 inch. The last figure also shows the height of the sewer water level for the same line.

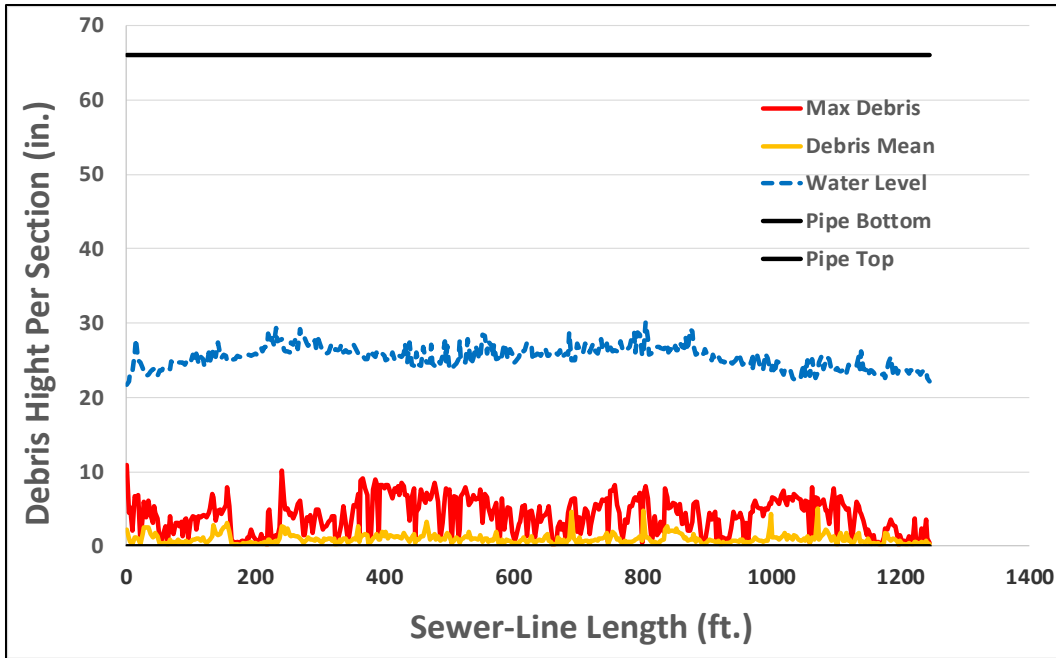
Figure 4-5 Debris level and sewer water level for line 17

From Figure 4-5, it can be concluded that line 17 has a maximum debris level of almost 11 inches and maximum mean level of almost 5 inches. Also, the average value of the mean debris height for the whole pipe is 0.96 inch. Figure 4-5 also shows the height of the sewer water level for line 17.

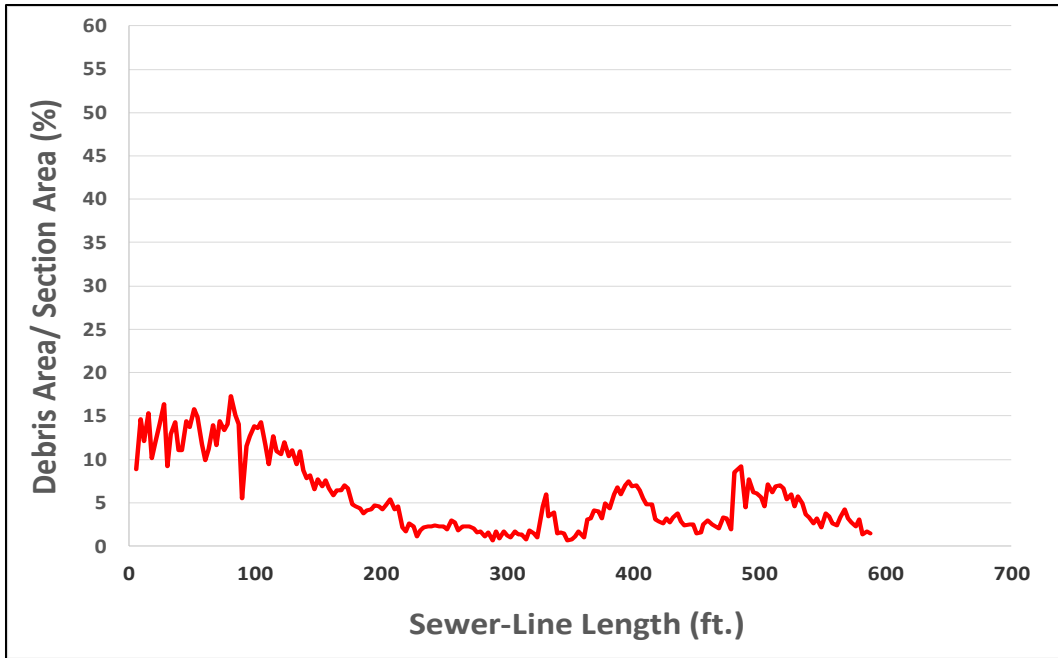
Figure 4-6 The percentage of debris area per cross section area for line 19

From Figure 4-6, it can be concluded that the maximum percentage of the debris area per cross section area is almost 18%. It also shows that the pipe (line 19) has more debris at the beginning of the pipe.

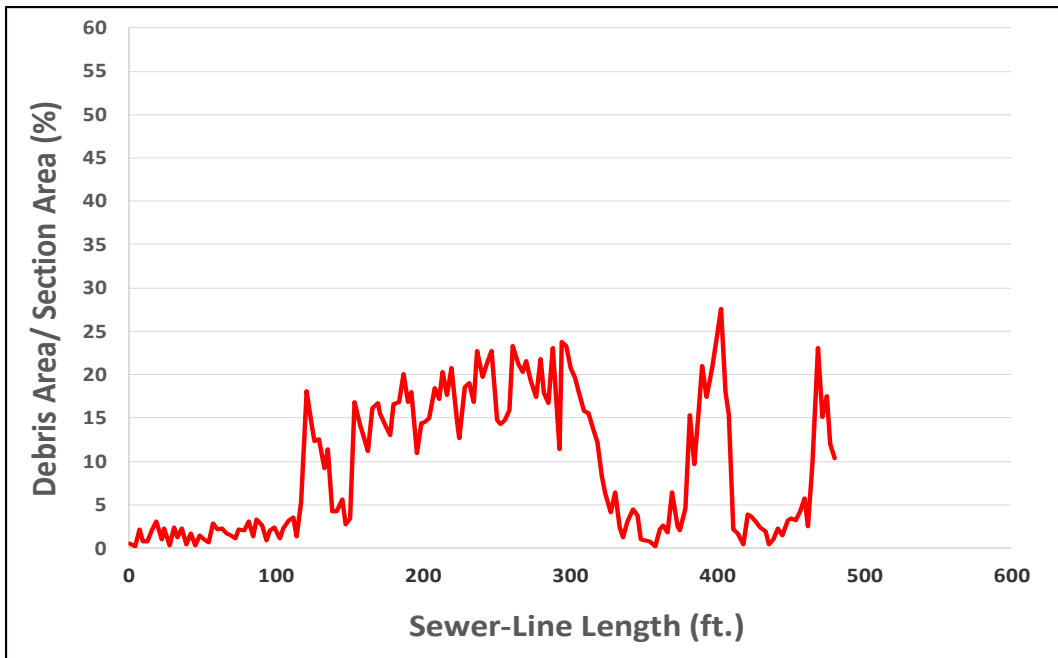
Figure 4-7 The percentage of debris area per cross section area for line 23

Furthermore, line 23 shows that it has the most percentage of the debris area per cross section amongst all lines even though it doesn't have the highest debris average level. The reason for that is because the cross-section area of the line is the least as it has 24 in. diameter (compared to line 19 of 36 in. diameter and line 23 of 66 in. diameter) so that the percentage of the debris of line 23 is showing higher than the other lines, as it clearly shown in Figure 4-7. Moreover, the latter figure also shows that the maximum percentage of the debris area is almost 27%. It also shows that the pipe is has the highest percentage in the middle and near the end of the pipe.

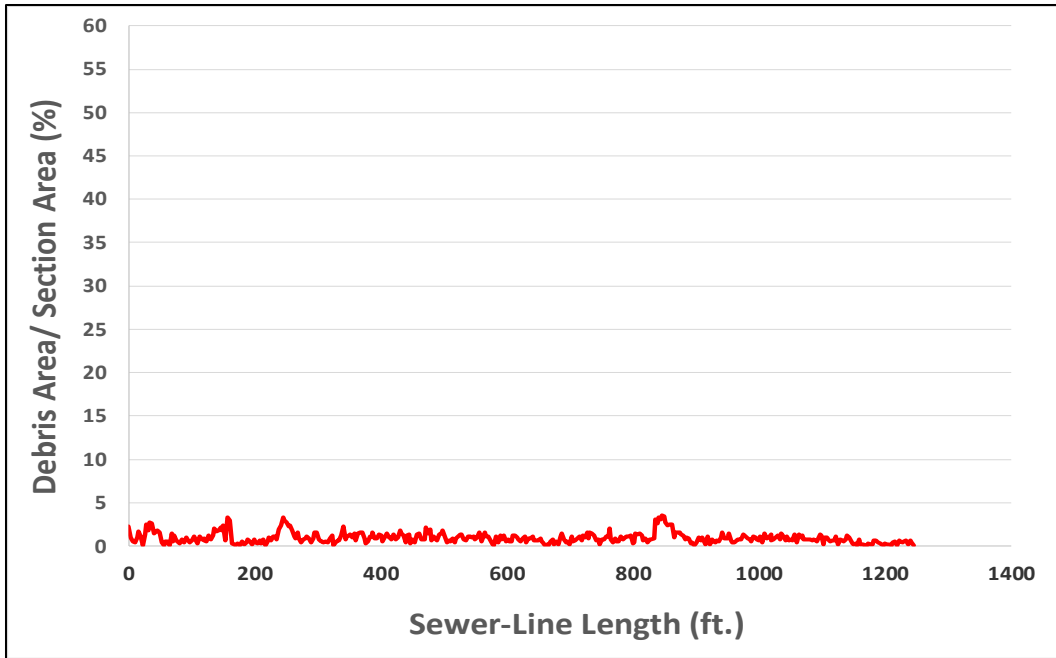
Figure 4-8 The percentage of debris area per cross section area for line 17

The percentage of the debris area per cross-section is the least for line 17, as it shown in Figure 4-8. That is because the pipe has the largest diameter of 66 in. The maximum debris percentage is almost 4%.

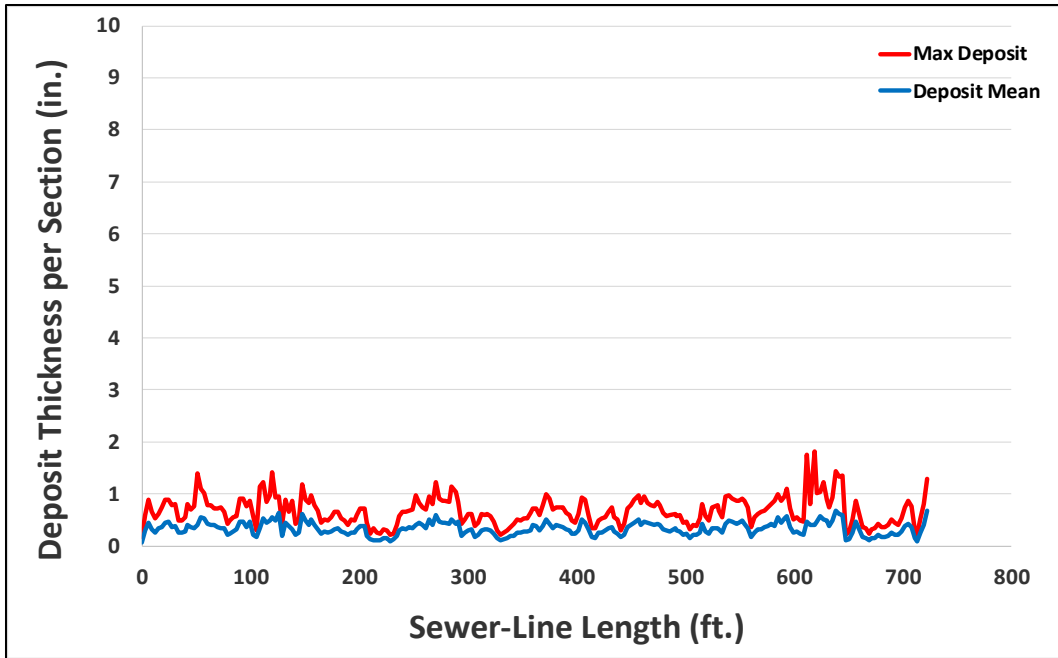
Figure 4-9 Deposit level for line 31

Figure 4-9 shows a maximum deposit level of almost 1.8 inch and a maximum mean level of almost 0.68 inch. Furthermore, the average value of the mean deposit height for the whole pipe is 0.33 inch.

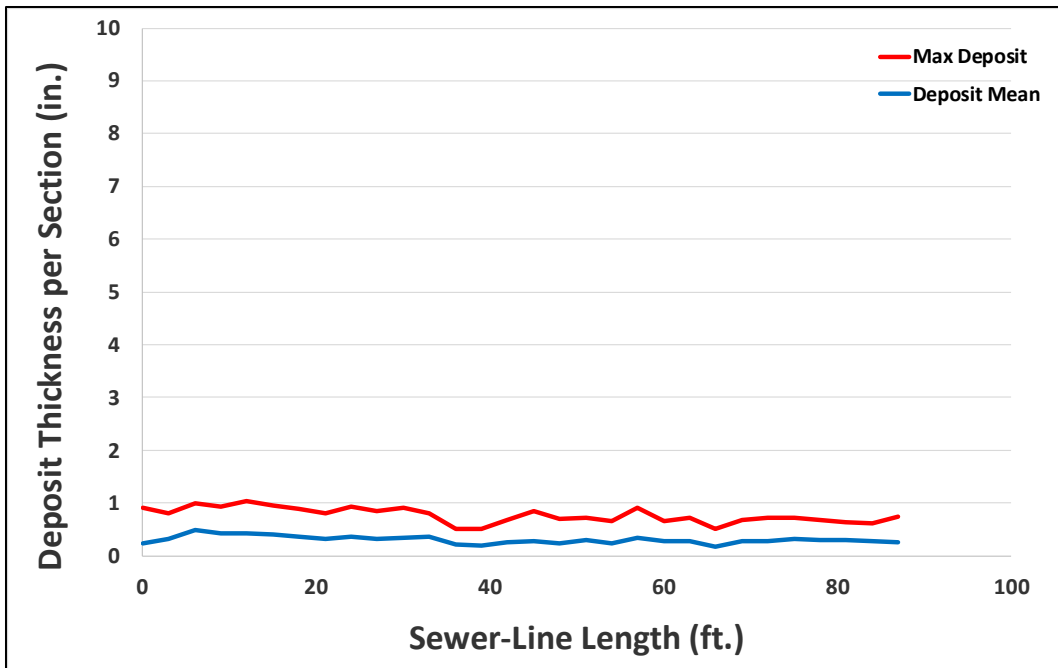
Figure 4-10 Deposit level for line 14

Figure 4-10 shows a maximum deposit level of 1.04 inch and a maximum mean level of almost 0.48 inch. Moreover, the average value of the mean deposit height for the whole pipe is 0.31 inch. From Figure 4-11, it can be concluded that line 30 has a maximum deposit level of almost 1.46 inch and maximum mean level of almost 0.57 inch. Also, the average value of the mean deposit height for the whole pipe is 0.29 inch.

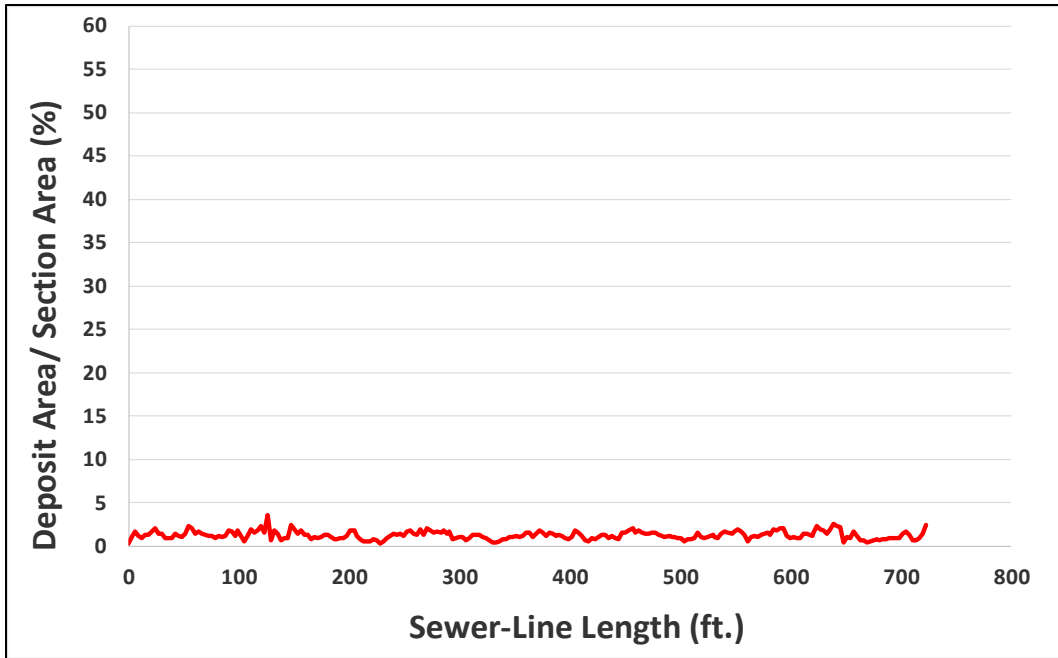
Figure 4-12 The percentage of deposit area per cross section area for line 31

From Figure 4-12, it can be concluded that the maximum percentage of the debris area per cross section area is almost 4%. Furthermore, line 14 shows that it has the least percentage of the deposit area per cross section amongst all lines. The reason for that is because the cross-section area of the line is the largest as it has 60 in. diameter (compared to lines 31 and 30 of 30 in. diameter) so that the percentage of the debris of line 14 is showing less than the other lines, as it clearly shown in Figure 4-13. Moreover, the latter figure also shows that the maximum percentage of the deposit area is almost 1.4%. The percentage of the deposit area per cross-section for line 17 is 2%, as it shown in Figure 4-14.

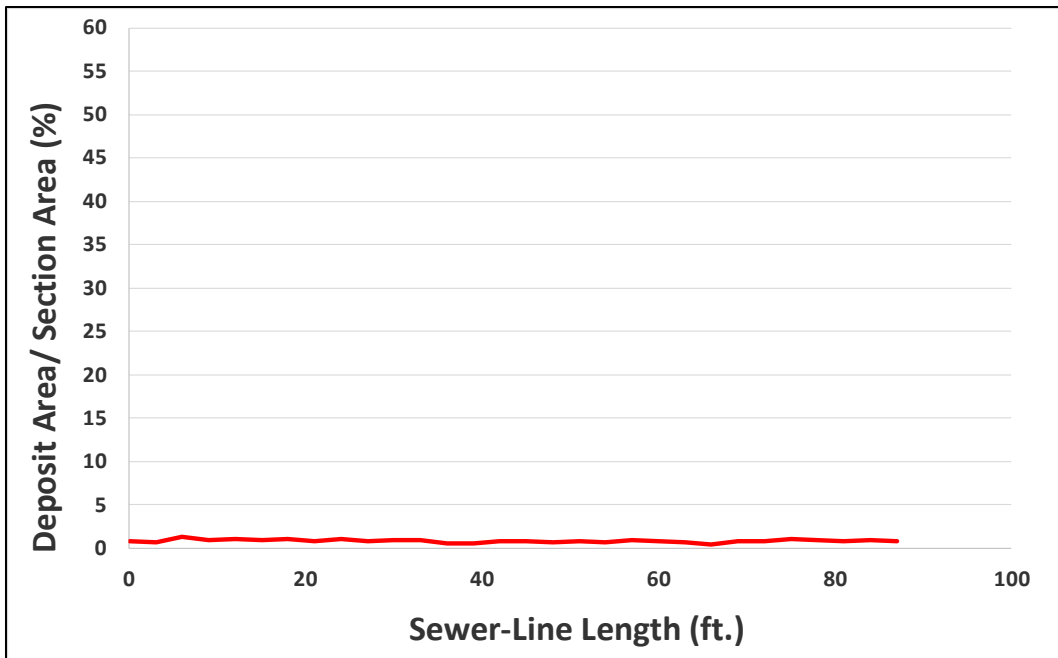
Figure 4-13 The percentage of deposit area per cross section area for line 14

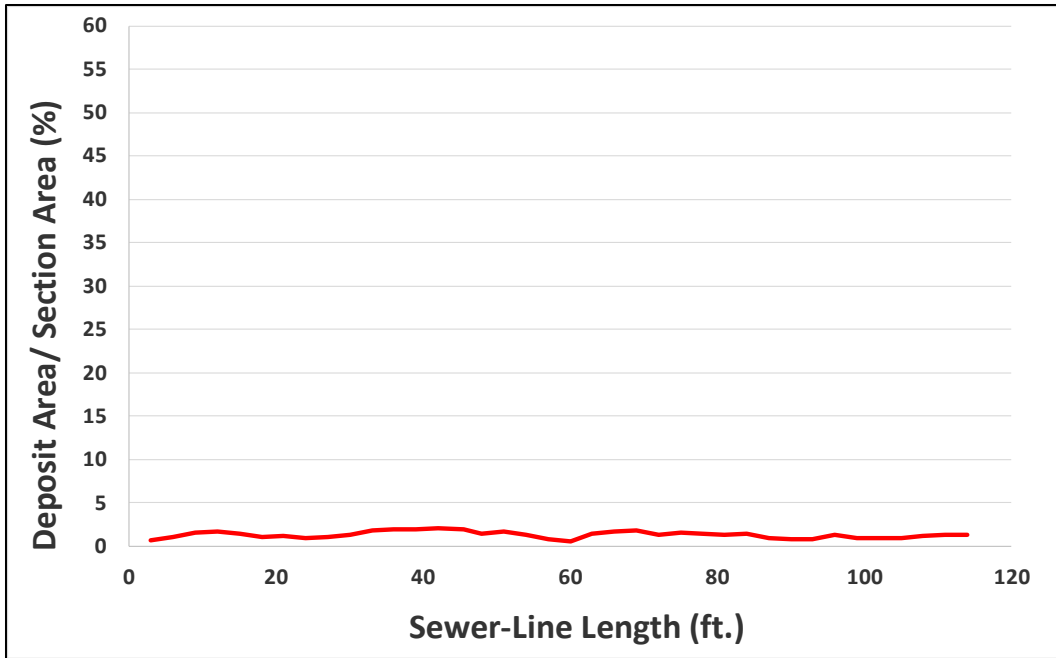
Figure 4-14 The percentage of deposit area per cross section area for line 30

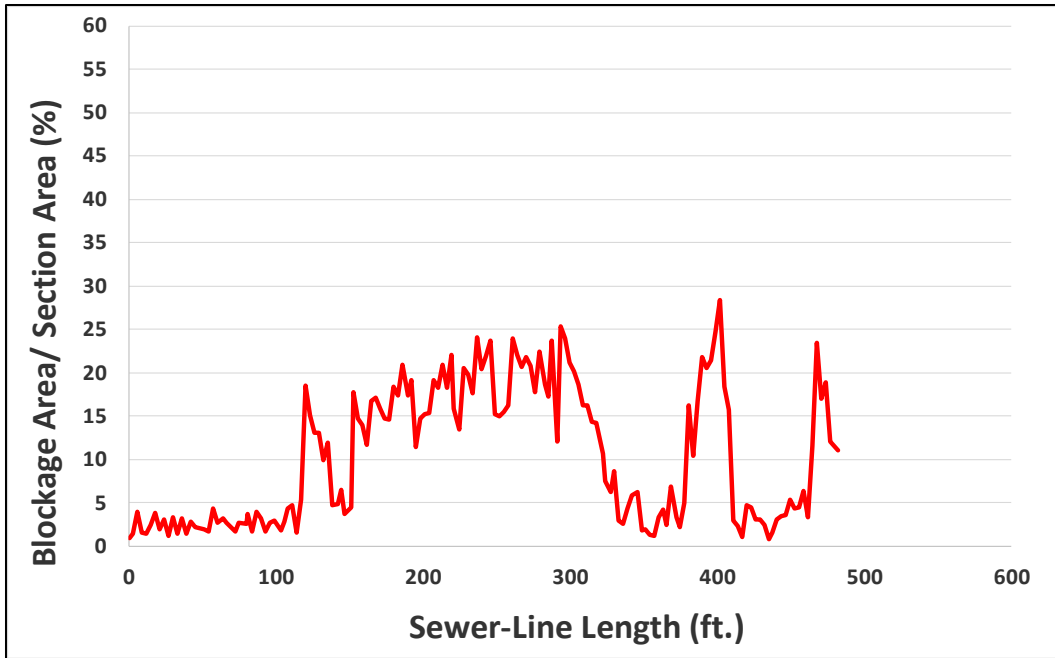
Figure 4-15 The percentage of the blockage area per cross section area for line 23

Figure 4-15 shows a maximum percentage of blockage area of almost 28%. The line is almost blocked by more than 20% by debris and deposits in the middle of the pipe and near the end as well. Furthermore, the line 23 has the highest mean percentage of the blocked area throughout the pipe length of a value of 10.3% amongst the whole 63 inspected sewer pipelines. That gives a good indication for the city decision makers for prioritization their sewer pipelines for the O&M and cleaning process.

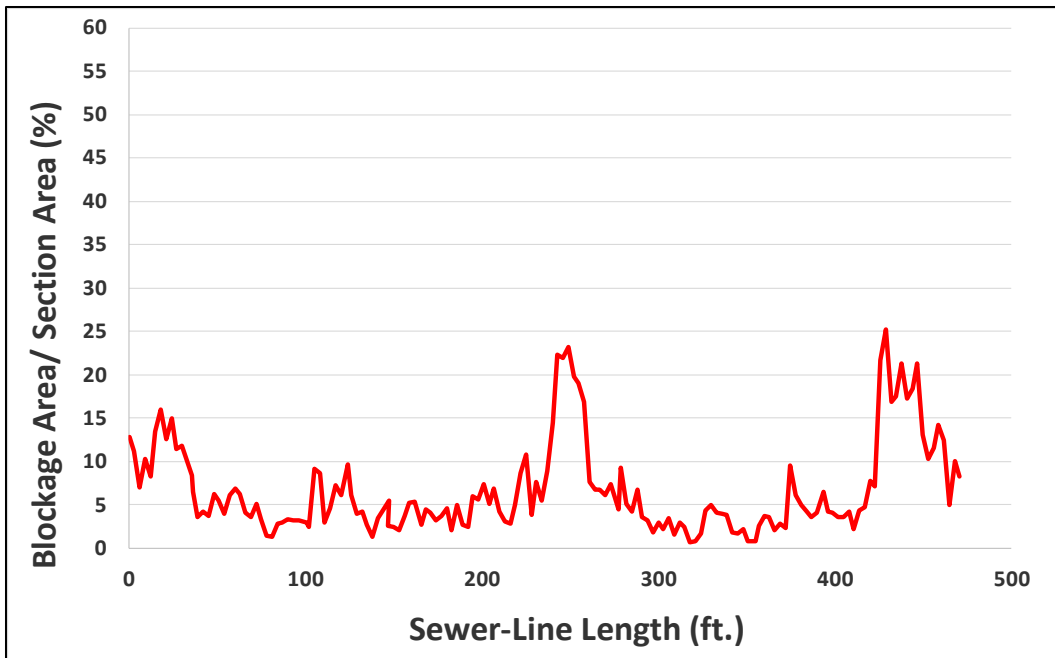
Figure 4-16 The percentage of the blockage area per cross section area for line 24

From Figure 4-16, it can be concluded that line 24 has a maximum percentage of blockage area of almost 25%, while the mean percentage of blockage area is almost 6.5%. The latter pipeline has the second highest mean value of the percentage of the blocked area throughout the pipe length.

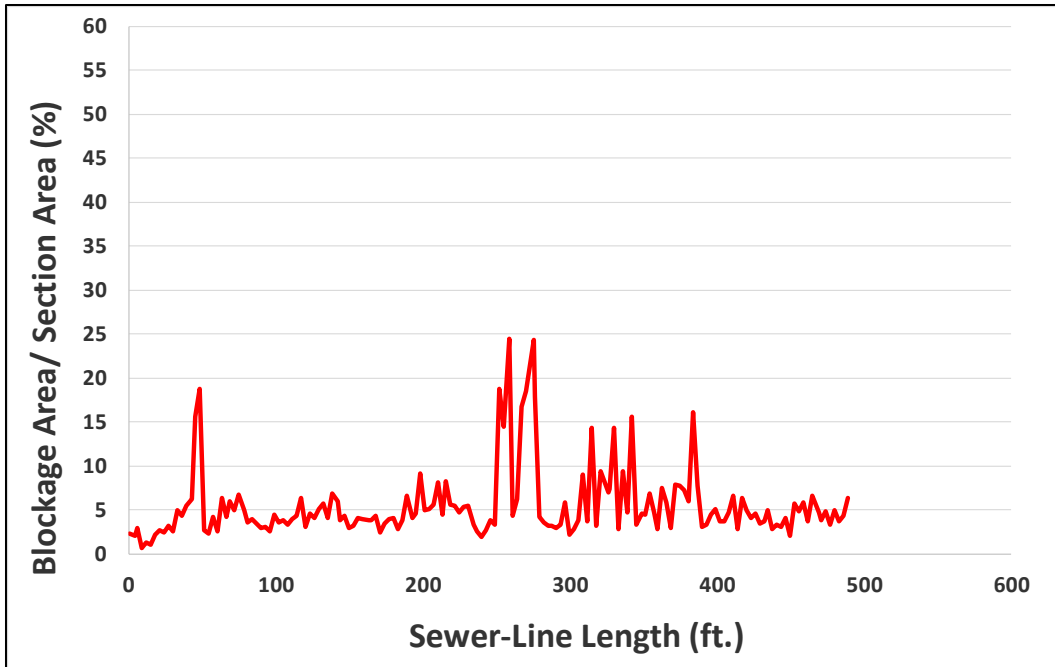
Figure 4-17 The percentage of the blockage area per cross section area for line 26

Moreover, line 26 has the third highest maximum percentage of the blockage area of 24.5%, as it shown in Figure 4-17, while the mean percentage of blockage area is

almost 5.5%. The latter pipeline has the fourth highest mean value of the percentage of the blocked area throughout the pipe length. The third highest mean value of 6.3% of the percentage of the blocked area throughout the pipe length is found in line number 19 (Figure 4-18).

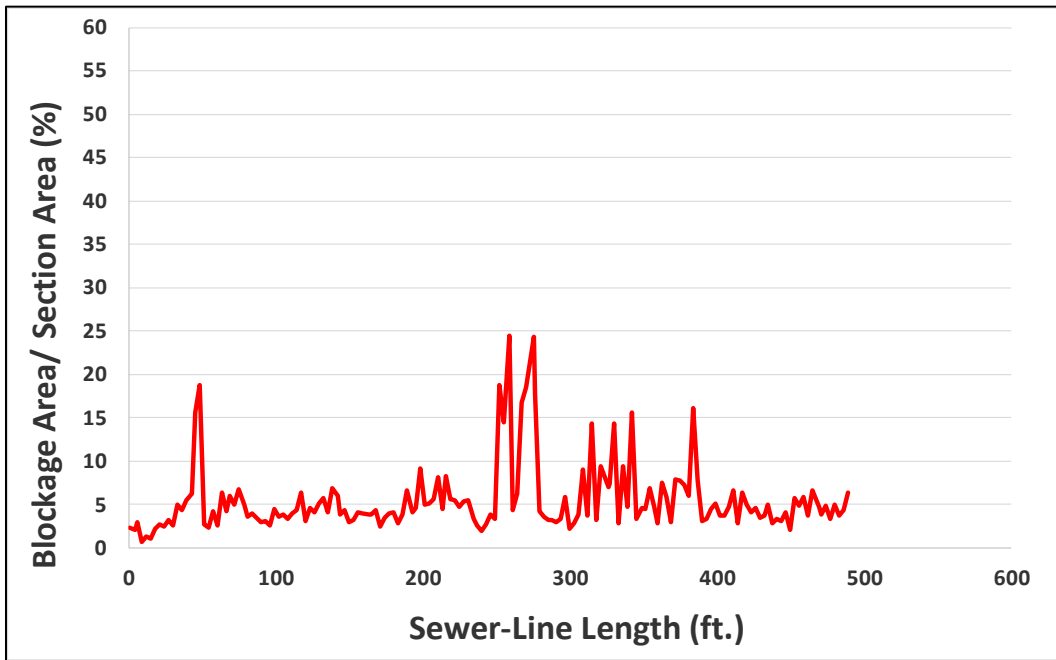
Figure 4-18 The percentage of the blockage area per cross section area for line 19

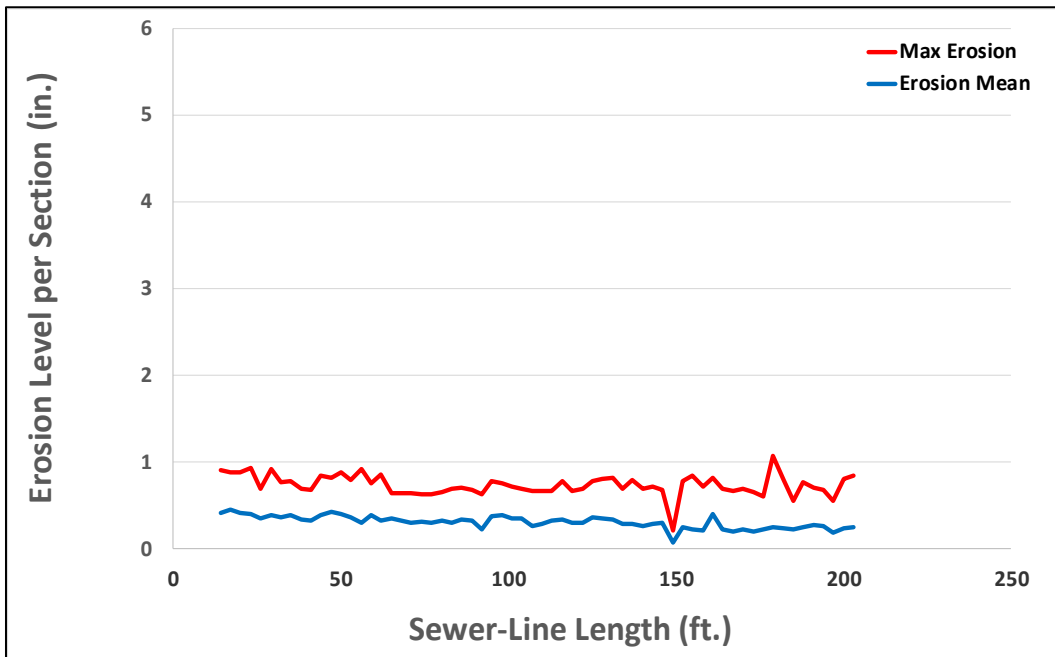
Figure 4-19 shows a maximum erosion level of almost 1.1 inch and a maximum mean level of almost 0.45 inch. Furthermore, the average value of the mean erosion level for the whole pipe is 0.3 inch.

Figure 4-19 The erosion level per section area for line 13

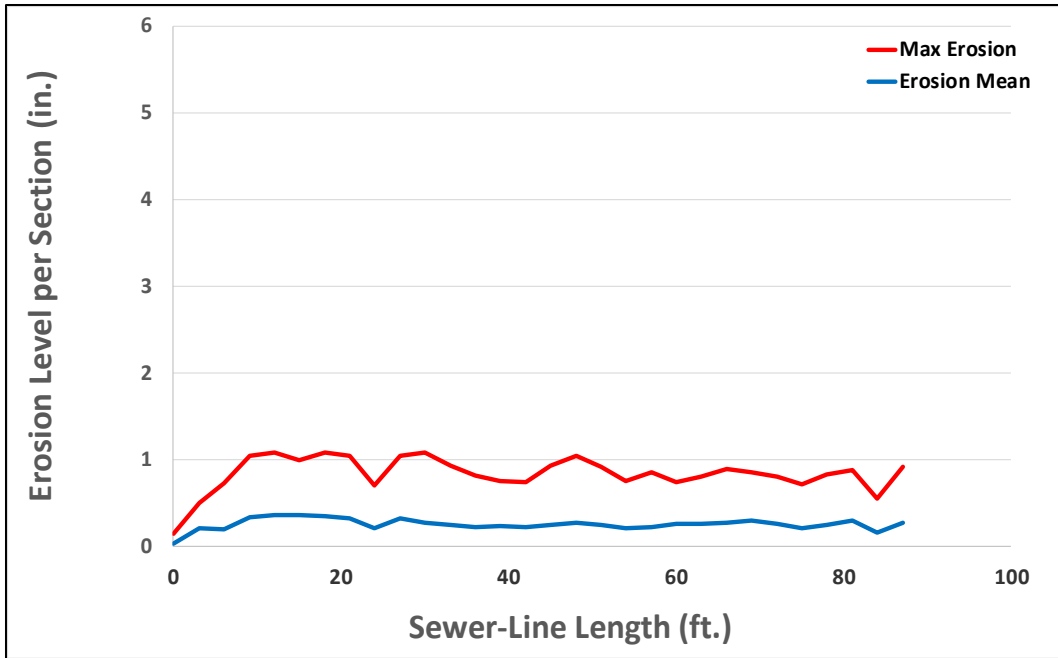
From Figure 4-20, it can be concluded that line 14 has a maximum erosion level of almost 1.1 inch and maximum mean level of almost 0.36 inch. Also, the average value of the mean erosion level for the whole pipe is 0.25 inch.

Figure 4-20 The erosion level per section area for line 14

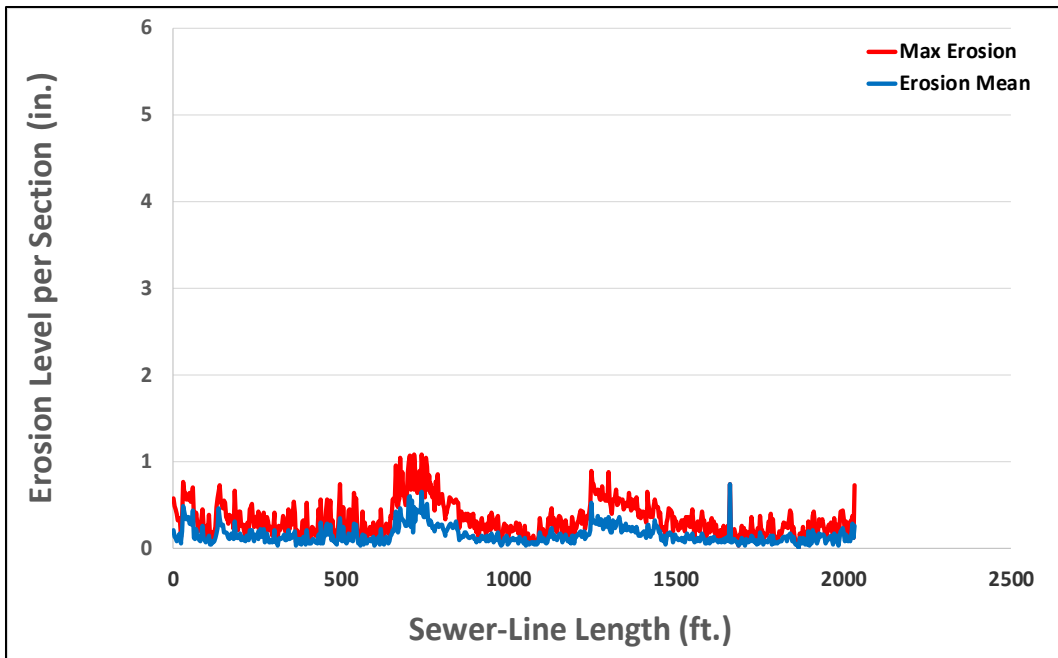
Figure 4-21 The erosion level per section area for line 18

Figure 4-21 shows a maximum erosion level of 1.1 inch and a maximum mean level of almost 0.74 inch. Moreover, the average value of the mean erosion level for the whole pipe is 0.15 inch.

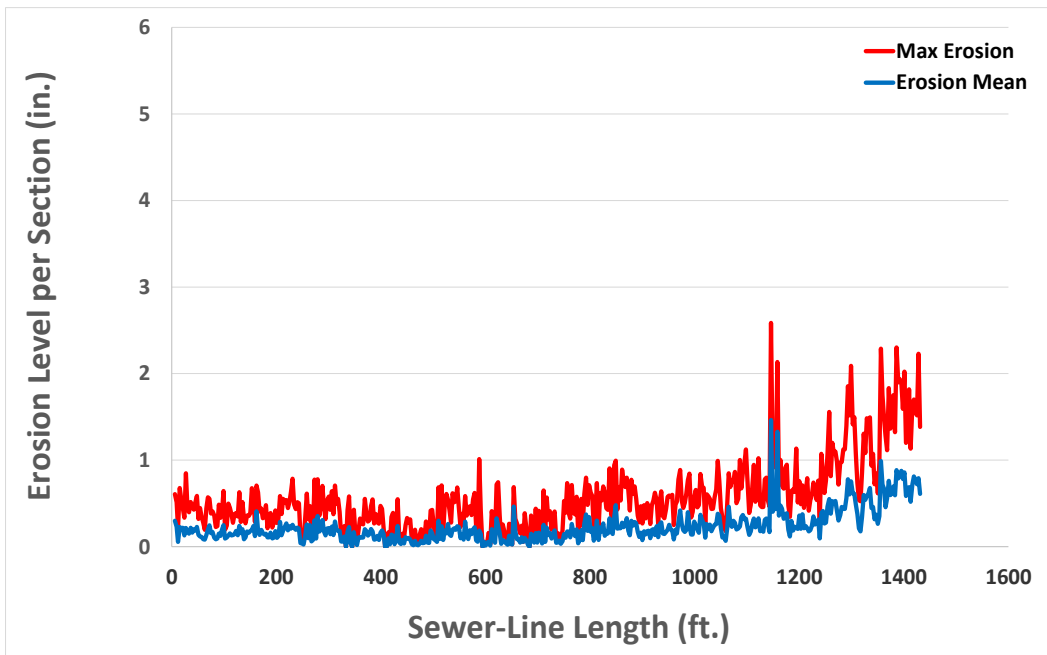
Figure 4-22 The erosion level per section area for City of Rowlett line

From Figure 4-22, it can be concluded that the City of Rowlett line has a maximum erosion level of almost 2.5 inches and maximum mean level of almost 0.36 inch. Also, the average value of the mean erosion level for the whole pipeline is 0.25 inch.

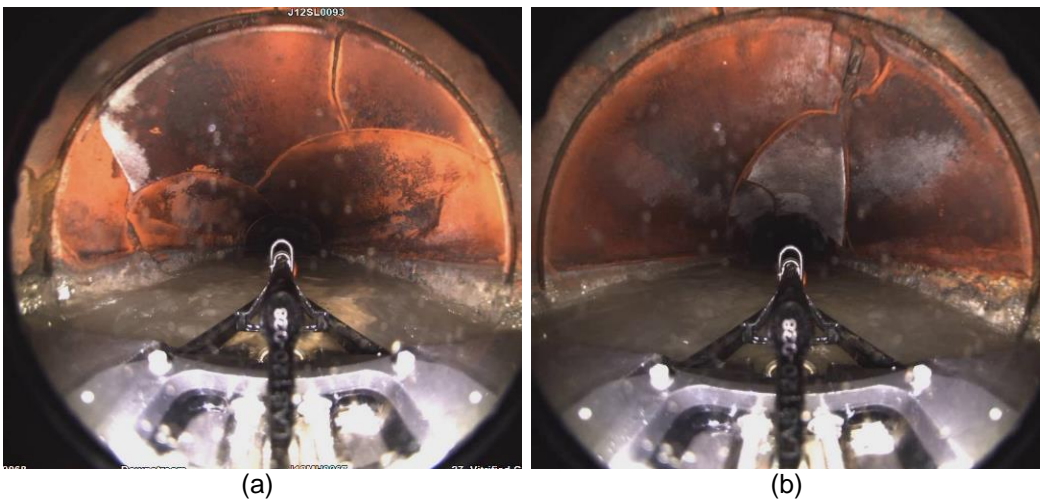
Figure 4-23 Worst structural defects for line 26. It shows (a) Fracture Multiple (FM) and (b) Deformed Rigid (DR)

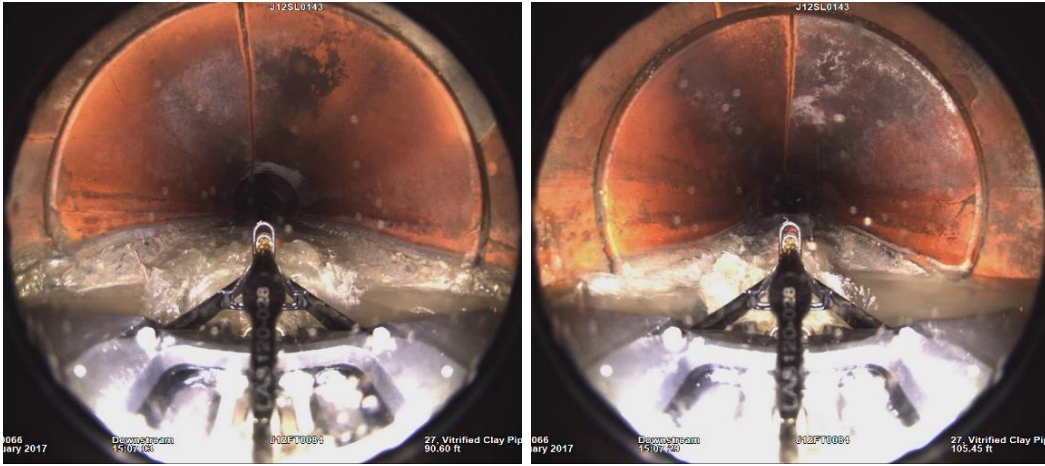
Figure 4-24 Worst structural defects for line 28. It shows (a) Fracture Longitudinal (FL) and (b) Fracture Longitudinal (FL)

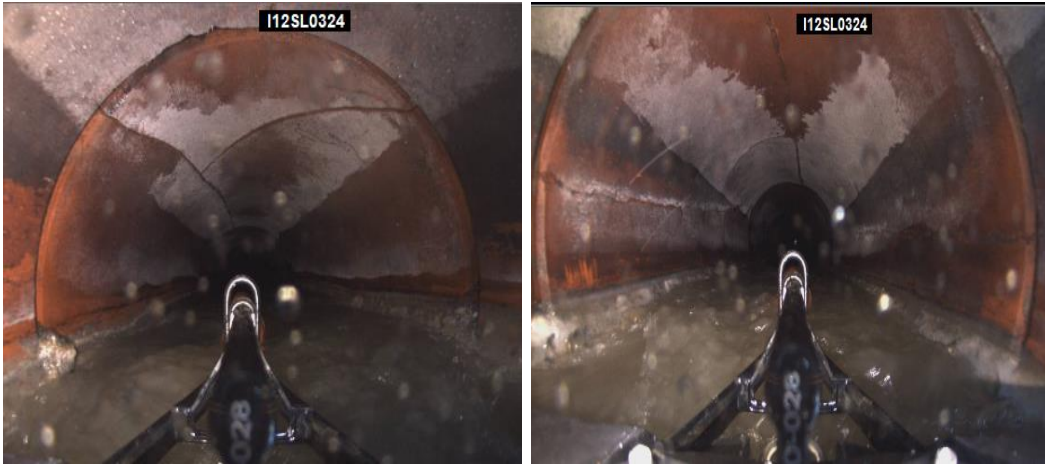
Figure 4-25 Worst structural defects for line 22. It shows (a) Fracture Multiple (FM) and (b) Fracture Hinge (FH3)

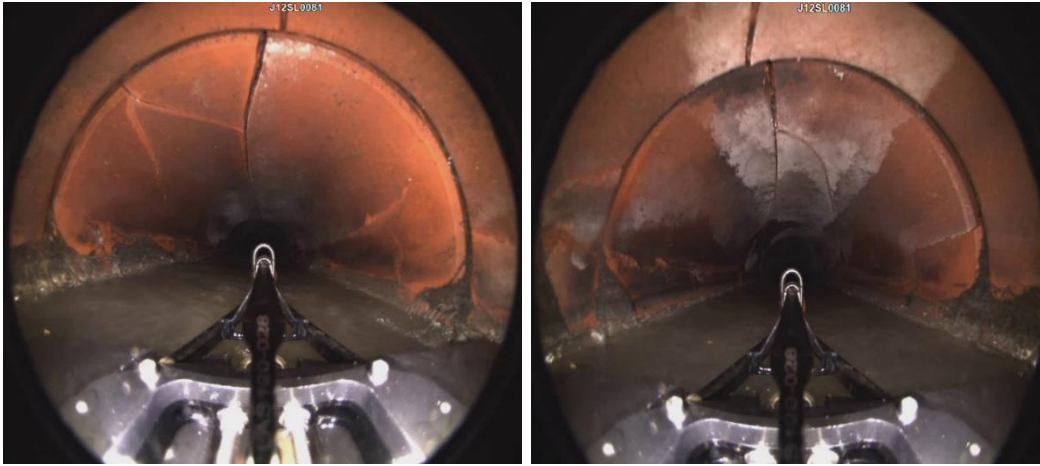
Figure 4-26 Worst structural defects for line 25. It shows (a) Fracture Multiple (FM) and (b) Broken (B)

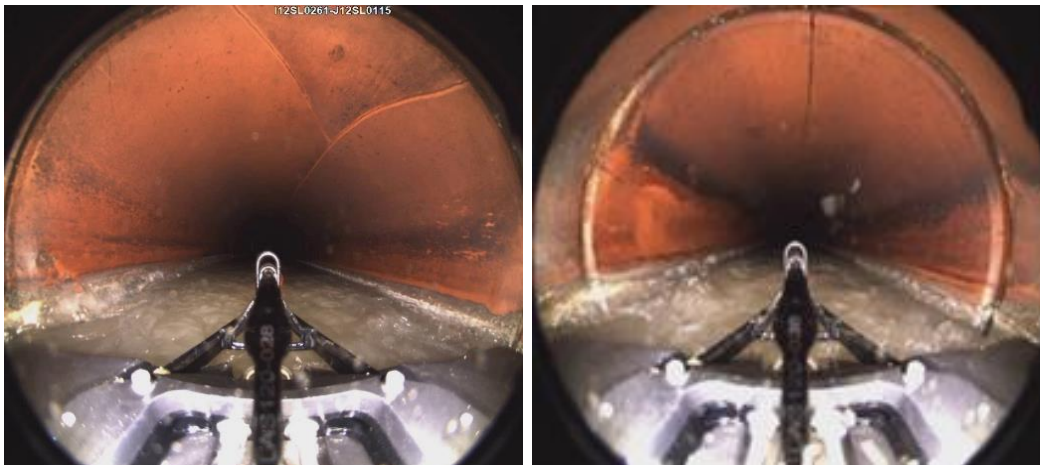
Figure 4-27 Worst structural defects for line 24. It shows (a) Fracture Multiple (FM) and (b) Fracture Longitudinal (FL)

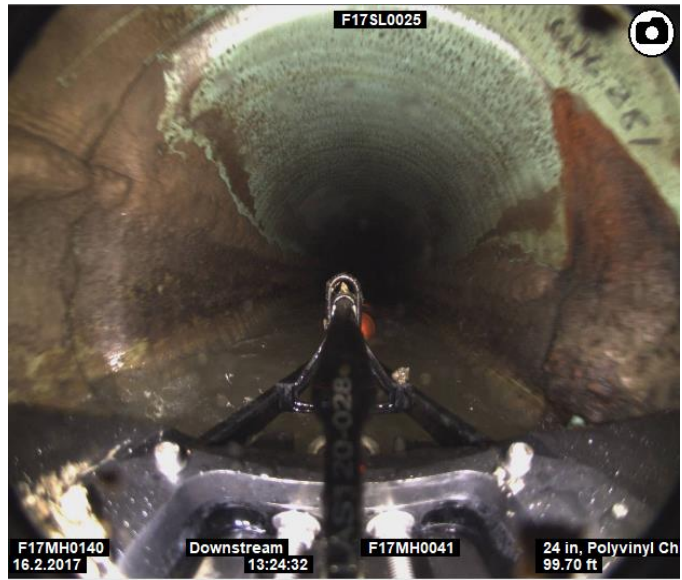
Figure 4-28 Roots intrusion for line 55

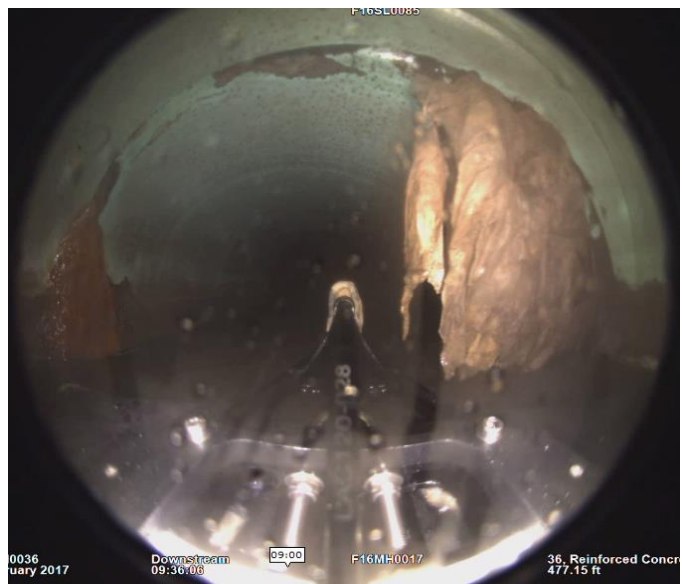
Figure 4-29 Roots intrusion for line 58

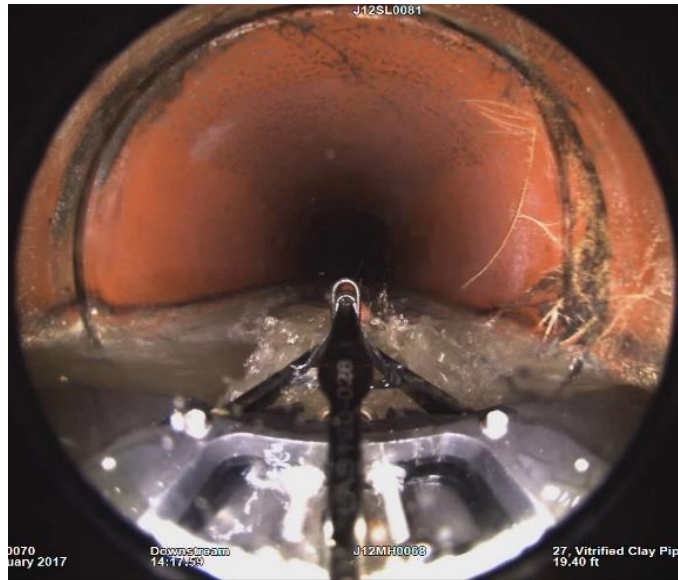
Figure 4-30 Roots intrusion for line 25

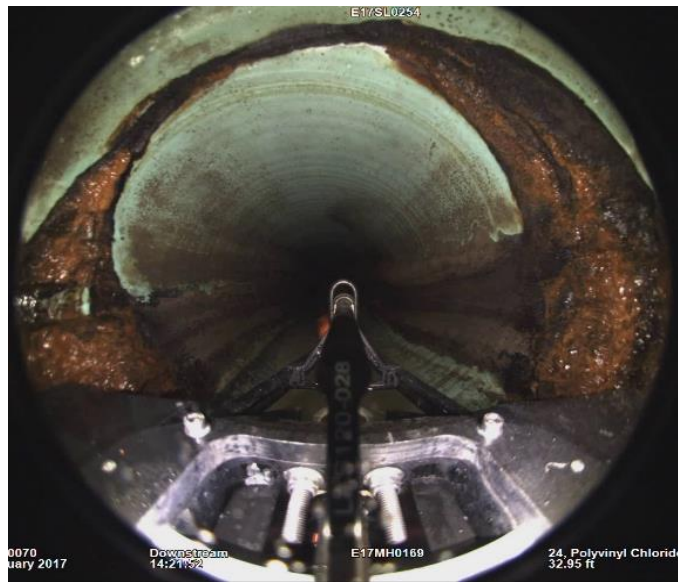
Figure 4-31 Roots intrusion for line 37

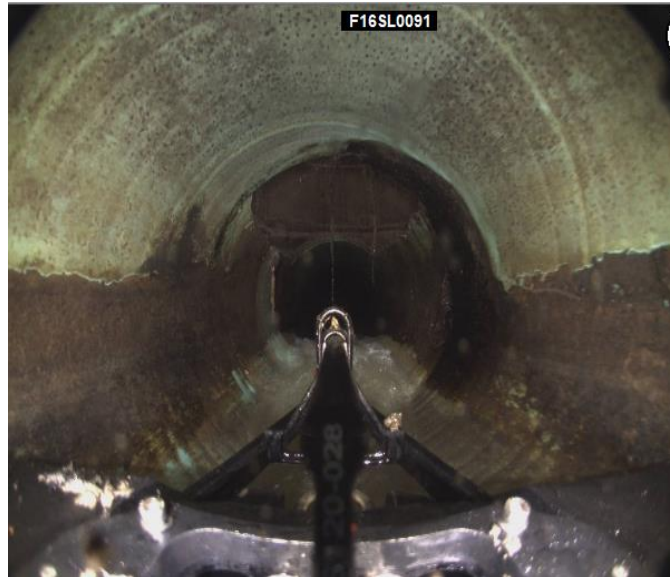
Figure 4-32 Roots intrusion for line 56

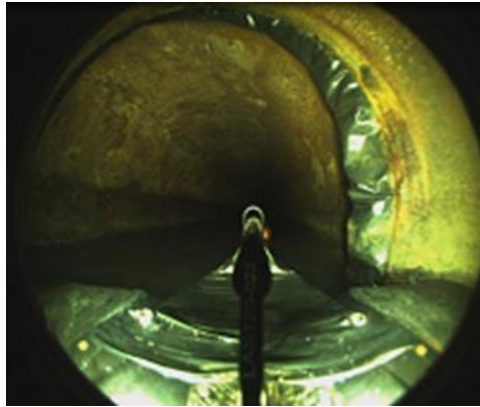
Figure 4-33 Significant defects in line 6 (ISGT and MGO)

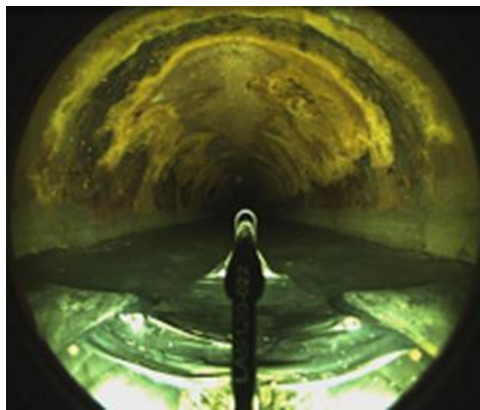
Figure 4-34 Significant defects in line 7 (MGO)

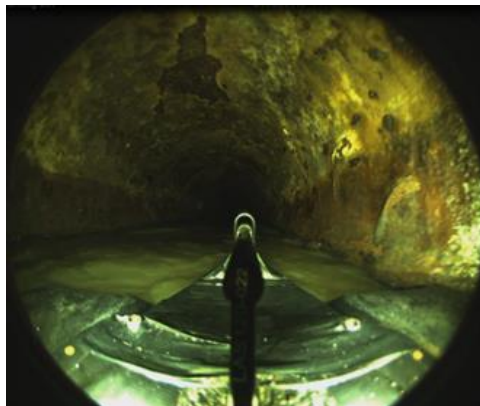
Figure 4-35 Significant defects in line 8 (MGO)

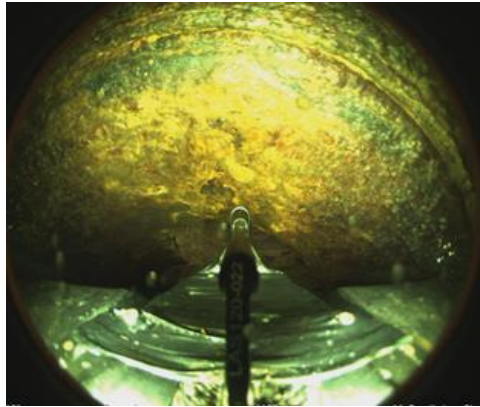
Figure 4-36 Significant defects in line 9 (MGO)

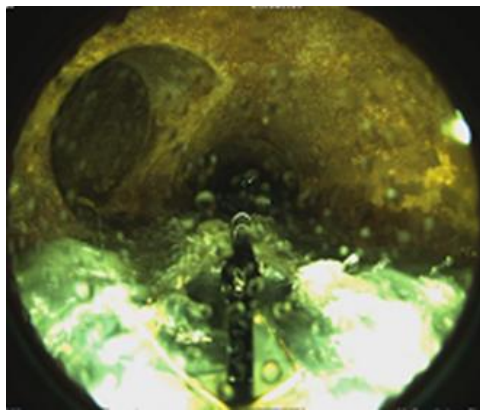
Figure 4-37 Significant defects in line 12 (TBA)

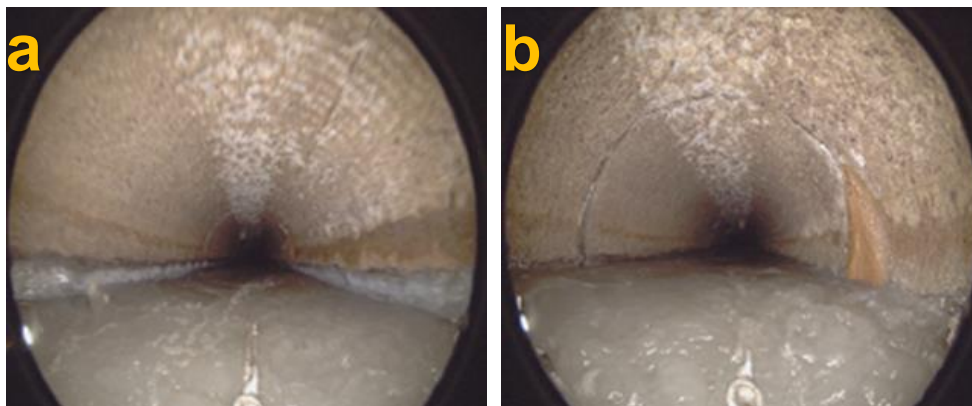
Figure 4-38 Significant defects in line 13. It shows (a) SRV and (b) SAV and JS

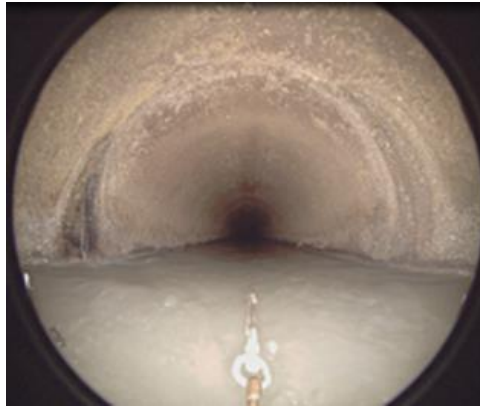
Figure 4-39 Significant defects in line 15 (IRJ)

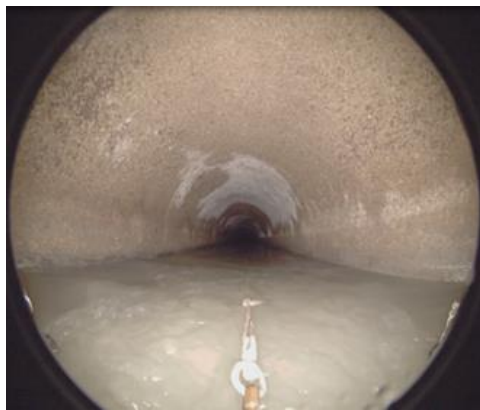
Figure 4-40 Significant defects in line 16 (SAV)

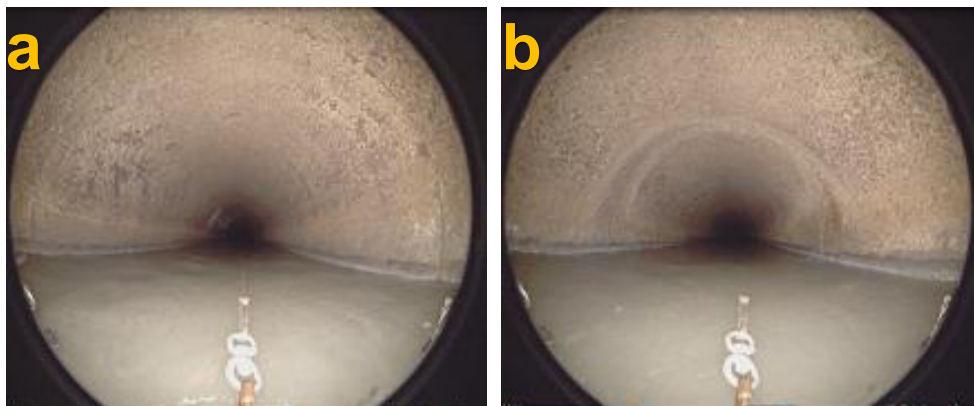
Figure 4-41 Significant defects in line 17. It shows (a) SAV and (b) IRJ

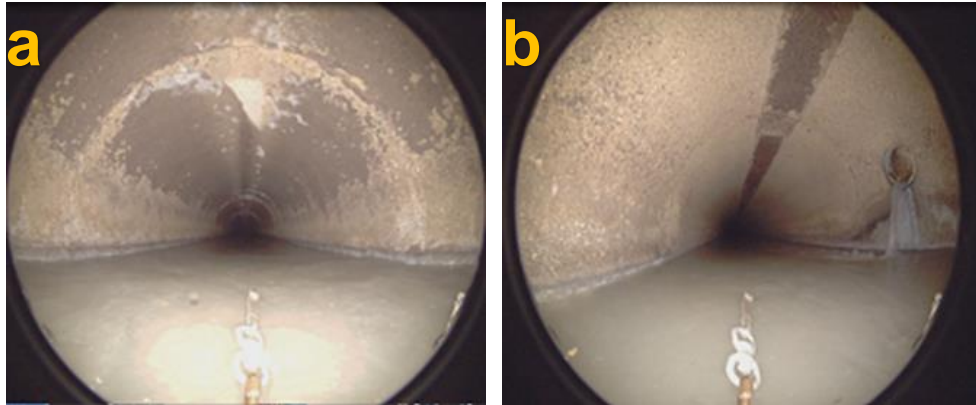
Figure 4-42 Significant defects in line 17. It shows (a) SAV and (b) TBA

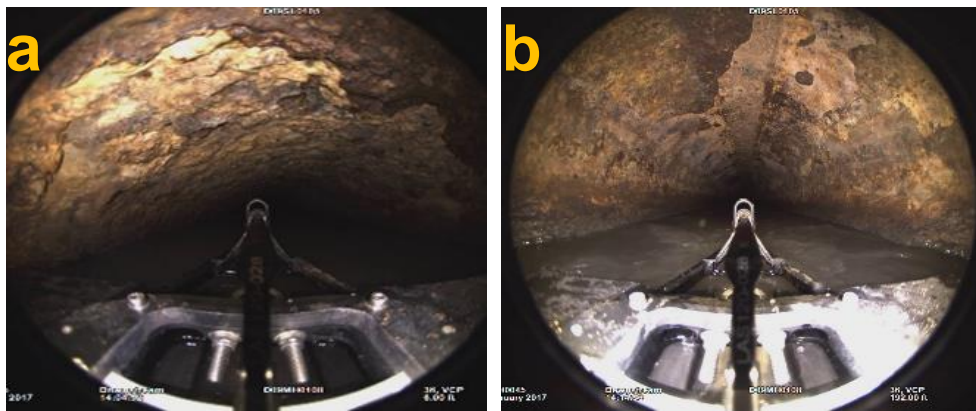
Figure 4-43 Significant defects in line 19. It shows (a) MGO and (b) DAG
