ALGORITHM DEVELOPMENT FOR SEWER PIPE SYSTEM CONDITION
ASSESSMENT USING MULTI-SENSOR (MSI) TECHNOLOGY

ALGORITHM DEVELOPMENT FOR SEWER PIPE SYSTEM CONDITION ASSESSMENT USING MULTI-SENSOR (MSI) TECHNOLOGY

This study investigates the performance of all the current large-diameter pipeline system of The City of Arlington (COA) sewer lines of 48 miles (24-inch inner diameter and above for rigid and flexible pipes). Proper inspection and rehabilitation plan for the city sewer pipeline system are better choice for the municipality and tax payers in terms of cost than dealing with pipe damage and collapsing problems when they happen.

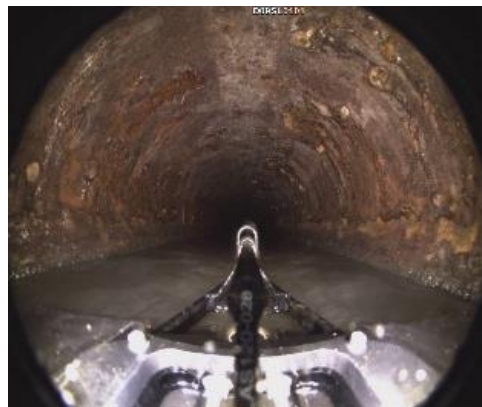
Figure 4-44 Significant defects in line 21 (DAG)

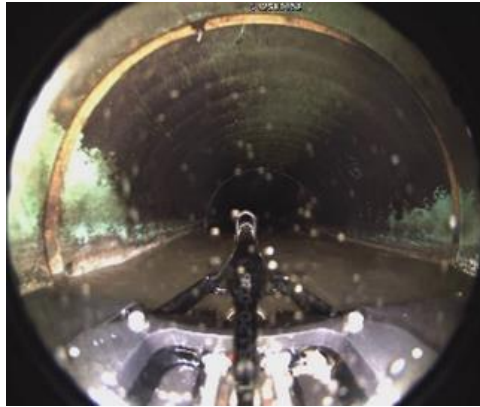
Figure 4-45 Significant defects in line 31 (JS)

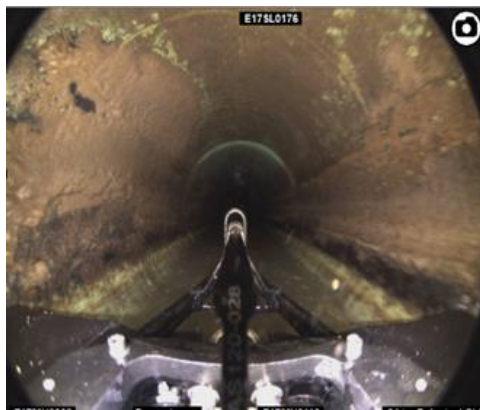
Figure 4-46 Significant defects in line 39 (DAE)

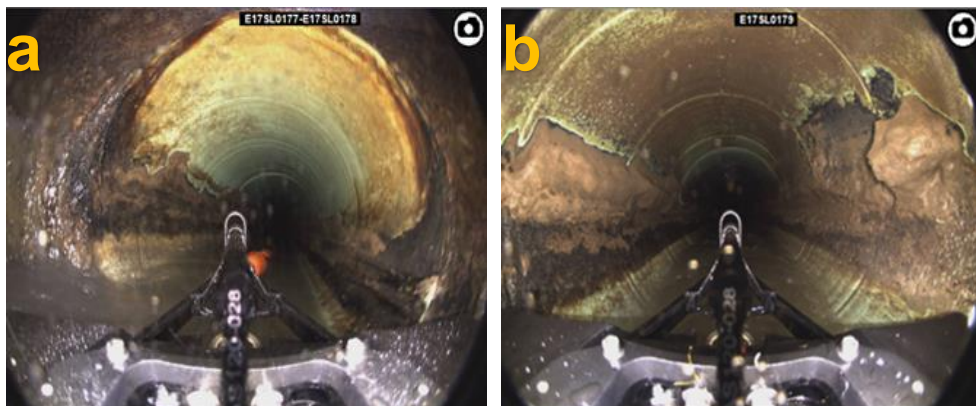
Figure 4-47 Significant defects in line 41. It shows (a) DAG and (b) DAE

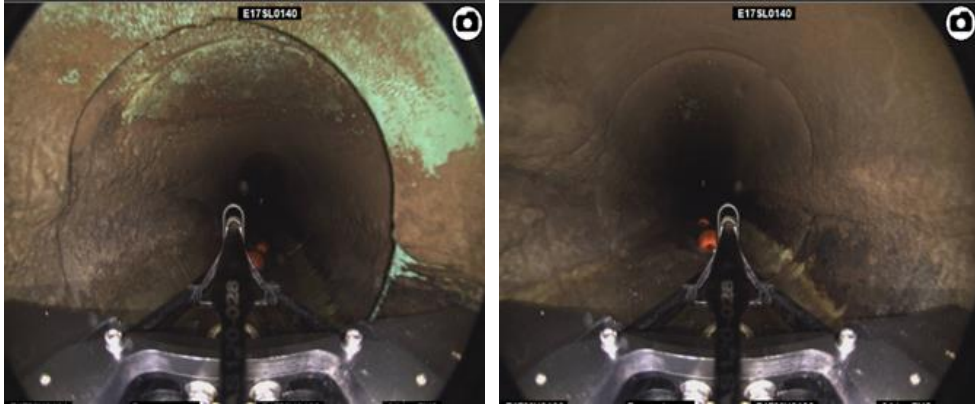
Figure 4-48 Significant defects in line 43 (DAE)

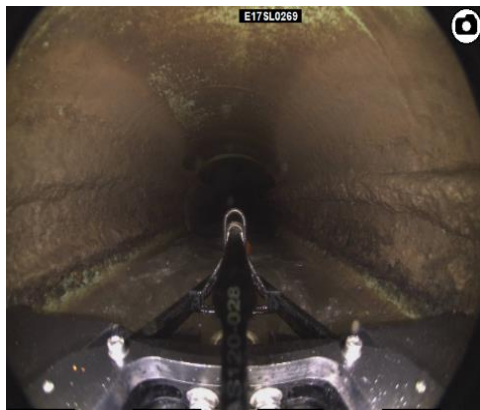
Figure 4-49 Significant defects in line 46 (DAE)

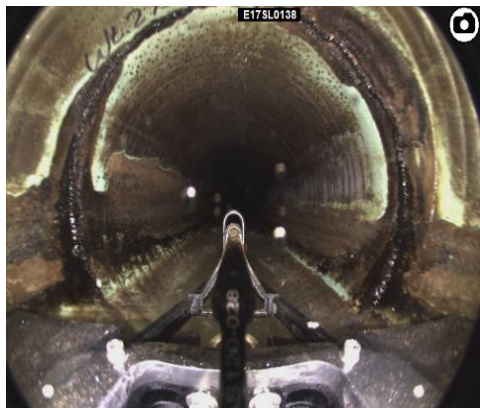
Figure 4-50 Significant defects in line 47 (DAG and DAE)

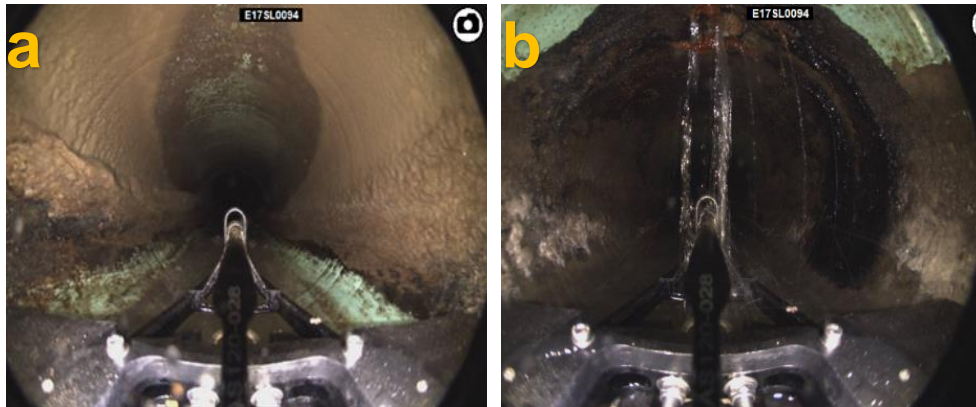
Figure 4-51 Significant defects in line 48. It shows (a) DAE and (b) IRJ

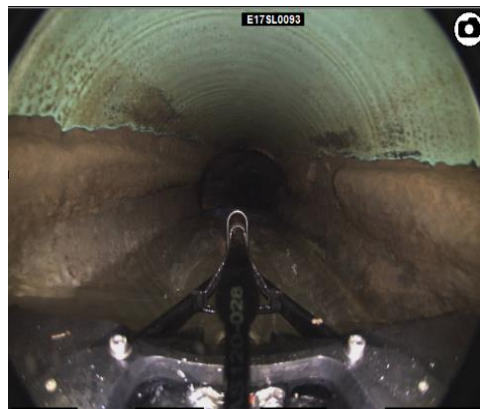
Figure 4-52 Significant defects in line 49 (DAE)

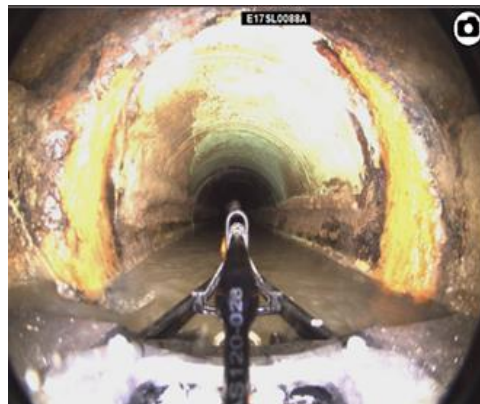
Figure 4-53 Significant defects in line 50 (DAG and DAE)

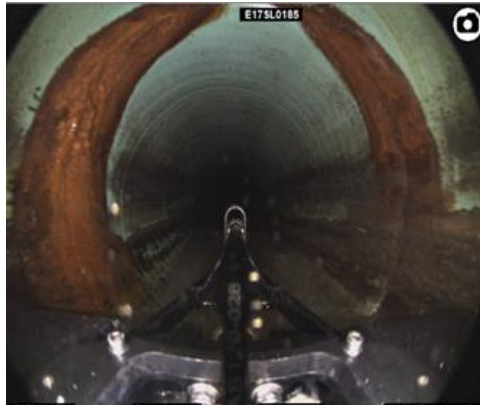
Figure 4-54 Significant defects in line 52 (JS)

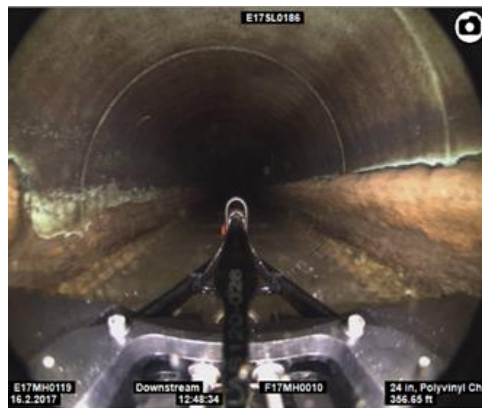
Figure 4-55 Significant defects in line 53 (DAE)

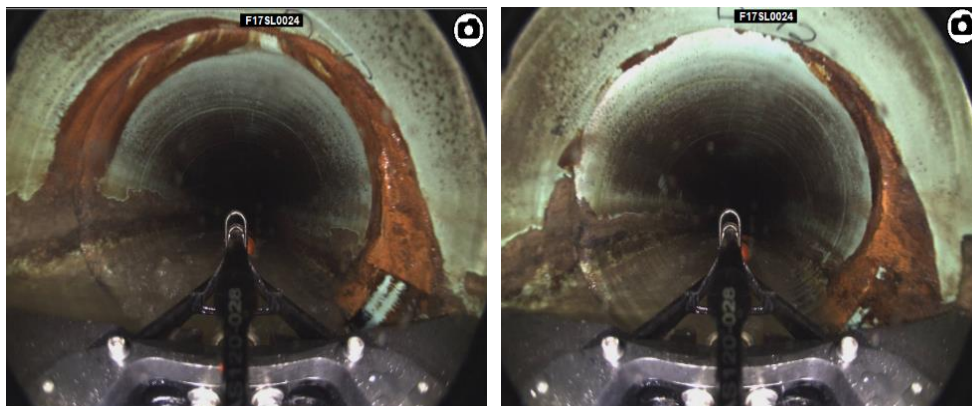
Figure 4-56 Significant defects in line 54 (JS)

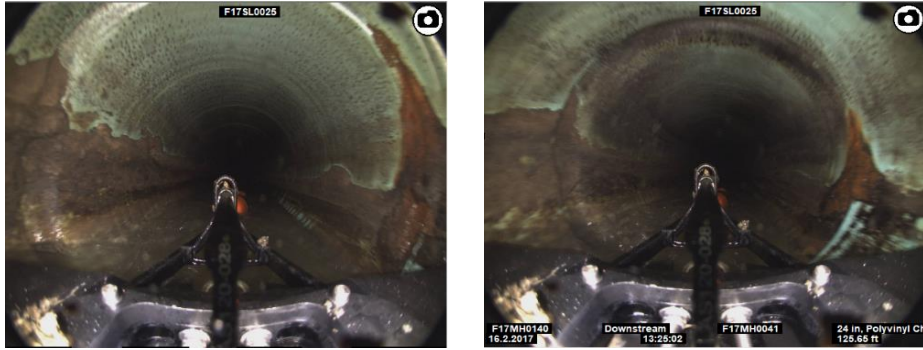
Figure 4-57 Significant defects in line 55 (JS)

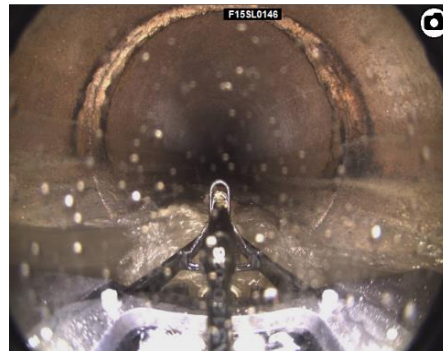
Figure 4-58 Significant defects in line 59 (JS)

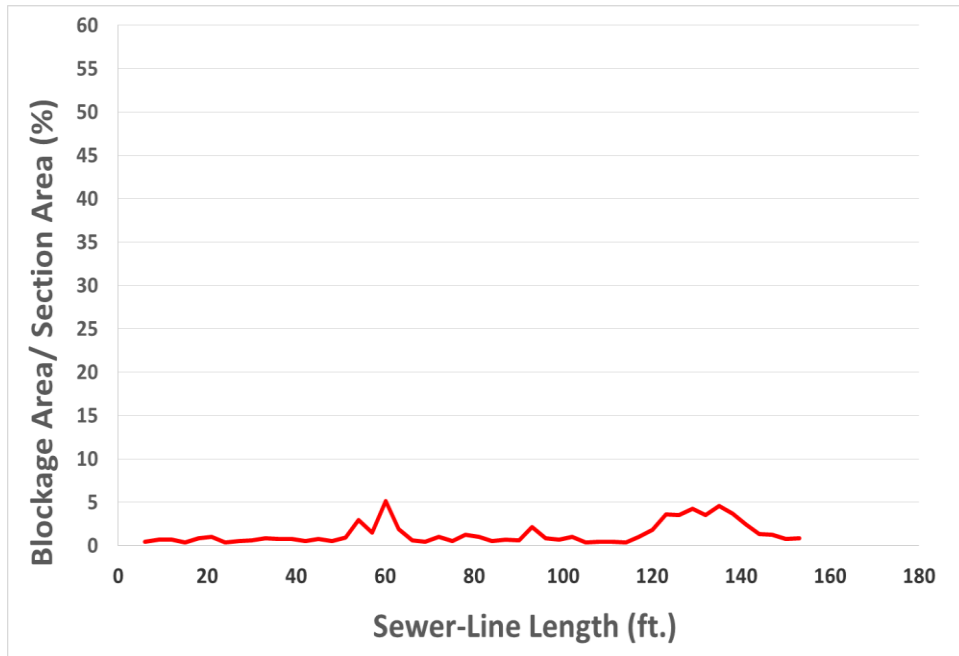
Figure A6-5 Blockage area (deposits and debris areas) percentage of pipe cross section area

LINE INSPECTION SUMMARY	
OBSERVATION METRIC	OBSERVATION
Distance Planned (ft.)	173.4
Percentage of The Line Not Inspected	0%
Total Collapsed	0
Total Fractures Multiple	0
Total Fractures Hinge	0
Total Fractures Longitudinal	0
Total Fractures Circumferential	0
Broken	0
Deformed Rigid	0
Joint Offsets	0
Total Roots Occurrences	0
Level 5 O&M Defects	0
Level 5 Structural Defects	0
Level 4 O&M Defects	0
Level 4 Structural Defects	0
Total Defects	2
Total Debris Volume (ft3)	10.76
Total Deposits Volume (in3)	7703.60
Maximum Blockage (%)	5.14
Maximum Deposit Height (in)	0.49

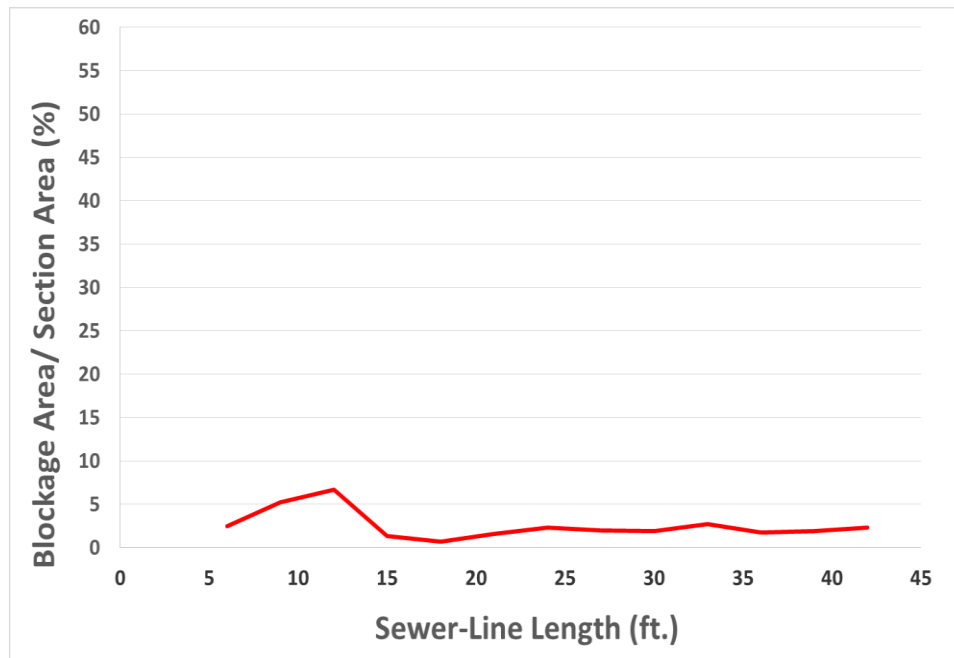
Figure A8-5 Blockage area (deposits and debris areas) percentage of pipe cross section area

LINE INSPECTION SUMMARY	
OBSERVATION METRIC	OBSERVATION
Distance Planned (ft.)	58.1
Percentage of The Line Not Inspected	21.77%
Total Collapsed	0
Total Fractures Multiple	0
Total Fractures Hinge	0
Total Fractures Longitudinal	0
Total Fractures Circumferential	0
Broken	0
Deformed Rigid	0
Joint Offsets	0
Total Roots Occurrences	0
Level 5 O&M Defects	0
Level 5 Structural Defects	0
Level 4 O&M Defects	0
Level 4 Structural Defects	0
Total Defects	1
Total Debris Volume (ft3)	3.53
Total Deposits Volume (in3)	5809.96
Maximum Blockage (%)	6.73
Maximum Deposit Height (in)	0.93

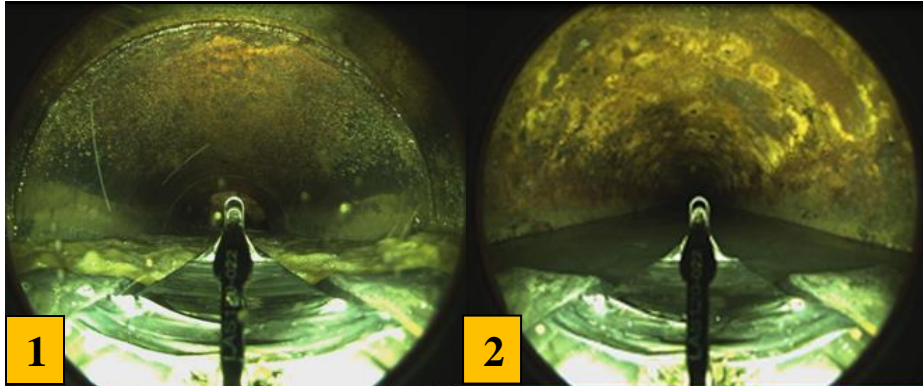
Figure A9-1 images from 1 through 2

SN	Distance (feet)	Video Ref.	Code	Continuous Defect	Value			Joint	Circumferential Location		Img Reference	Remarks
			Group/ Descriptor/ Modifier		Dimension		%		At/From	To		
					1st	2nd						
1	0		AMH									
2	0.6		MWL				10%					
3	14.4									1	CORROSION	
4	18.6									2	CORROSION	
5	19.35		MSA

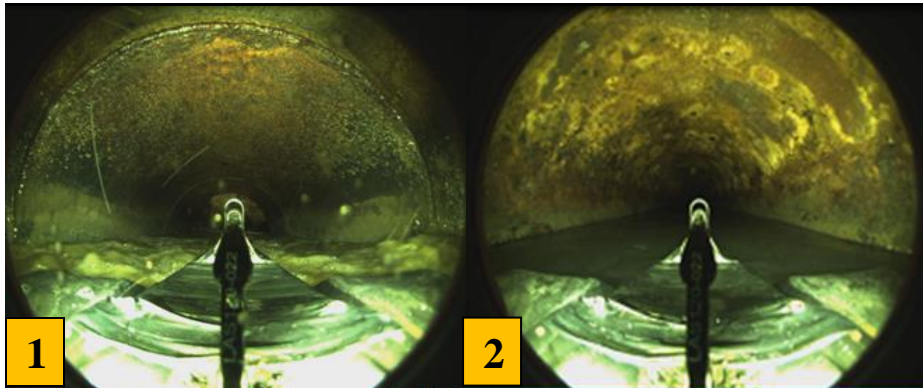
Figure A11-1 images from 1 through 2

SN	Distance (feet)	Video Ref.	Code	Continuous Defect	Value			Joint	Circumferential Location		Img Reference	Remarks
			Group/Descriptor/Modifier		Dimension		%		At/From	To		
					1st	2nd						
1	0		AMH									
2	2.65		MWL				10%					
3	52.5			S01						1		CORROSION
4	60.25			F01								CORROSION
5	85.05			S02						2		CORROSION
6	96.1			F02								CORROSION
9	1167.55		MSA

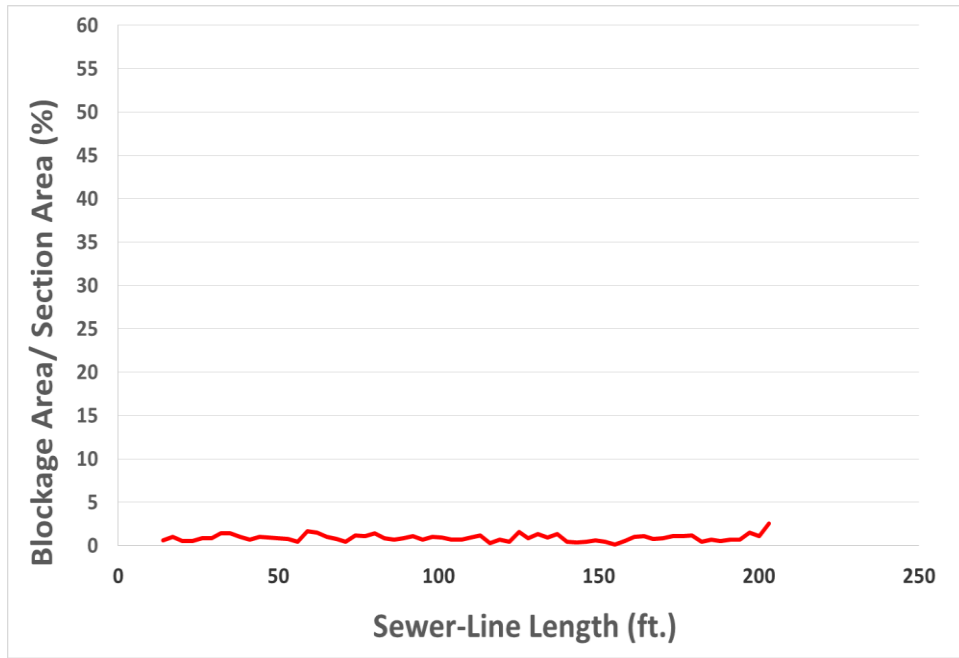
Figure A13-5 Blockage area (deposits and debris areas) percentage of pipe cross section area

LINE INSPECTION SUMMARY	
OBSERVATION METRIC	OBSERVATION
Distance Planned (ft.)	202
Percentage of The Line Not Inspected	6.18%
Total Collapsed	0
Total Fractures Multiple	0
Total Fractures Hinge	0
Total Fractures Longitudinal	0
Total Fractures Circumferential	0
Broken	0
Deformed Rigid	0
Joint Offsets	0
Total Roots Occurrences	0
Level 5 O&M Defects	0
Level 5 Structural Defects	0
Level 4 O&M Defects	3
Level 4 Structural Defects	0
Total Defects	4
Total Debris Volume (ft3)	19.88
Total Deposits Volume (in3)	2183.89
Maximum Blockage (%)	2.58
Maximum Deposit Height (in)	0.48

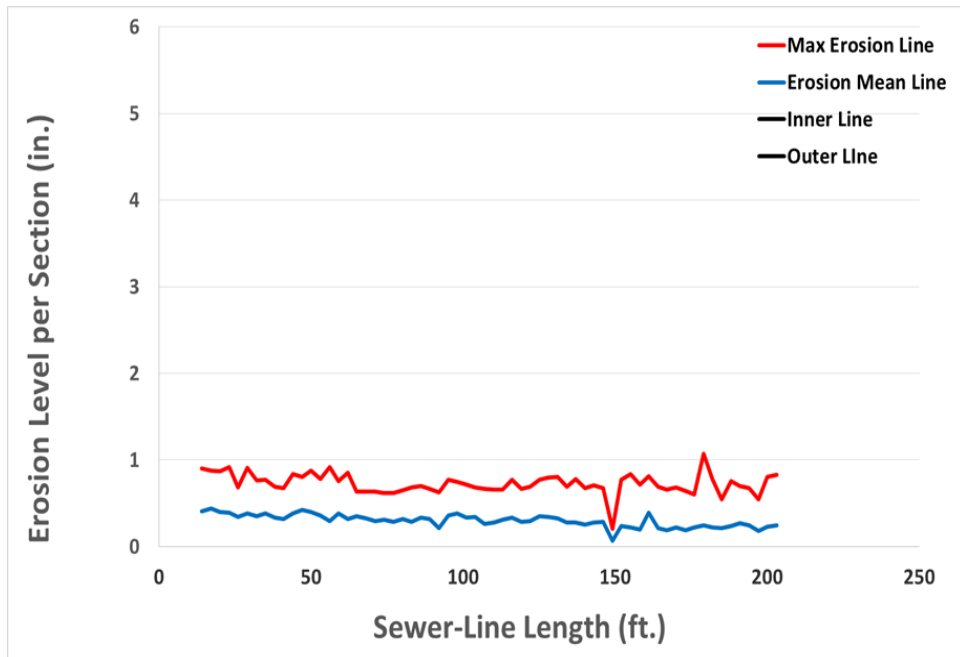
Figure A13-6 Erosion level per-section

Rank	Line ID	Observed Pipe Material	GIS Pipe Diameter (inches)	Observed Pipe Diameter (inches)	Approx. Max Erosion (Inches)	Approx. Mean Pipe Erosion (inches)
1	D09SL0032-33-3	RCP	48	48	1.07	0.3

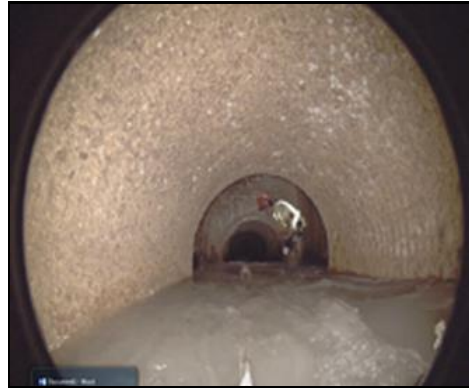
Figure A12-7 image 9

SN	Distance (feet)	Video Ref.	Code	Continuous Defect	Value			Joint	Circumferential Location		Img Reference	Remarks
			Group/Descriptor/Modifier		Dimension		%		At/From	To		
					1st	2nd						
1	0		AMH									
2	6.1		MWL				10%					
3	6.1		SRV								1	
4	7.75		SAV	S01							2,4,5	
5	9.8							J			3	MUD INTRUDING
6	160.45							J			6	MUD INTRUDING
7	161.9		SRV								7	
8	186.7		SRV	S02							8	
9	193.8		SRV	F02								
9	202.65		SAV	F01							9	
10	205.3		MSA

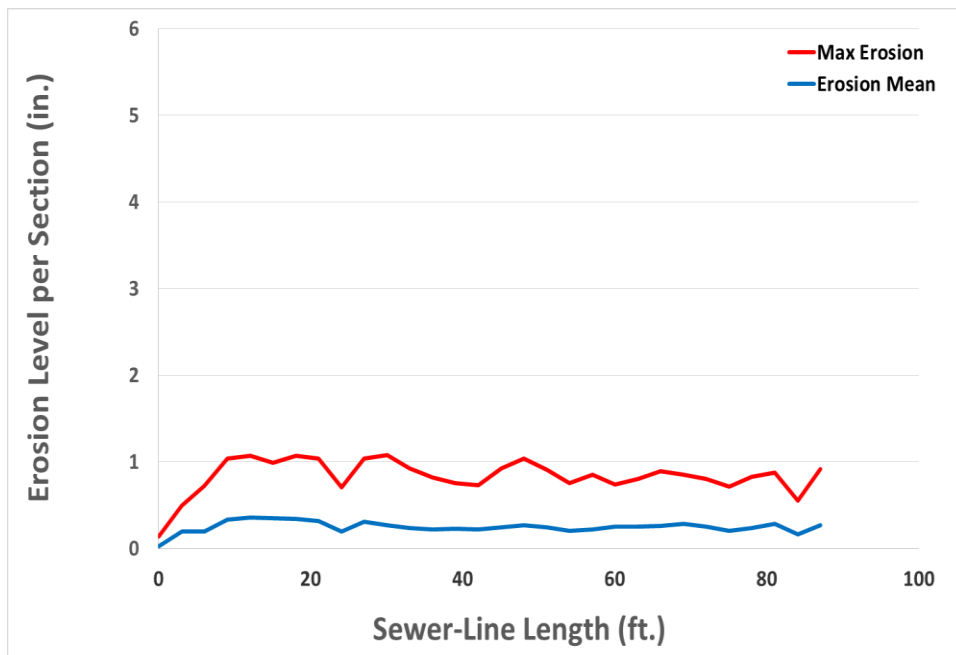
Figure A14-4 Erosion level per section.

Rank	Line ID	Observed Pipe Material	GIS Pipe Diameter (inches)	Observed Pipe Diameter (inches)	Approx. Max Erosion (Inches)	Approx. Mean Pipe Erosion (inches)
1	D09SL0189	RCP	60	60	1.08	0.25

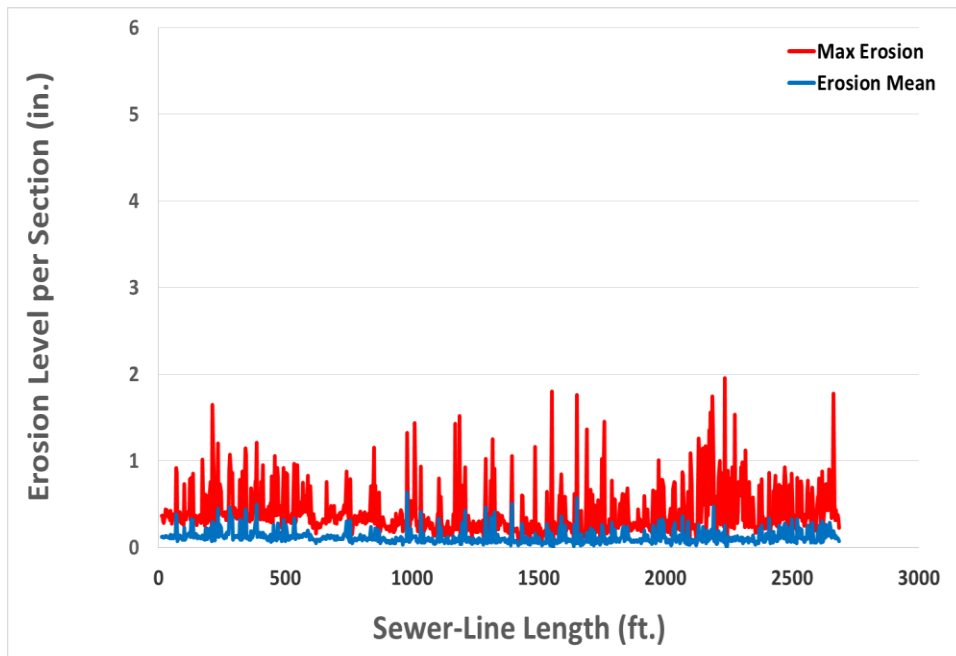
Figure A15-4 Erosion level per section

Rank	Line ID	Observed Pipe Material	GIS Pipe Diameter (inches)	Observed Pipe Diameter (inches)	Approx. Max Erosion (Inches)	Approx. Mean Pipe Erosion (inches)
1	D08SL0002	RCP	60	60	1.96	0.12

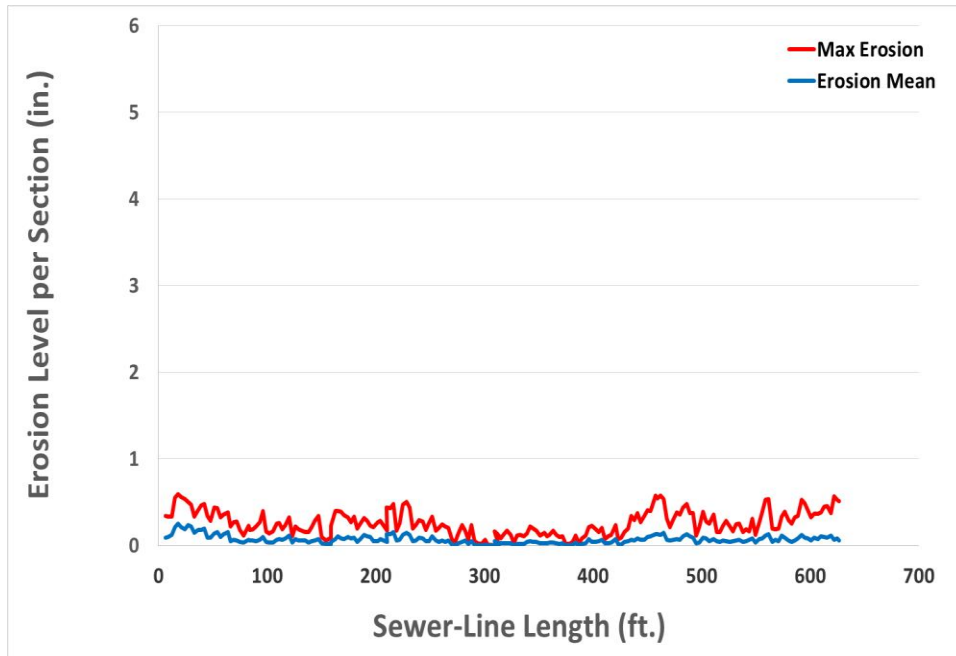
Figure A16-4 Erosion level per section

Rank	Line ID	Observed Pipe Material	GIS Pipe Diameter (inches)	Observed Pipe Diameter (inches)	Approx. Max Erosion (Inches)	Approx. Mean Pipe Erosion (inches)
1	D08SL0002	RCP	60	60	0.6	0.07

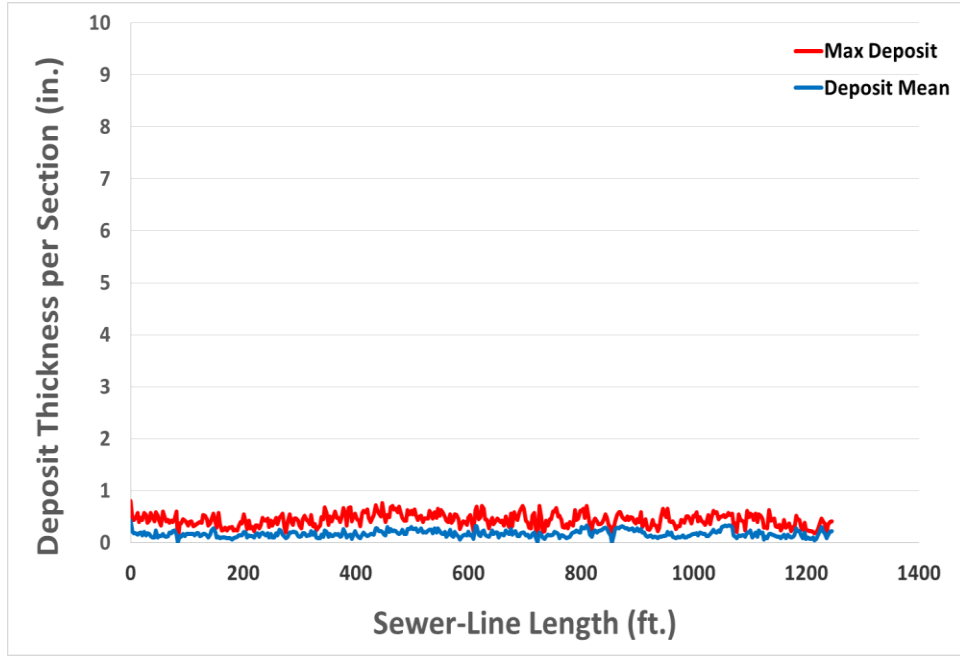
Figure A17-1 Deposit thickness per cross-section

LINE INSPECTION SUMMARY	
OBSERVATION METRIC	OBSERVATION
Distance Planned (ft.)	1391.8
Percentage of The Line Not Inspected	0%
Total Collapsed	0
Total Fractures Multiple	0
Total Fractures Hinge	0
Total Fractures Longitudinal	0
Total Fractures Circumferential	0
Broken	0
Deformed Rigid	0
Joint Offsets	0
Total Roots Occurrences	0
Level 5 O&M Defects	0
Level 5 Structural Defects	0
Level 4 O&M Defects	0
Level 4 Structural Defects	0
Total Defects	2
Total Debris Volume (ft3)	3261.21
Total Deposits Volume (in3)	220563.27
Maximum Blockage (%)	4.27
Maximum Deposit Height (in)	0.8

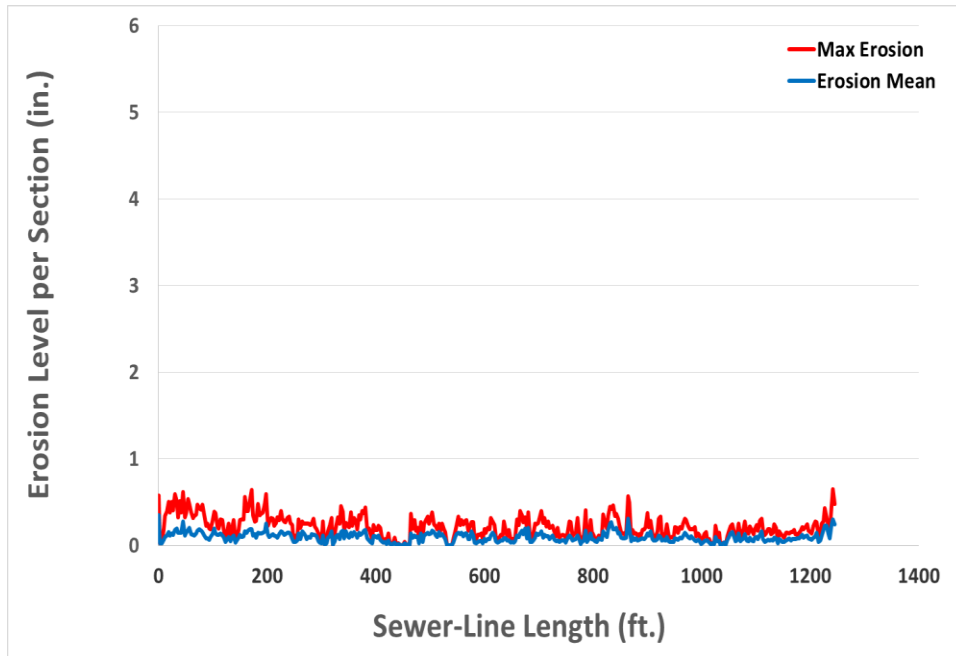
Figure A17-6 Erosion level per section

Rank	Line ID	Observed Pipe Material	GIS Pipe Diameter (inches)	Observed Pipe Diameter (inches)	Approx. Max Erosion (Inches)	Approx. Mean Pipe Erosion (inches)
1	E08SL0001	RCP	66	66	0.65	0.65

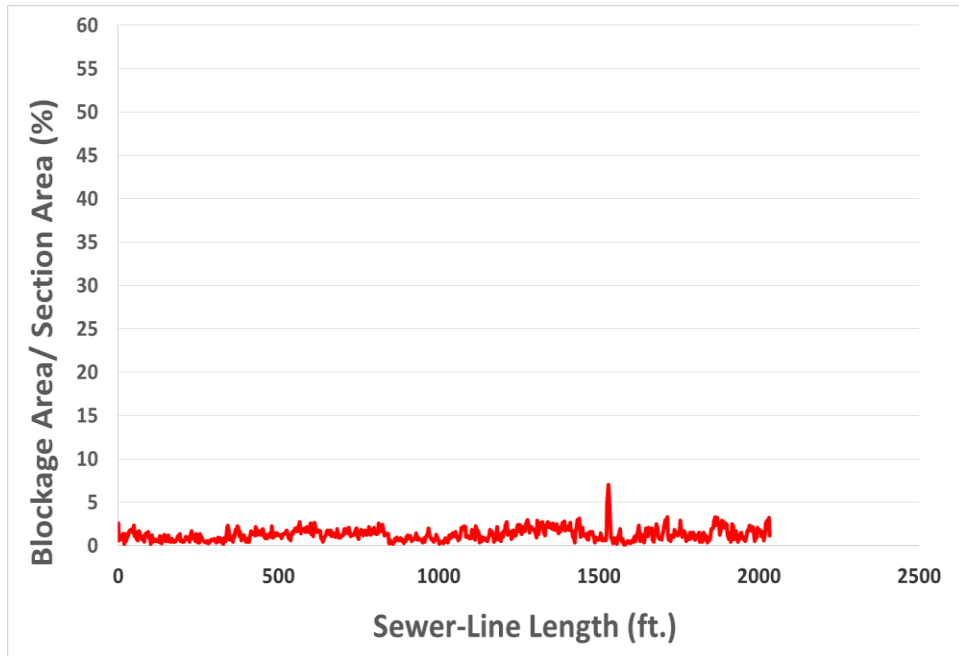
Figure A18-5 Blockage area (deposits and debris areas) percentage of pipe cross section area

LINE INSPECTION SUMMARY	
OBSERVATION METRIC	OBSERVATION
Distance Planned (ft.)	2090.5
Percentage of The Line Not Inspected	0%
Total Collapsed	0
Total Fractures Multiple	0
Total Fractures Hinge	0
Total Fractures Longitudinal	0
Total Fractures Circumferential	0
Broken	0
Deformed Rigid	0
Joint Offsets	0
Total Roots Occurrences	0
Level 5 O&M Defects	0
Level 5 Structural Defects	0
Level 4 O&M Defects	0
Level 4 Structural Defects	0
Total Defects	2
Total Debris Volume (ft3)	486.98
Total Deposits Volume (in3)	239652.49
Maximum Blockage (%)	6.99
Maximum Deposit Height (in)	1.00

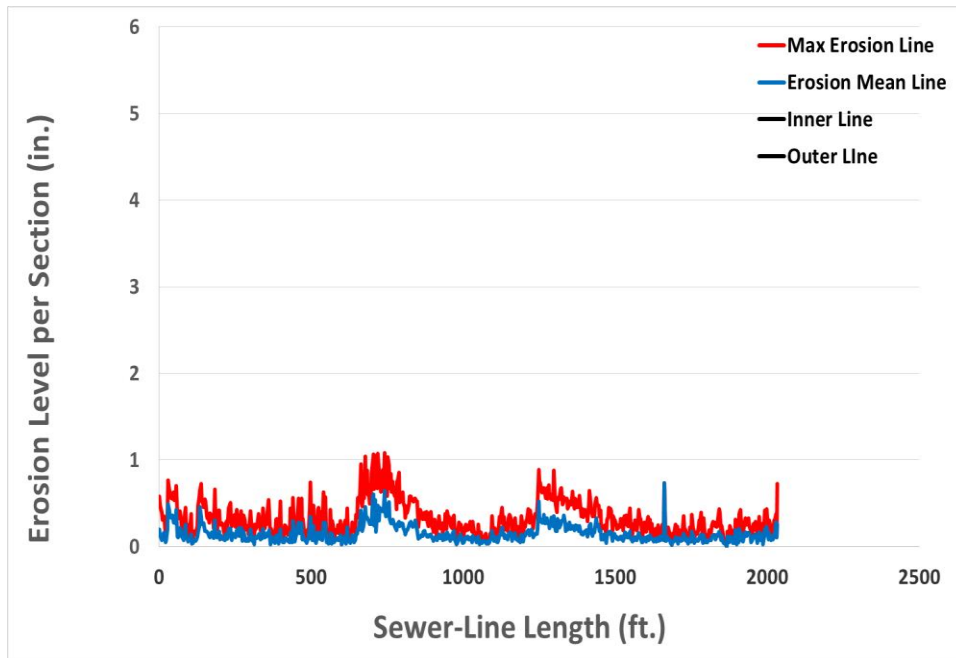
Figure A18-6 Erosion level per section

Rank	Line ID	Observed Pipe Material	GIS Pipe Diameter (inches)	Observed Pipe Diameter (inches)	Approx. Max Erosion (Inches)	Approx. Mean Pipe Erosion (inches)
1	E08SL0209-243	RCP	66	66	1.08	0.15

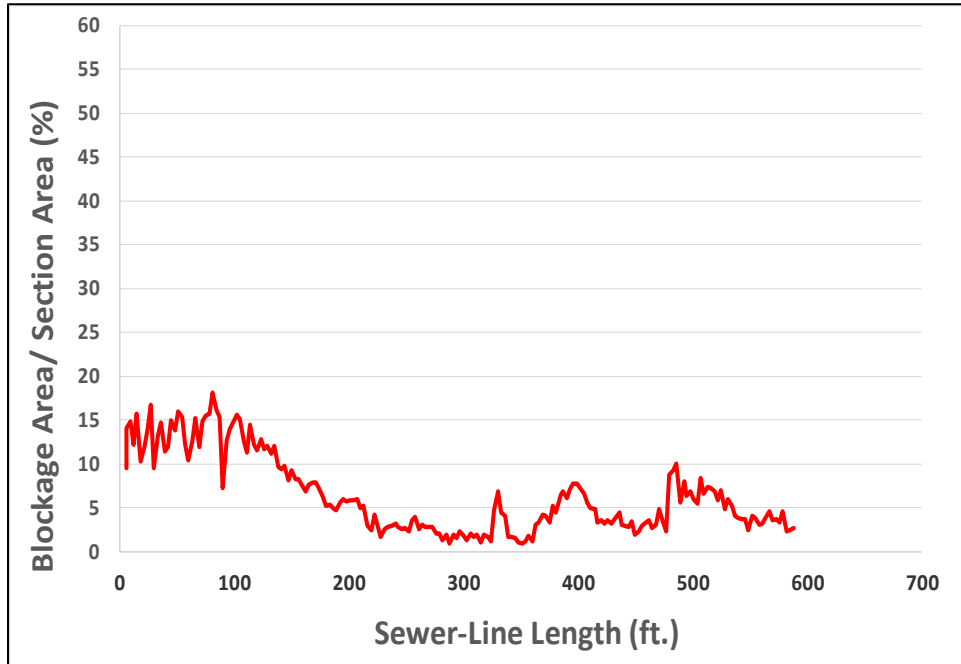
Figure A19-5 Blockage area (deposits and debris areas) percentage of pipe cross section area

LINE INSPECTION SUMMARY	
OBSERVATION METRIC	OBSERVATION
Distance Planned (ft.)	592
Percentage of The Line Not Inspected	0%
Total Collapsed	0
Total Fractures Multiple	0
Total Fractures Hinge	0
Total Fractures Longitudinal	0
Total Fractures Circumferential	0
Broken	0
Deformed Rigid	0
Joint Offsets	0
Total Roots Occurrences	0
Level 5 Defects	0
Level 4 Defects	2
Total Defects	18
Total Debris Volume (ft ³)	20.9
Total Deposits Volume (in ³)	49983.5
Maximum Blockage (%)	18
Maximum Deposit Height (in)	1.6

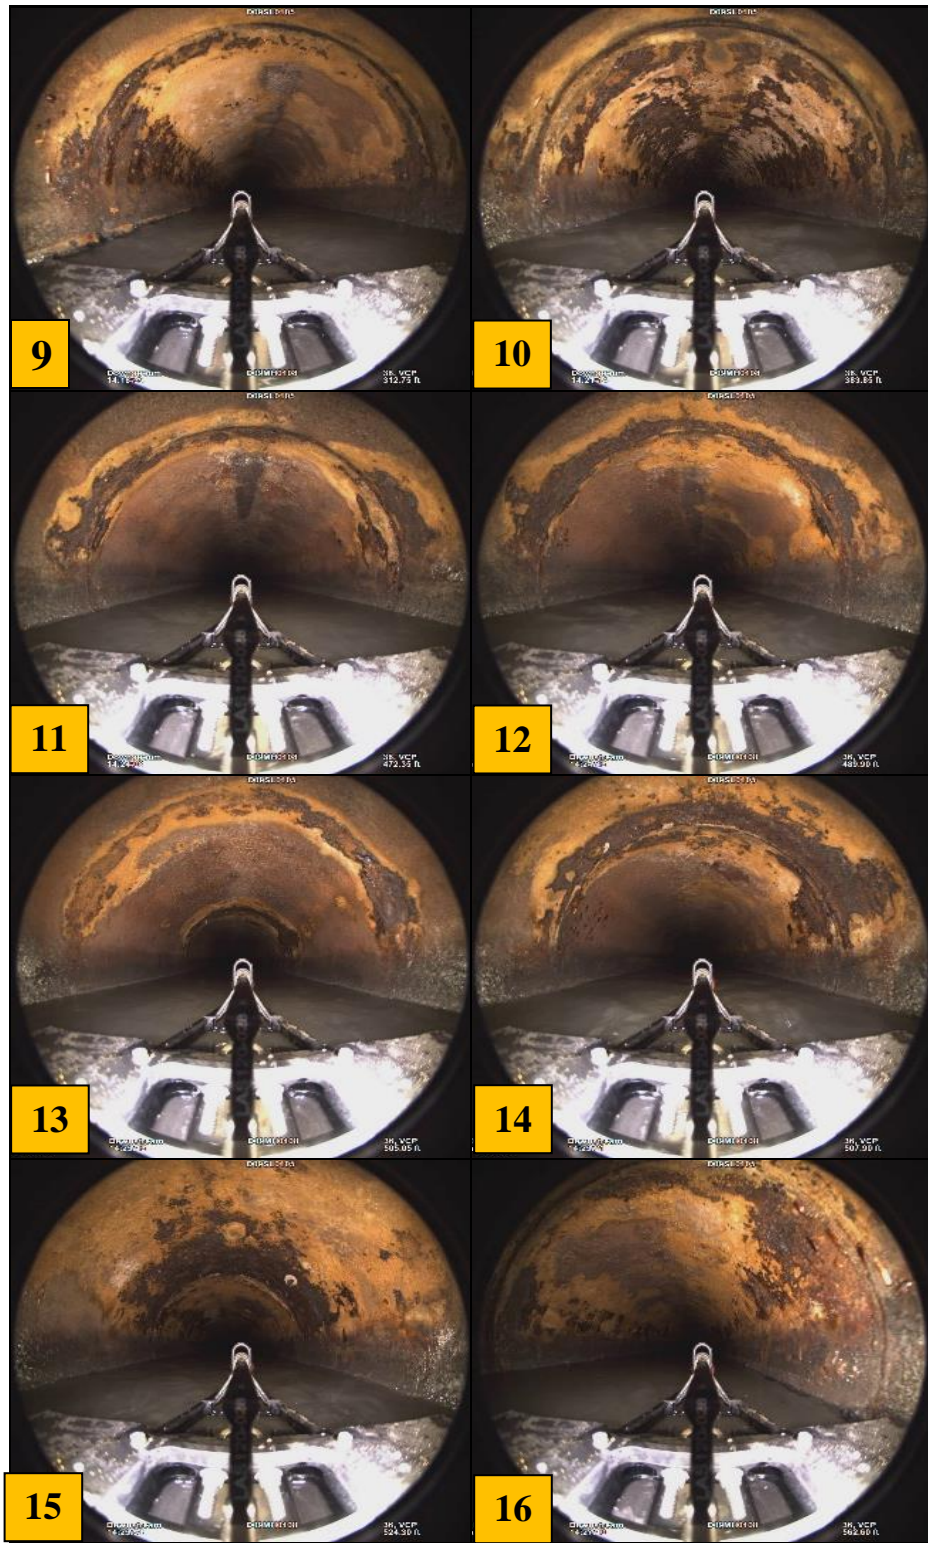
Figure A19-7 images from 9 through 16

SN	Distance (feet)	Video Ref.	Code Group/Descriptor/Modifier	Continuous Defect	Value		Joint	Circumferential Location		Img Reference	Remarks	
					Dimension			%	At/From			To
					1st	2nd						
1	0		AMH									
2	0		MWL			40%						
3	6		DAE	S01		30%				1	COVERED AS A LAYER	
4	6		DAG	S02		30%				1		
5	10.45		DAE	F01						2		
6	10.45		DAG	F02						2		
7	10.45		DAE	S03		20%				2 TO 7	COVERED AS A LAYER	
8	10.45		DAG	S04		20%				2 TO 7		
9	278.5		DAG	F04						17		
10	278.5		DAE	F03						17		
11	295.05		DAE			5%	J			8		
12	295.05		DAG			5%				8		
13	312.75		DAG	S05		5%				9		
14	312.75		DAE	S06		5%				9		
15	367.5		DAE	F06						18		
16	367.5		DAG	F05						18		
17	383.85		DAE	S07		10%				10		
18	383.85		DAG	S08		10%				10		
19	457.1		DAE	F07						19		
20	457.1		DAG	F08						19		
21	472.35		DAG			5%	J			11		
22	489.9		DAG			5%	J			12		
23	505.05		DAG			5%				13		
24	507.9		DAG			5%				14		
25	524.3		DAG	S09		5%				15		
26	524.3		DAE	S10		5%				15

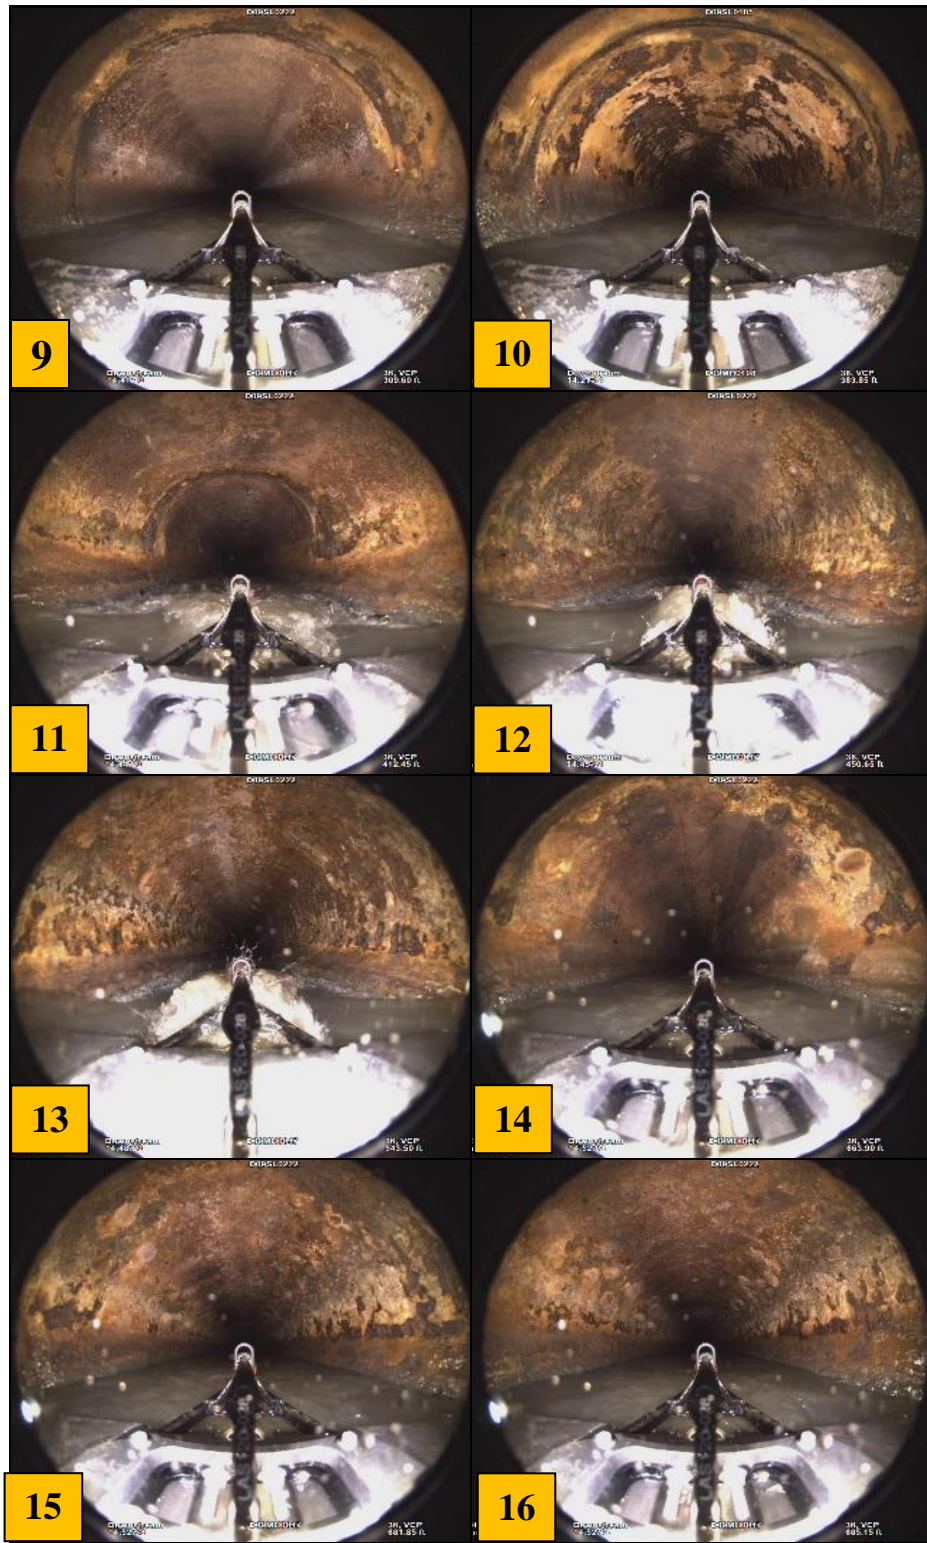
Figure A20-7 images from 9 through 16

SN	Distance (feet)	Video Ref.	Code Group/ Descriptor/ Modifier	Continuous Defect	Value		Joint	Circumferential Location		Img Reference	Remarks	
					Dimension			%	At/From			To
					1st	2nd						
1	0		AMH									
2	0		MWL			30%						
3	5.35		DAG	S01		10%				1		
4	43		DAG	F01						17		
5	76.9		DAG	S02		10%				2		
6	95.2		DAG	F02						18		
7	112.5		DAG	S03		10%				3		
8	127.8		DAE	S04		15%				4		
9	132		DAG	F03						19		
10	166.2		DAG			10%				5		
11	220.8		DAG			10%				6		
12	239.75		DAE	F04						20		
13	256.65		DAG			5%				7		
14	274.2		DAG	S05		10%				8		
15	292.95		DAG	F05						21		
16	309.6		DAG			5%	J			9		
17	379.9		DAG			5%	J			10		
18	412.45		DAG	S06		5%				11		
19	415.1		DAG	F06						22		
20	450.65		DAG	S07		10%				12,13		
21	642.05		DAG	F07						23		
22	663.7		DAG			5%				14		
23	681.85		DAG	S09		10%				15,24		
24	700		DAG	F09						25		
25	721.3		DAG	S10		5%				16		
26	735.4		DAG	F10						26		
27	747.2		MSA

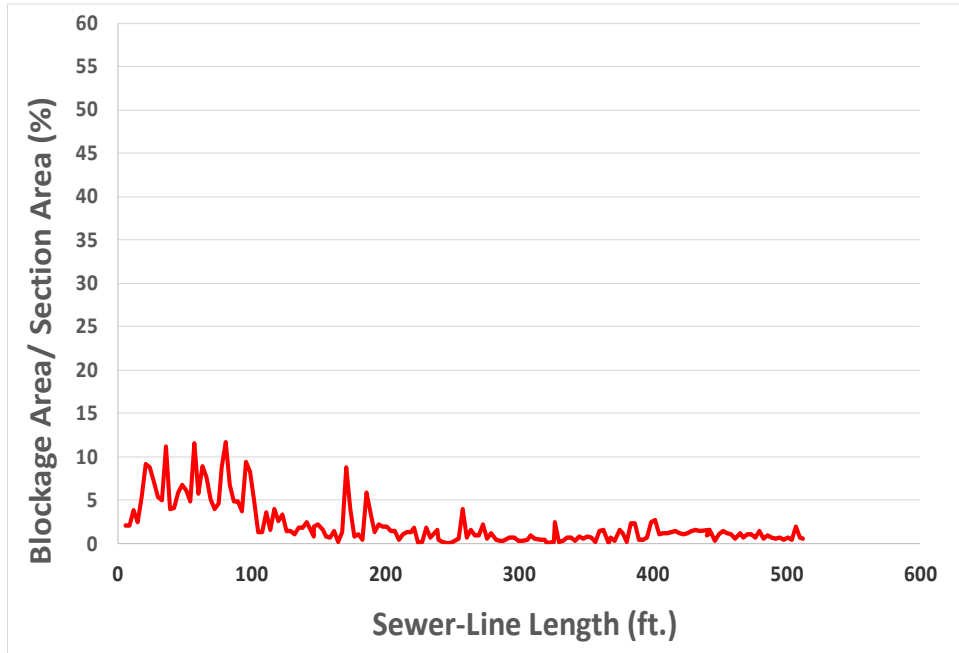
Figure A22-5 Blockage area (deposits and debris areas) percentage of pipe cross section area

LINE INSPECTION SUMMARY	
OBSERVATION METRIC	OBSERVATION
Distance Planned (ft.)	519
Percentage of The Line Not Inspected	0%
Total Collapsed	0
Total Fractures Multiple	6
Total Fractures Hinge	3
Total Fractures Longitudinal	24
Total Fractures Circumferential	2
Broken	0
Deformed Rigid	0
Joint Offsets	0
Total Roots Occurrences	0
Level 5 Defects	0
Level 4 Defects	9
Total Defects	39
Total Debris Volume (ft ³)	24.3
Total Deposits Volume (in ³)	27338.7
Maximum Blockage (%)	11.6
Maximum Deposit Height (in)	0.9

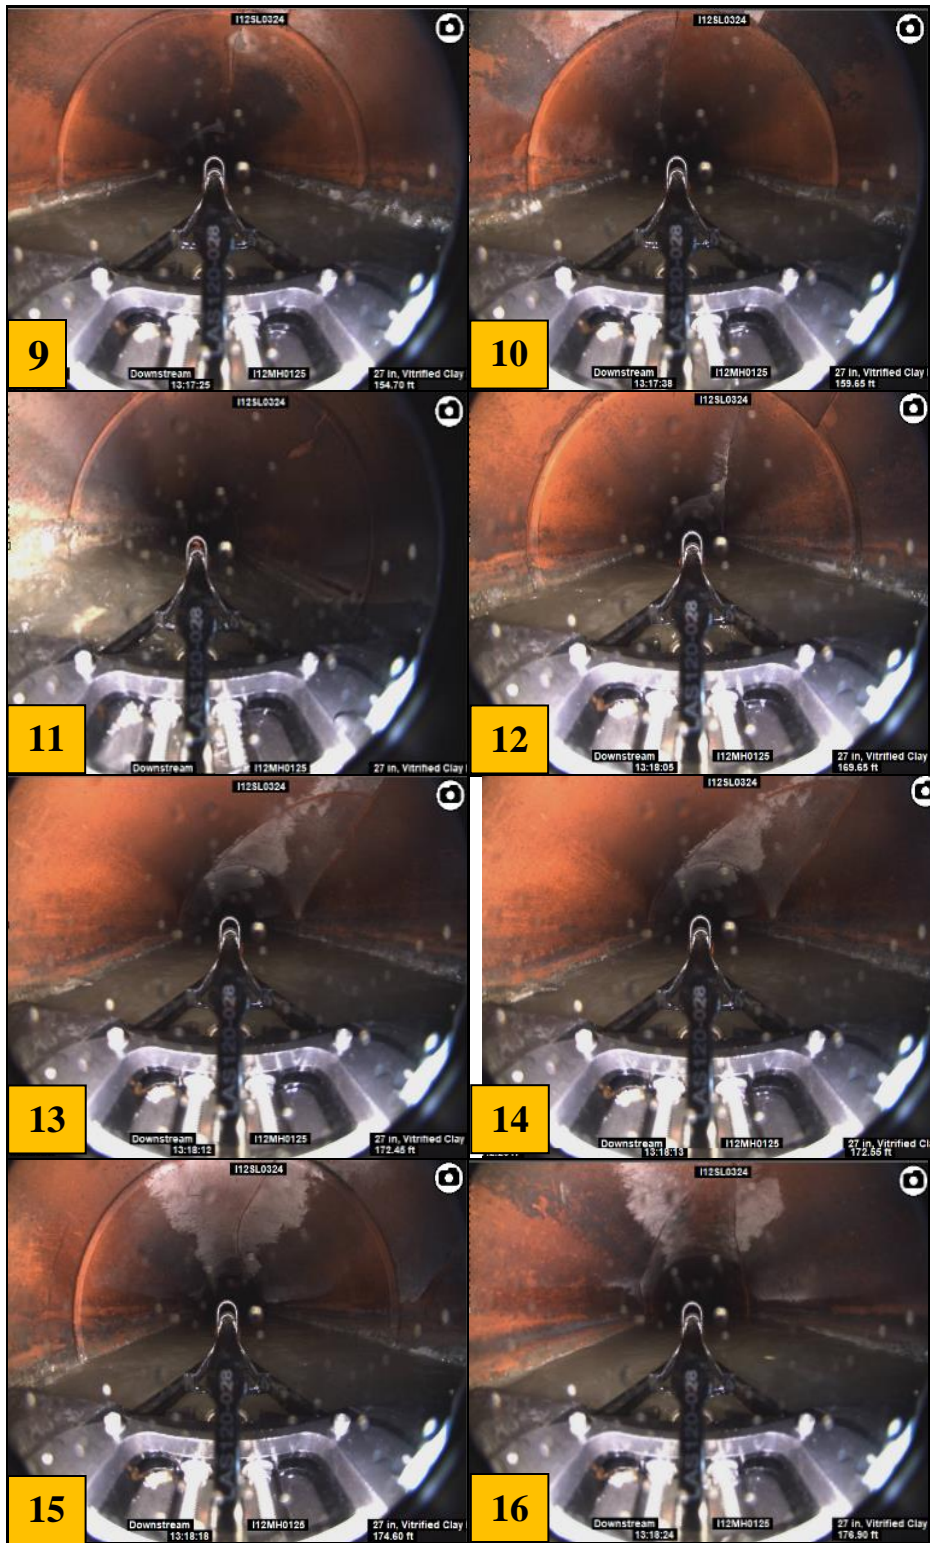
Figure A22-7 images from 9 through 16

SN	Distance (feet)	Video Ref.	Code Group/Descriptor/Modifier	Continuous Defect	Value			Joint	Circumferential Location		Img Reference	Remarks
					Dimension		%		At/From	To		
					1st	2nd						
1	0		AMH									
2	6		MWL				10%					
3	60.5		DAE	S01			10%				1,2	
4	65.05		DAE	F01							70	
5	125.6		FL	S02				J			3,38	LASER SHOWS VERY LITTLE VERTICAL FRACTURE MOVEMENT
6	139.55		FL	F02							4	
7	139.55		FM					J			4,39	LASER SHOWS LITTLE VERTICAL FRACTURE MOVEMENT
8	144.85		FL	S03				J			5,40	LASER SHOWS VERY LITTLE FRACTURE HORIZONTAL AND VERTICAL MOVEMENT
9	148.2		FL	F03				J			6	LASER SHOWS VERY LITTLE VERTICAL FRACTURE MOVEMENT
10	148.2		FM								6,41	LASER SHOWS VERY LITTLE VERTICAL FRACTURE MOVEMENT
11	149.7		FL	S04				J			7,42	LASER SHOWS VERY LITTLE FRACTURE OPENING
12	150.25		FC								8,43	LASER DOESN'T SHOW FRACTURE MOVEMENT
13	154.7		FL	F04				J			9	
14	154.7		FL	S05				J			9,44	LASER SHOWS LITTLE HORIZONTAL FRACTURE MOVEMENT

15	159.65		FL	F05				J			10	
16	159.65		FL	S06				J			10,45	LASER SHOWS LITTLE HORIZONTAL FRACTURE MOVEMENT
17	164.6		FL	F06				J			11

18	164.6		FL	S07				J			11,46	LASER SHOWS LITTLE VERTICAL FRACTURE MOVEMENT
19	169.65		FL	F07				J			12	
20	169.65		FL	S08				J			12,47	LASER SHOWS LITTLE VERTICAL FRACTURE MOVEMENT
21	172.45		FL	F08				J			13	
22	172.45		FL	S09				J			13,48	LASER SHOWS LITTLE VERTICAL FRACTURE MOVEMENT
23	172.55		FL	F09							14	
24	172.55		FM	S10							14,49	LASER SHOWS LITTLE VERTICAL FRACTURE MOVEMENT
25	174.6		FM	F10				J			15	
26	174.6		FL								15,50	LASER SHOWS LITTLE HORIZONTAL FRACTURE MOVEMENT
27	176.94		FM	S11							16,51	LASER DOESN'T SHOW FRACTURE OPENING
28	179.65		FM	F11							71	
29	188.8		DAE	S12			10%	J			17	
30	198.85		DAE	F12							72	
31	236.6		FL	S13							18,19	
32	243.85		FL	F13							20	
33	256.7		FL								21	JUST 1 FOOT
34	323.35		DAE	S14			15%				52	
35	328.15		DAE	F14							75	
36	358.1		DAE	S15			15%				73	
37	362.95		DAE	F15							74	
38	402.15		FL	S16				J			22,53	LASER DOESN'T SHOW FRACTURE OPENING

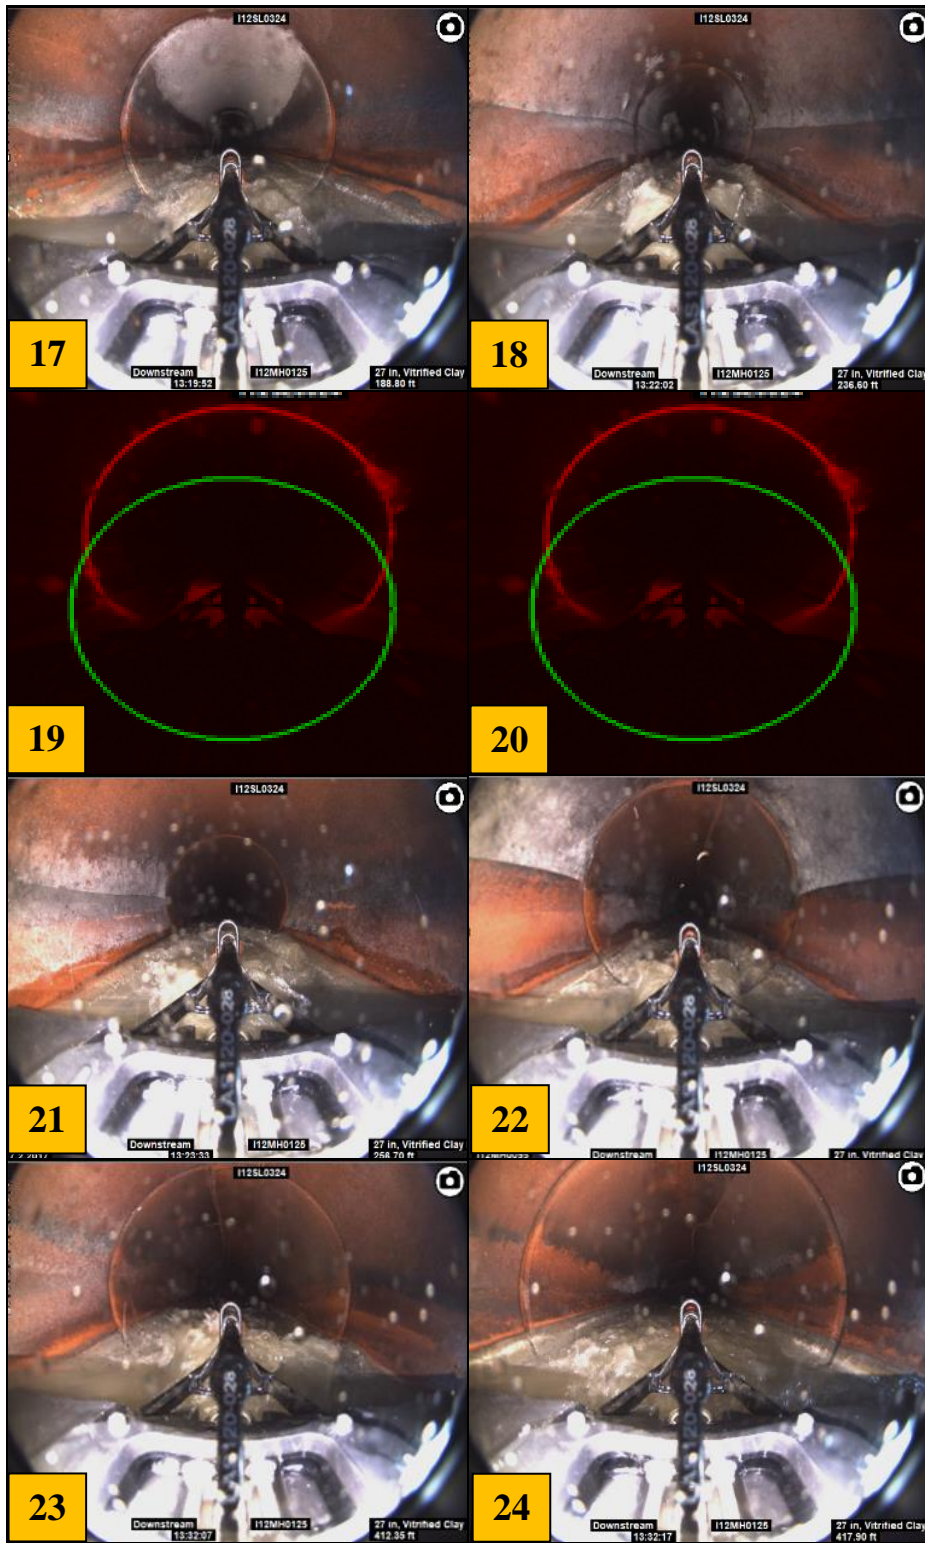
Figure A22-8 images from 17 through 24

39	412.35		FL	F16				J			23	
40	412.35		FL	S17				J			23,54	LASER SHOWS BOTH HORIZONTAL AND VERTICAL FRACTURE MOVEMENT
41	417.9		FL	F17				J			24	
42	417.9		FL	S18				J			24,55	LASER SHOWS LITTLE VERTICAL FRACTURE MOVEMENT
43	423.2		FL	F18				J			25	
44	423.2		FH3	S19				J			25,56	LASER SHOWS LITTLE HORIZONTAL MOVEMENT AND LASER RING DEFORMED
45	428		FH3	F19				J			26	
46	428		FL	S20				J			26,57	LASER SHOWS LITTLE HORIZONTAL MOVEMENT AND LASER RING DEFORMED

47	432.85		FL	F20			J			27	
48	432.85		FL	S21			J			27,58	LASER SHOWS LITTLE HORIZONTAL FRACTURE MOVEMENT AND LASER RING DEFORMED
49	432.85		FL	S22			J			27,58	LASER SHOWS LITTLE HORIZONTAL FRACTURE MOVEMENT AND LASER RING DEFORMED
50	438.25		FL	F21			J			28	
51	438.25		FL	F22			J			28	
52	438.25		FH3	S23			J			28,59	LASER SHOWS BOTH HORIZONTAL AND VERTICAL FRACTURE MOVEMENT AND LASER RING DEFORMED
53	439.8		FC							64	LASER SHOWS LITTLE HORIZONTAL FRACTURE MOVEMENT AND LASER RING DEFORMED
54	443.3		FH3	F23			J			29	
55	443.3		FH3	S24			J			29,60	LASER SHOWS BOTH HORIZONTAL AND VERTICAL FRACTURE MOVEMENT AND LASER RING DEFORMED
56	447.3		FH3	F24			J			30	
57	447.3		FL	S25			J			30,61	LASER SHOWS VERTICAL FRACTURE MOVEMENT AND LASER RING DEFORMED
58	452.8		FL	F25			J			31	
59	452.8		FL	S26			J			31,62	LASER SHOWS VERTICAL FRACTURE MOVEMENT AND LASER RING DEFORMED
60	452.8		FL	S27			J			31,62	LASER SHOWS VERTICAL FRACTURE MOVEMENT AND LASER RING DEFORMED
