ALGORITHM DEVELOPMENT FOR SEWER PIPE SYSTEM CONDITION
ASSESSMENT USING MULTI-SENSOR (MSI) TECHNOLOGY

ALGORITHM DEVELOPMENT FOR SEWER PIPE SYSTEM CONDITION ASSESSMENT USING MULTI-SENSOR (MSI) TECHNOLOGY

This study investigates the performance of all the current large-diameter pipeline system of The City of Arlington (COA) sewer lines of 48 miles (24-inch inner diameter and above for rigid and flexible pipes). Proper inspection and rehabilitation plan for the city sewer pipeline system are better choice for the municipality and tax payers in terms of cost than dealing with pipe damage and collapsing problems when they happen.

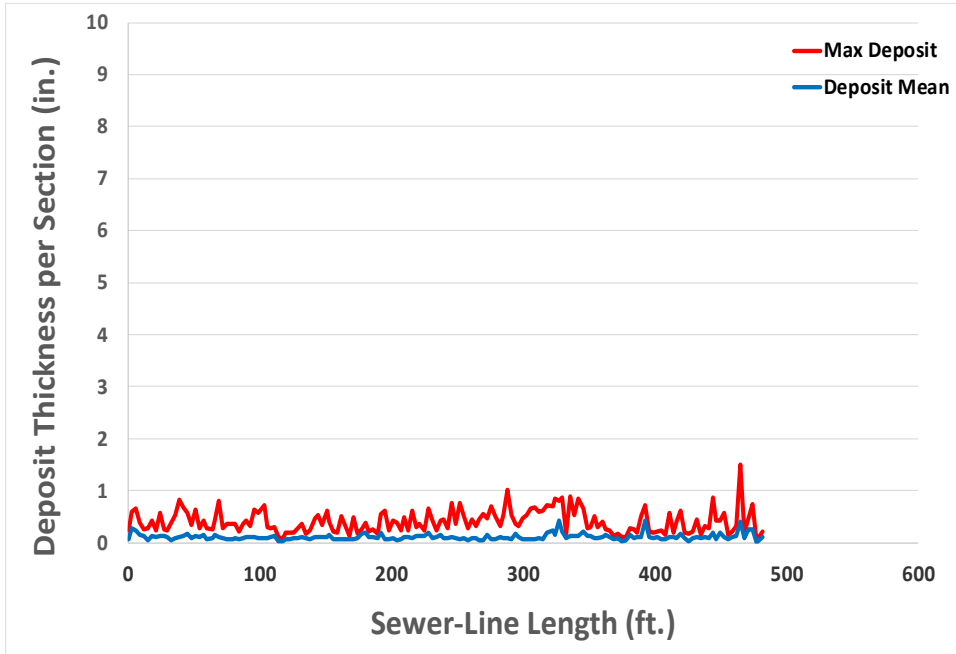
Figure A23-1 Deposit thickness per cross-section

LINE INSPECTION SUMMARY	
OBSERVATION METRIC	OBSERVATION
Distance Planned (ft.)	495
Percentage of The Line Not Inspected	2.3%
Total Collapsed	0
Total Fractures Multiple	0
Total Fractures Hinge	0
Total Fractures Longitudinal	4
Total Fractures Circumferential	0
Broken	0
Deformed Rigid	0
Joint Offsets	0
Total Roots Occurrences	0
Level 5 Defects	0
Level 4 Defects	0
Total Defects	4
Total Debris Volume (ft ³)	168.6
Total Deposits Volume (in ³)	25492.6
Maximum Blockage (%)	28.3
Maximum Deposit Height (in)	1.4

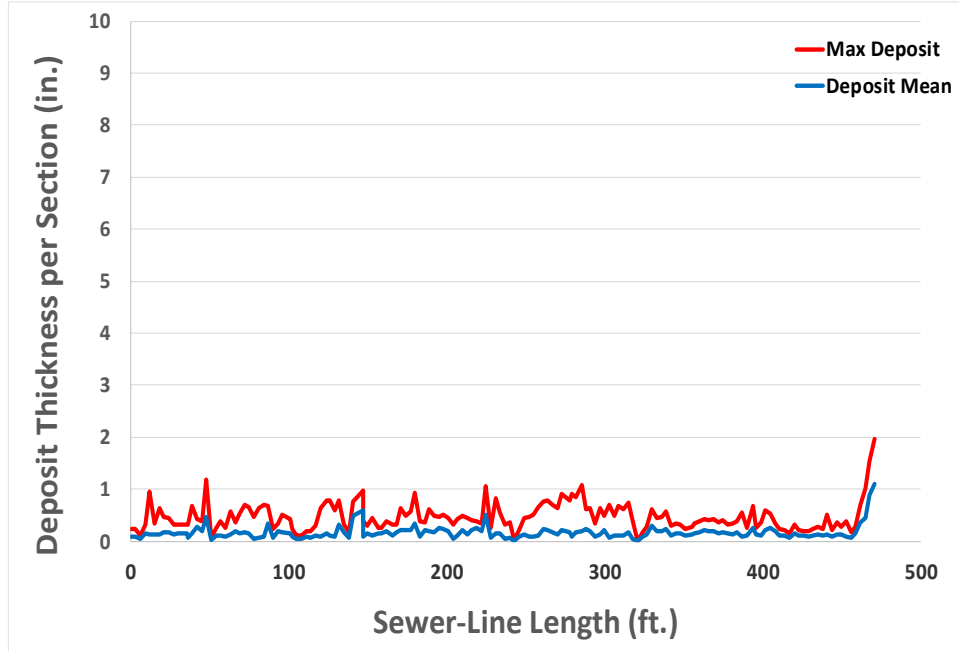
Figure A24-1 Deposit thickness per cross-section

LINE INSPECTION SUMMARY	
OBSERVATION METRIC	OBSERVATION
Distance Planned (ft.)	483
Percentage of The Line Not Inspected	0%
Total Collapsed	0
Total Fractures Multiple	1
Total Fractures Hinge	0
Total Fractures Longitudinal	16
Total Fractures Circumferential	0
Broken	0
Deformed Rigid	0
Joint Offsets	0
Total Roots Occurrences	0
Level 5 Defects	0
Level 4 Defects	1
Total Defects	18
Total Debris Volume (ft ³)	93.9
Total Deposits Volume (in ³)	40538.9
Maximum Blockage (%)	25.2
Maximum Deposit Height (in)	1.9

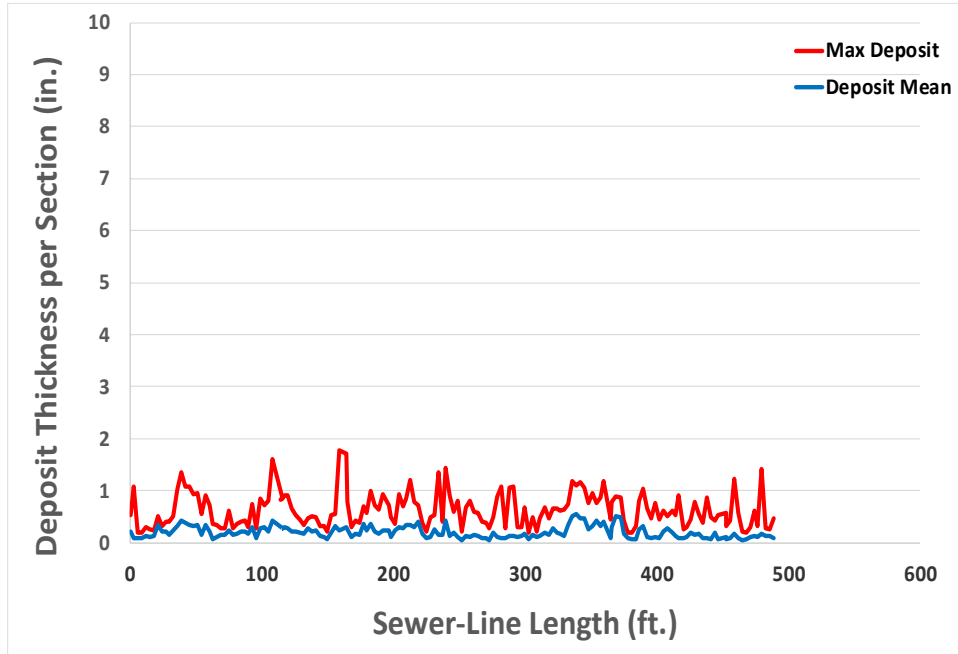
Figure A25-1 Deposit thickness per cross-section

LINE INSPECTION SUMMARY	
OBSERVATION METRIC	OBSERVATION
Distance Planned (ft.)	501
Percentage of The Line Not Inspected	0%
Total Collapsed	0
Total Fractures Multiple	11
Total Fractures Hinge	0
Total Fractures Longitudinal	20
Total Fractures Circumferential	0
Broken	1
Deformed Rigid	0
Joint Offsets	0
Total Roots Occurrences	10
Level 5 Defects	0
Level 4 Defects	12
Total Defects	41
Total Debris Volume (ft ³)	9.8
Total Deposits Volume (in ³)	50329.6
Maximum Blockage (%)	8.2
Maximum Deposit Height (in)	1.7

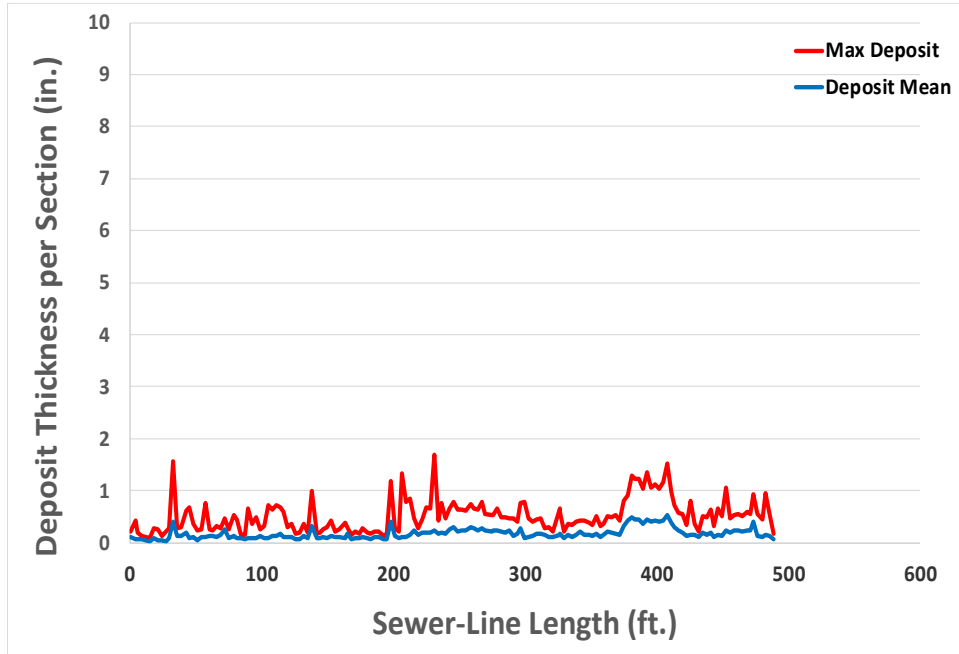
Figure A26-1 Deposit thickness per cross-section

LINE INSPECTION SUMMARY	
OBSERVATION METRIC	OBSERVATION
Distance Planned (ft.)	418.8
Percentage of The Line Not Inspected	0%
Total Collapsed	0
Total Fractures Multiple	8
Total Fractures Hinge	0
Total Fractures Longitudinal	39
Total Fractures Circumferential	0
Broken	0
Deformed Rigid	2
Joint Offsets	0
Total Roots Occurrences	0
Level 5 Defects	0
Level 4 Defects	10
Total Defects	53
Total Debris Volume (ft ³)	81
Total Deposits Volume (in ³)	38161.8
Maximum Blockage (%)	24.4
Maximum Deposit Height (in)	1.6

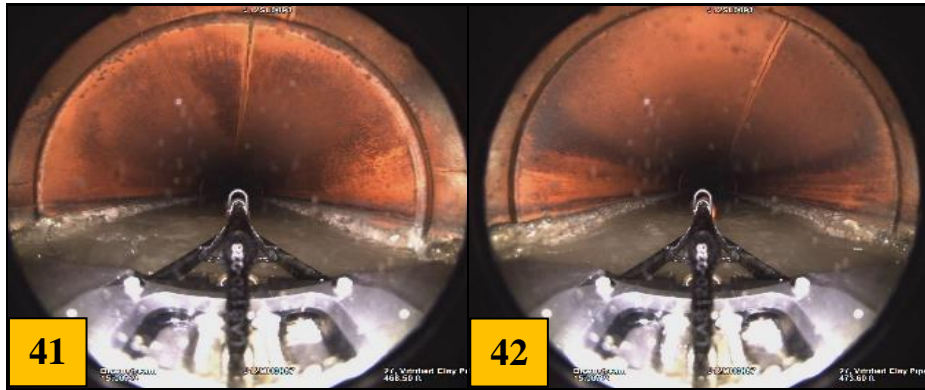
Figure A25-10 images from 41 through 42

82	438.6		FL	S35				J			36,84	LASER SHOWS VERY VERY LITTLE HORIZONTAL FRACTURE MOVEMENT
83	443.65		FL	F35				J			37	
84	443.65		FL	S36				J			37,85	LASER SHOWS VERY VERY LITTLE HORIZONTAL FRACTURE MOVEMENT
85	448.65		FL	F36				J			38	
86	448.65		FL	S37				J			38,86	LASER DOESN'T SHOW FRACTURE OPENING
87	453.4		FL	F37				J			39	
88	453.4		FL	S38				J			39,87	LASER DOESN'T SHOW FRACTURE OPENING
89	458.65		FL	F38				J			40	
90	458.65		FL	S39				J			40,88	LASER DOESN'T SHOW FRACTURE OPENING
91	463.5		FL	F39				J			41	
92	463.5		FL	S40				J			41,89	LASER SHOWS VERY VERY LITTLE HORIZONTAL FRACTURE MOVEMENT
93	468.5		FL	F40				J			42	
94	468.5		FL	S41				J			42,90	LASER DOESN'T SHOW FRACTURE OPENING
99	473.6		FL	F41				J			43	
96	473.6		FL	S42				J			43,91	LASER DOESN'T SHOW FRACTURE OPENING
97	478.75		FL	F42							44	
98	490.45		MSA

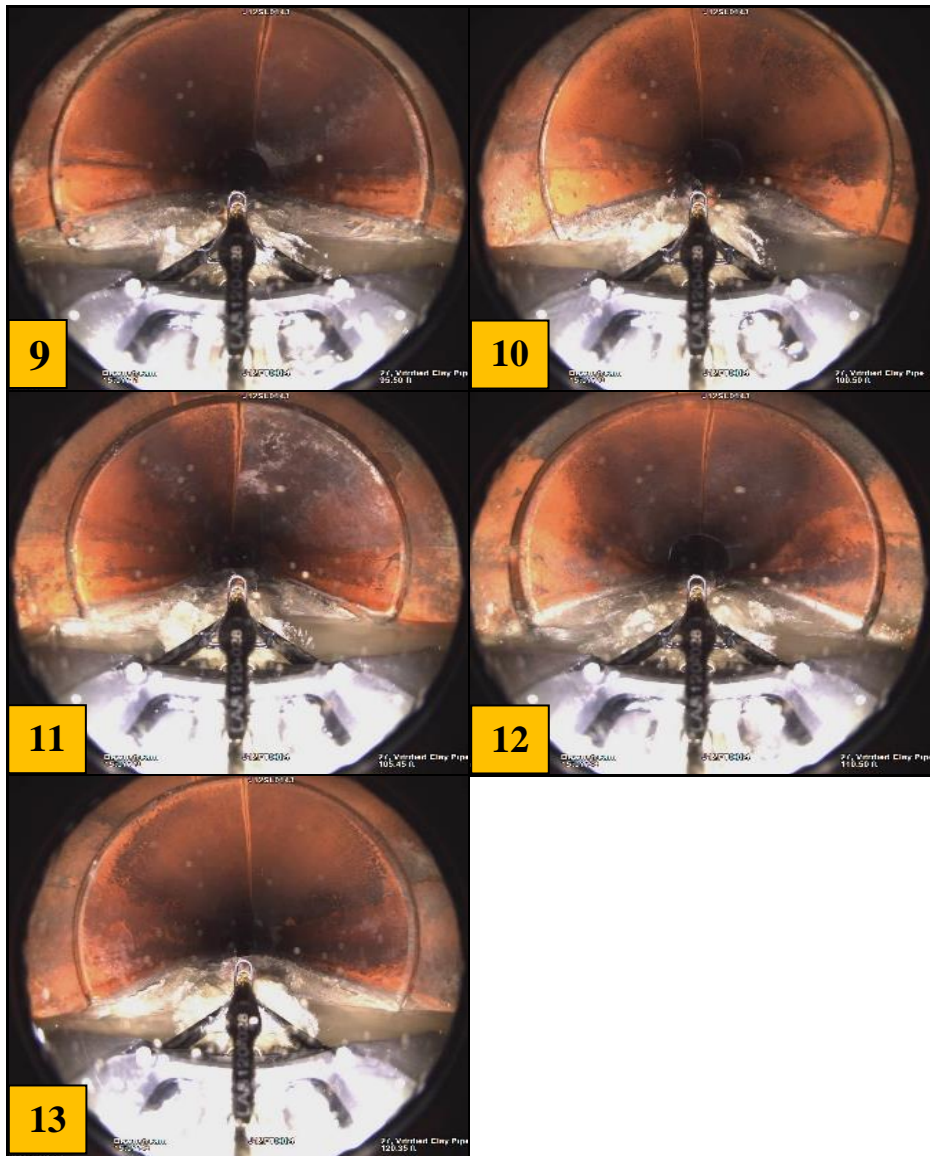
Figure A28-5 images from 9 through 13

18	95.5		FL	F08			J			9	
19	95.5		FL	S09			J			9,22	LASER SHOWS VERY VERY LITTLE HORIZONTAL FRACTURE MOVEMENT AND LASER RING DEFORMED
20	100.5		FL	F09			J			10	
21	100.5		FL	S10			J			10,23	LASER DOESN'T SHOW FRACTURE MOVEMENT
22	105.45		FL	F10			J			11	
23	105.45		FL	S11			J			11,24	LASER SHOWS VERY LITTLE HORIZONTAL FRACTURE MOVEMENT AND LASER RING DEFORMED
24	110.5		FL	F11			J			12	
25	110.5		FL	S12			J			12,25	LASER SHOWS VERY LITTLE HORIZONTAL FRACTURE MOVEMENT AND LASER RING DEFORMED
26	120.35		FL	F12			J			13	
27	120.35		FL	S13			J			13,26	LASER DOESN'T SHOW FRACTURE MOVEMENT
28	125.45		FL	F13						29	
29	162.25		MSA

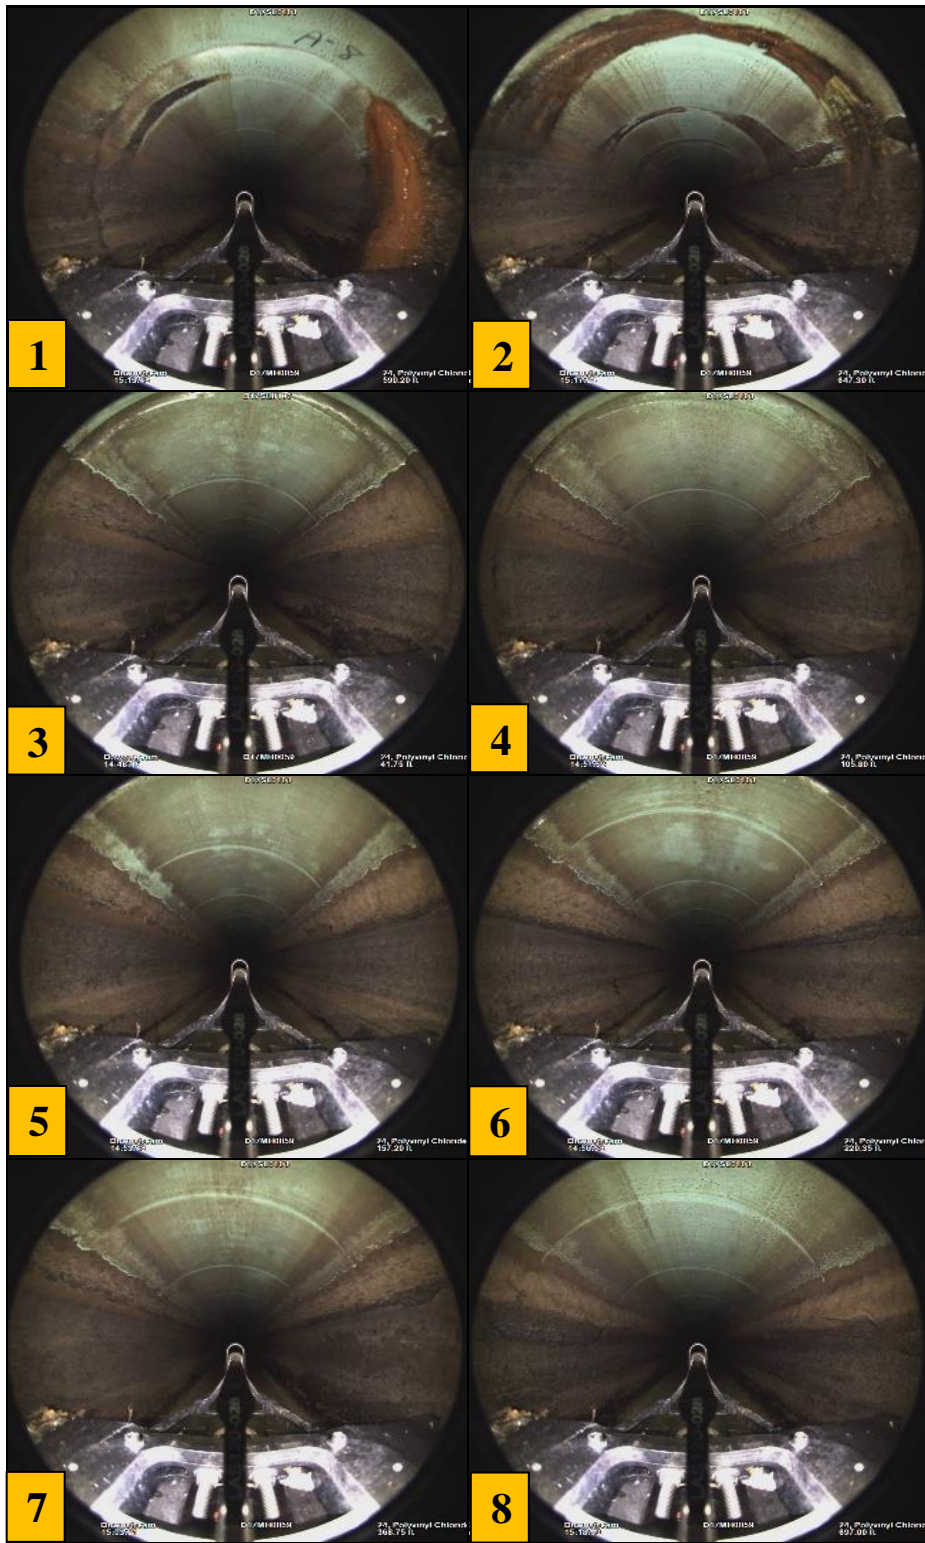
Figure A34-4 images from 1 through 8

SN	Distance (feet)	Video Ref.	Code Group/ Descriptor/ Modifier	Continuous Defect	Value			Joint	Circumferential Location		Img Reference	Remarks
					Dimension		%		At/From	To		
					1st	2nd						
1	0		AMH									
2	0		MWL				0%					
3	6		DAE	S01			5%				3 TO 8	
4	590.2		RMJ				5%	J			1	MIGHT BE MUD ENTERING IN TO THE PIPE THROUGH A FRACTURE.
5	647.3		DAG				5%				2	
6	851		DAE	F01								
7	851		MSA

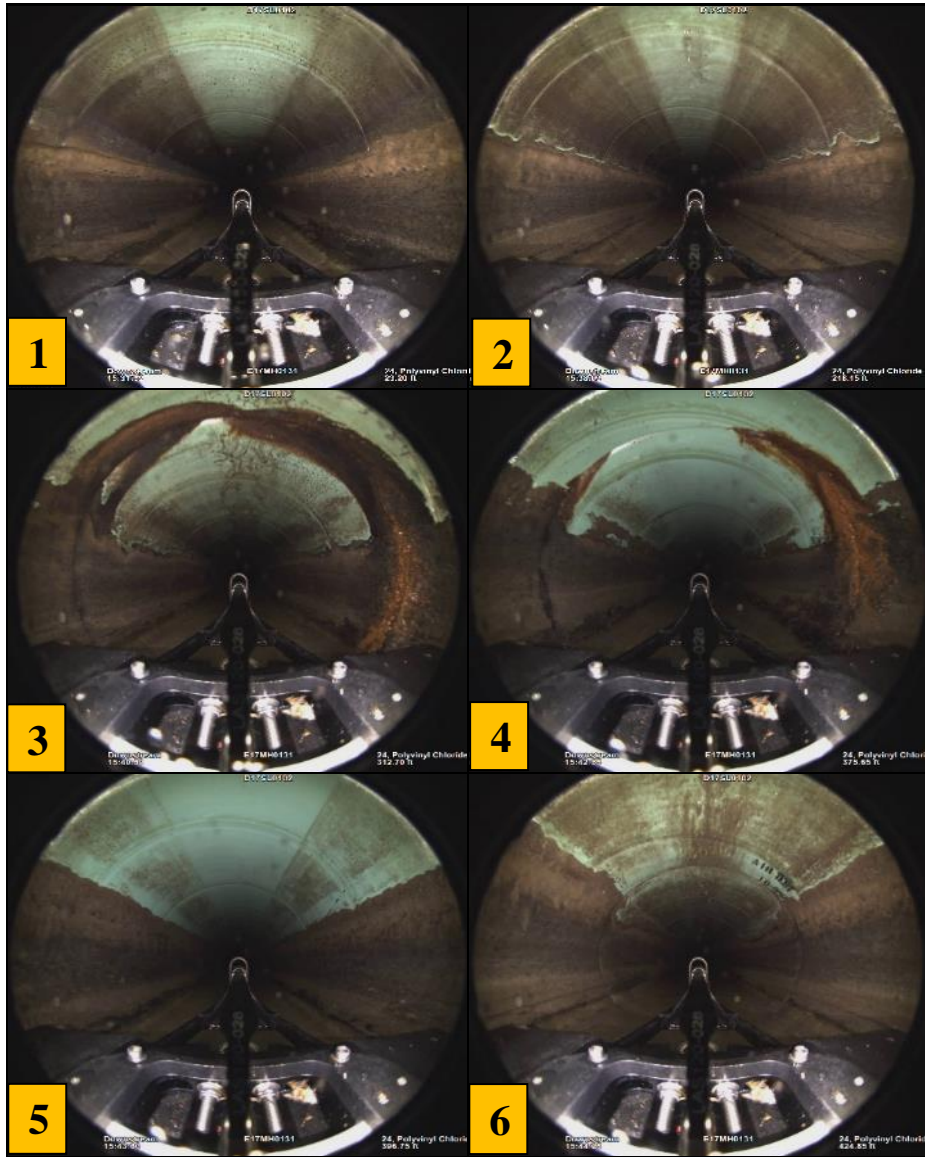
Figure A35-4 images from 1 through 6

SN	Distance (feet)	Video Ref.	Code Group/ Descriptor/ Modifier	Continuous Defect	Value			Joint	Circumferential Location		Img Reference	Remarks
					Dimension		%		At/From	To		
					1st	2nd						
1	0		AMH									
2	0		MWL			5%						
3	6		DAE	S01		5%				1,2,5,6		
4	312.7		DAG			10%	J			3		
5	375.65		DAG			5%	J			4		
6	525.85		DAE	F01								
7	525.85		MSA

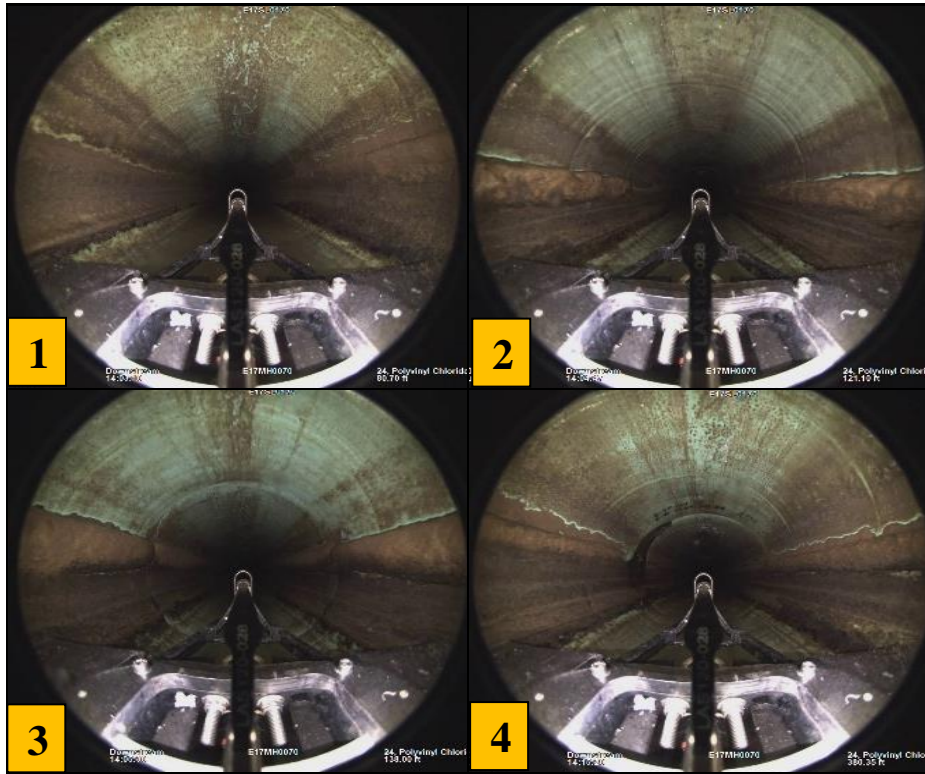
Figure A36-4 images from 1 through 4

SN	Distance (feet)	Video Ref.	Code	Continuous Defect	Value			Joint	Circumferential Location		Img Reference	Remarks
			Group/ Descriptor/ Modifier		Dimension		%		At/From	To		
					1st	2nd						
1	0		AMH									
2	0		MWL				3%					
3	6		DAE	S01			5%			1 TO 4		
4	472.05		DAE	F01								
5	472.05		MSA

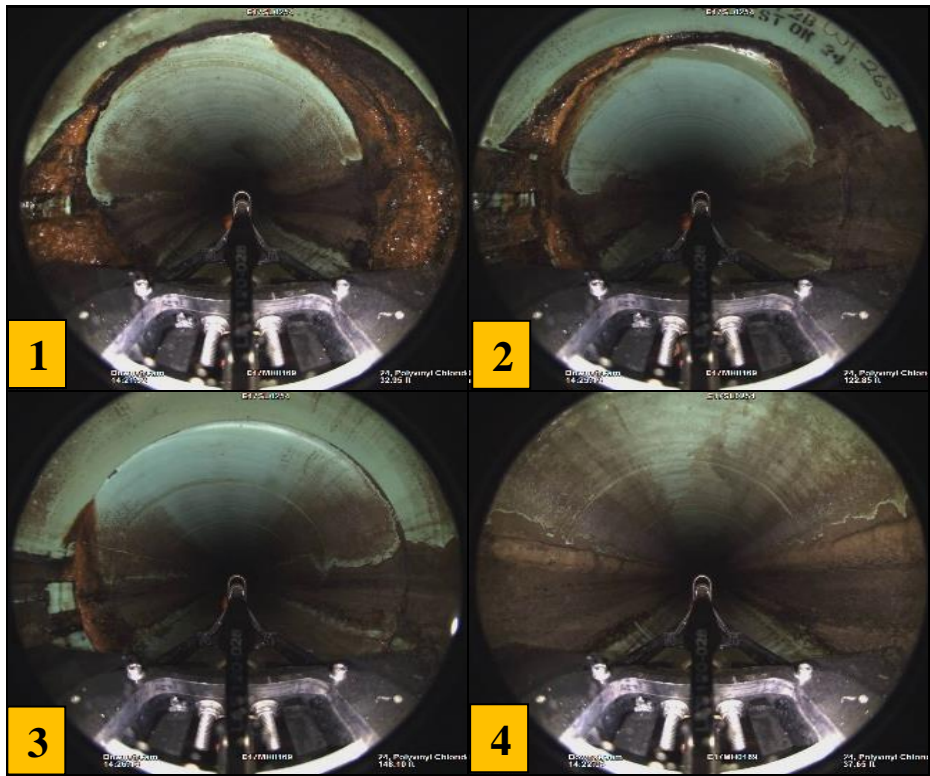
Figure A37-4 images from 1 through 4

SN	Distance (feet)	Video Ref.	Code Group/ Descriptor/ Modifier	Continuous Defect	Value			Joint	Circumferential Location		Img Reference	Remarks
					Dimension		%		At/From	To		
					1st	2nd						
1	0		AMH									
2	0		MWL				3%					
3	0		DAE	S01			5%				4	
4	32.95		RLJ					J			1	
5	122.85		RLJ					J			2	
6	148.1		RLJ					J			3	
7	263.1		DAE	F01								
8	263.1		MSA

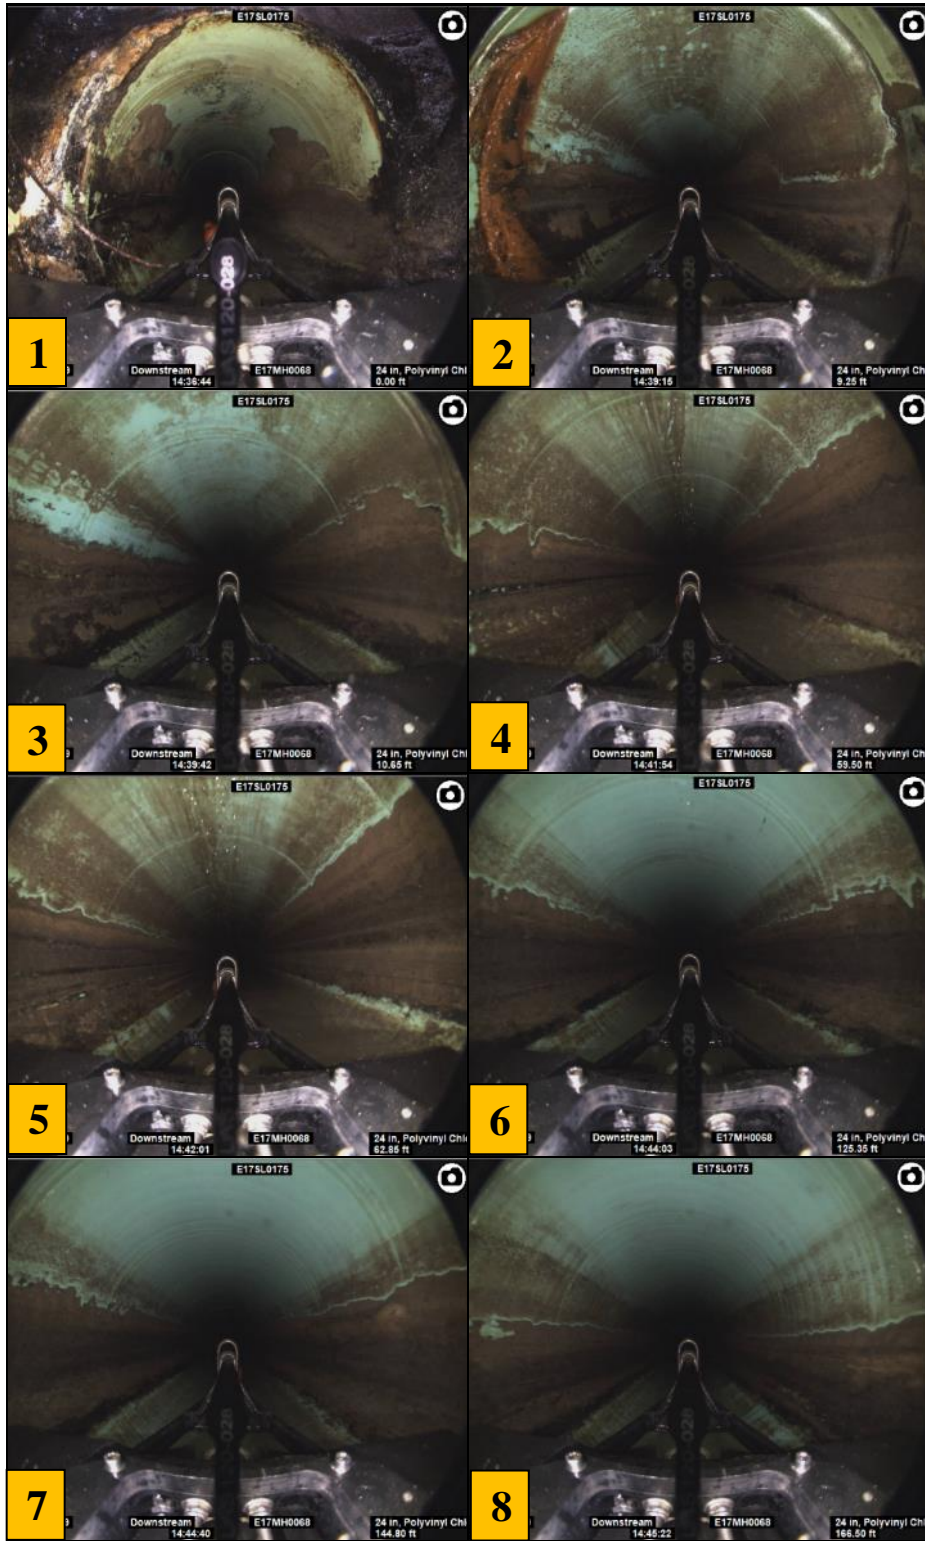
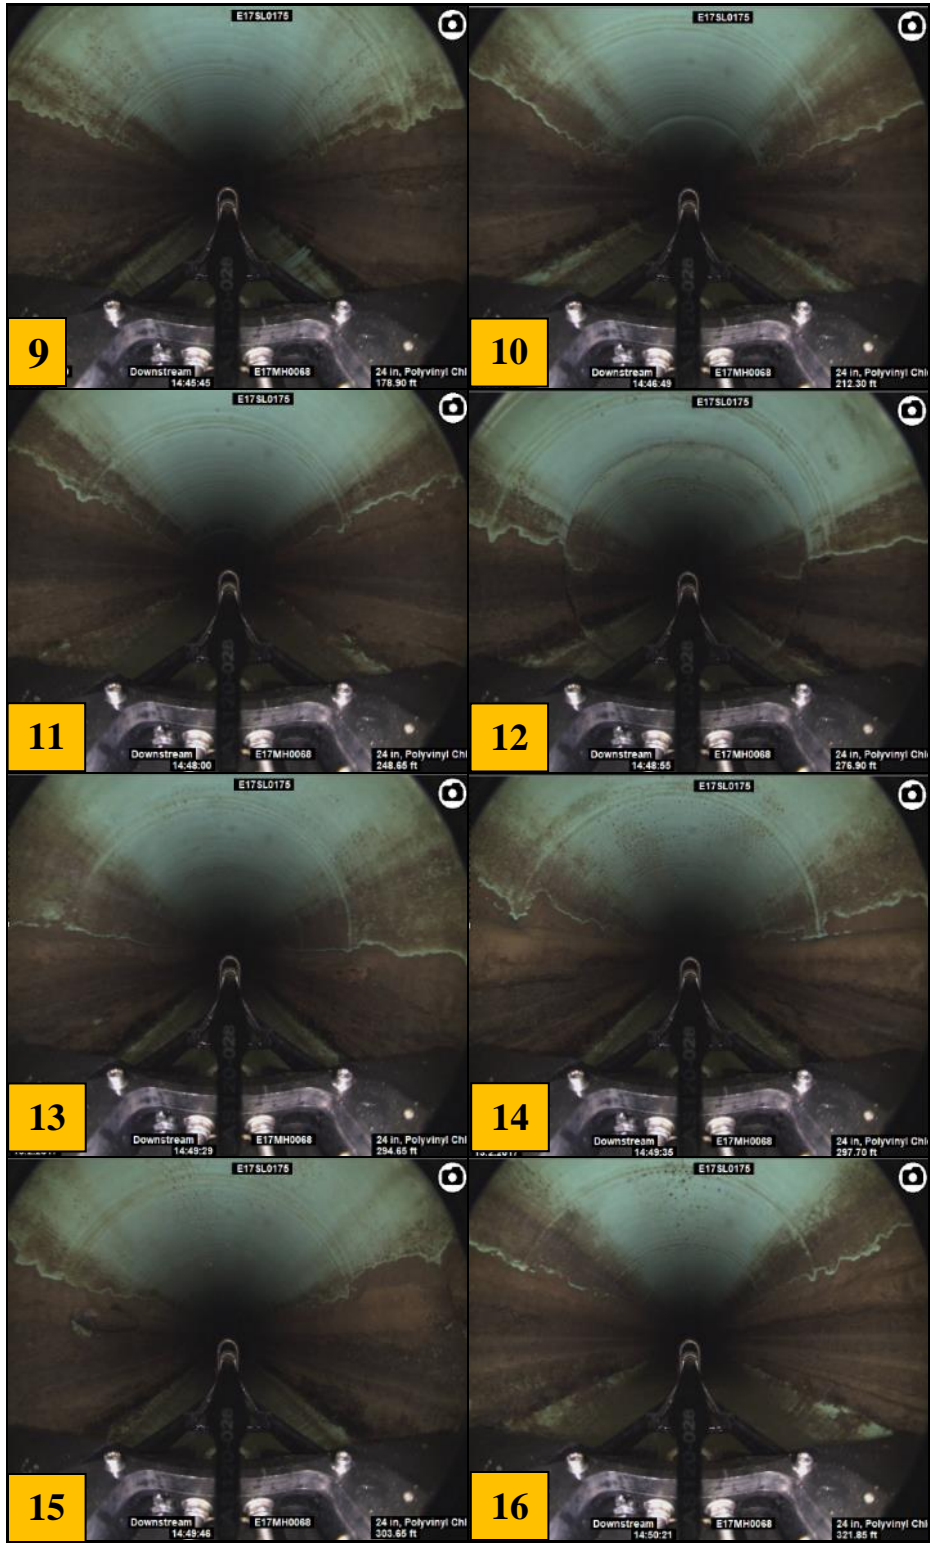
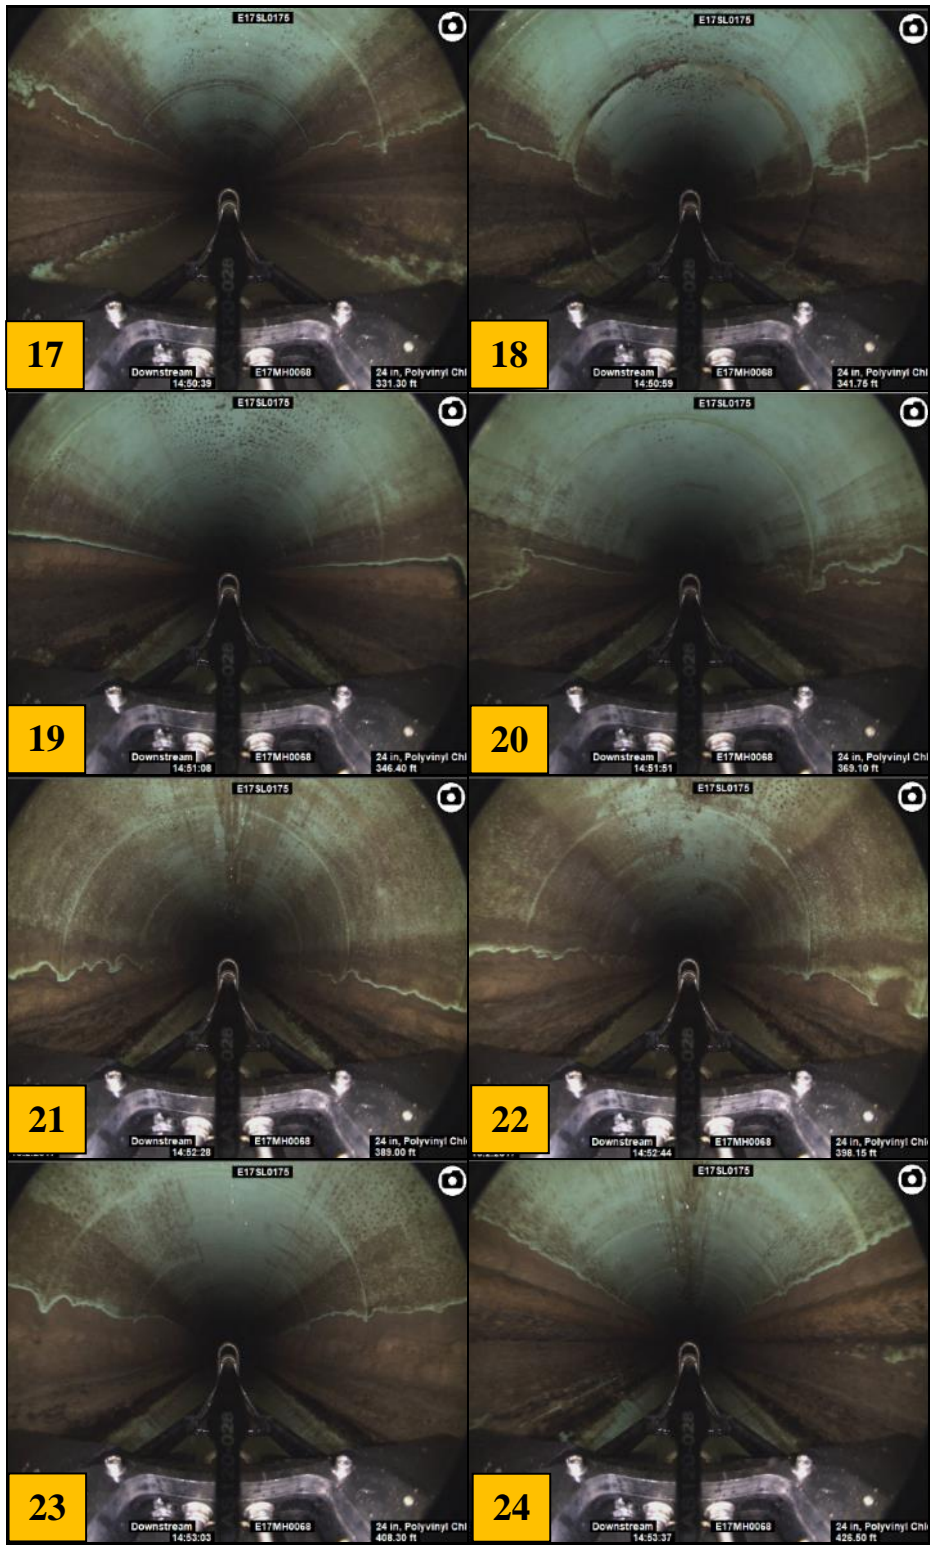
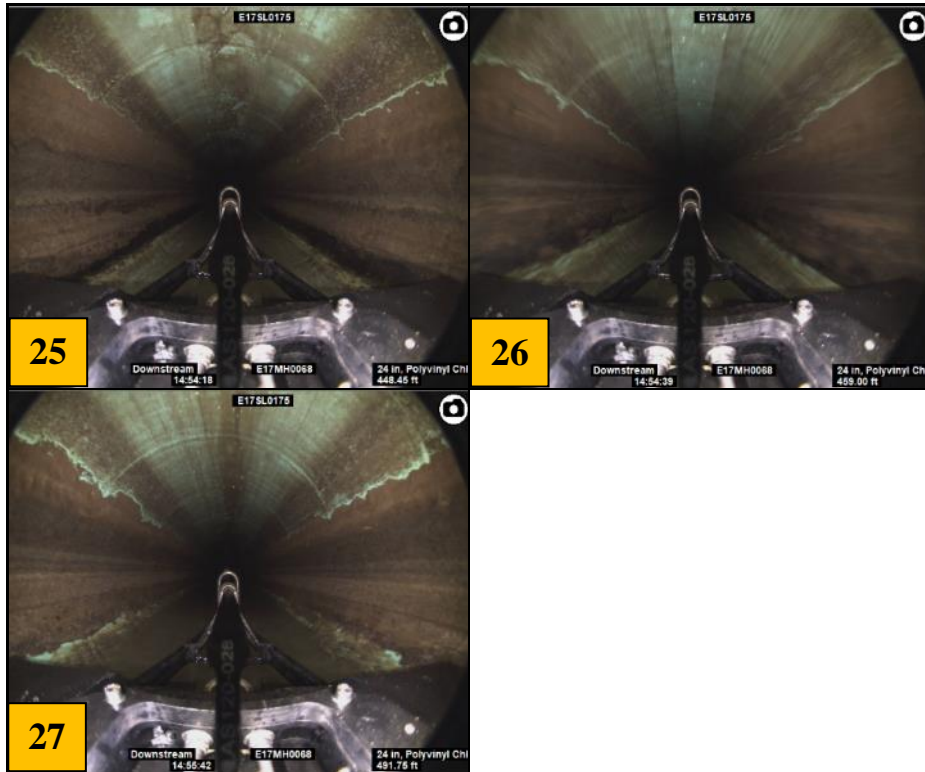
SN	Distance (feet)	Video Ref.	Code Group/ Descriptor/ Modifier	Continuous Defect	Value			Joint	Circumferential Location		Img Reference	Remarks
					Dimension		%		At/ From	To		
					1st	2nd						
1	0		AMH									
2	0		MWL				5%					
3	0		DAE	S01			10%				1	
4	8.35		DAE	F01								
5	9.25		DAG				5%				2	
6	10.65		DAE	S02			10%				3	
7	59.5		DAE	F02								
8	59.5		DAE	S03			5 TO 10%				4 TO 8	
9	62.85		MWL				10%				9	
10	125.35		MWL				5%				10	
11	248.65		MWL				10%				11	
13	276.9		MWL				5%				12	
14	294.65		DAE	F03								
15	294.65		DAE	S04			10%				13,14	
16	303.65		DAE	F04								
17	303.65		DAE	S05			10%				15	
18	321.85		MWL				10%				16	
19	331.3		DAE	F05								
20	331.3		DAE	S06			5%				17	
21	341.75		MWL				5%				18	
22	346.4		DAE	F06								
23	346.4		DAE	S07			10%				19	
24	369.1		DAE	F07								
25	369.1		DAE	S08			10%				20 TO 25	
26	459		DAE	F08								
24	459		DAE	S09			5%				26	
25	491.75		MWL				10%				27

26	534.35		DAE	F09								
27	534.35		MSA

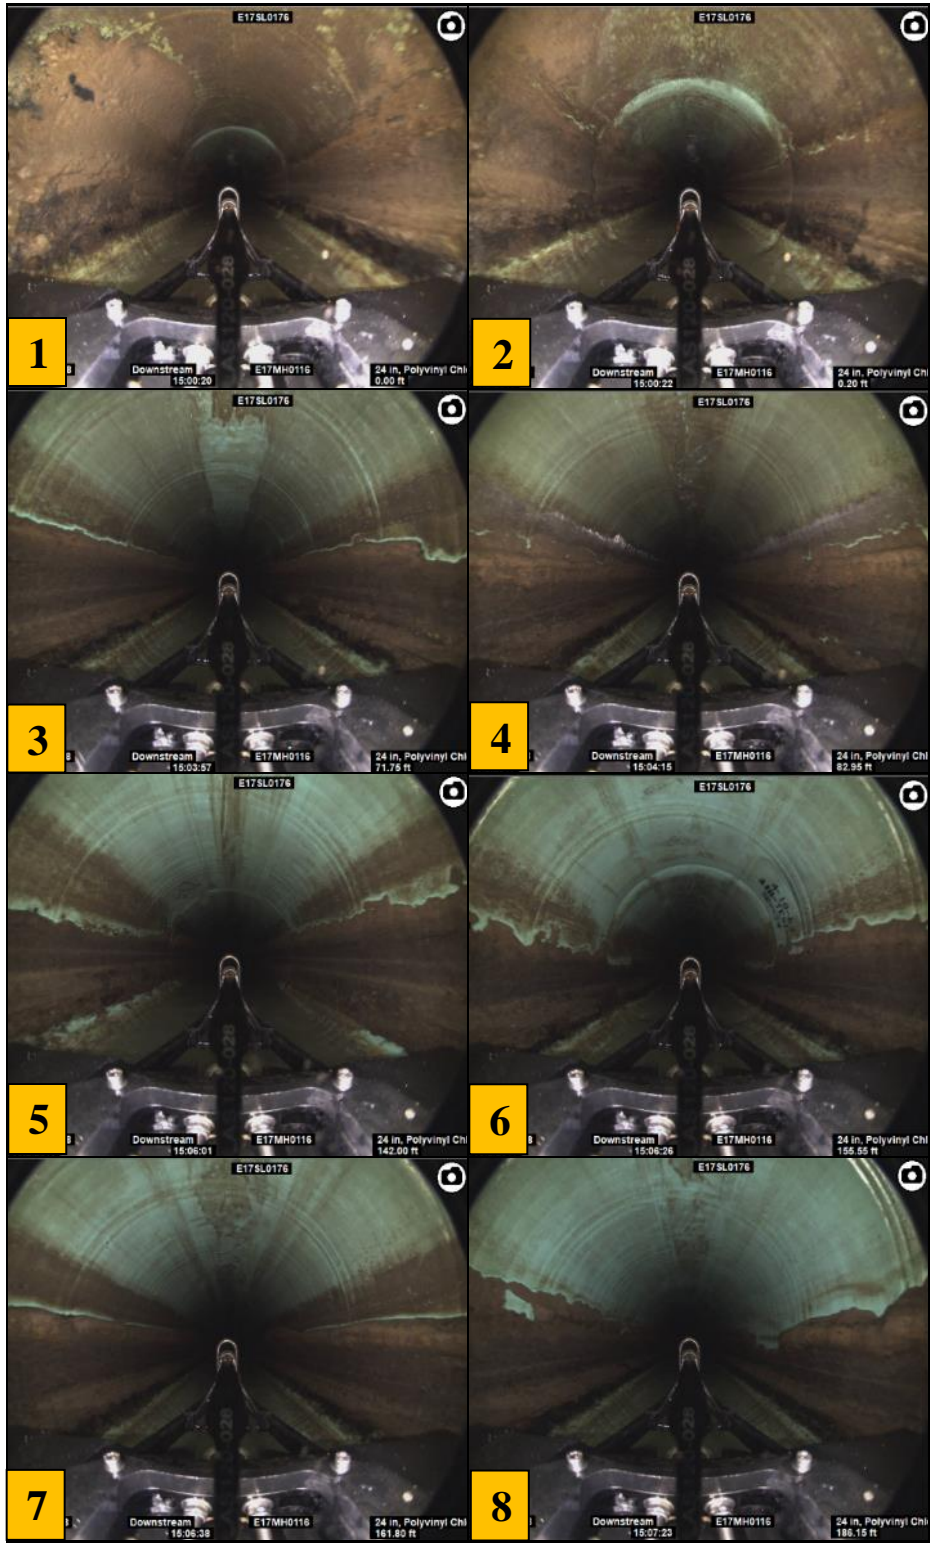
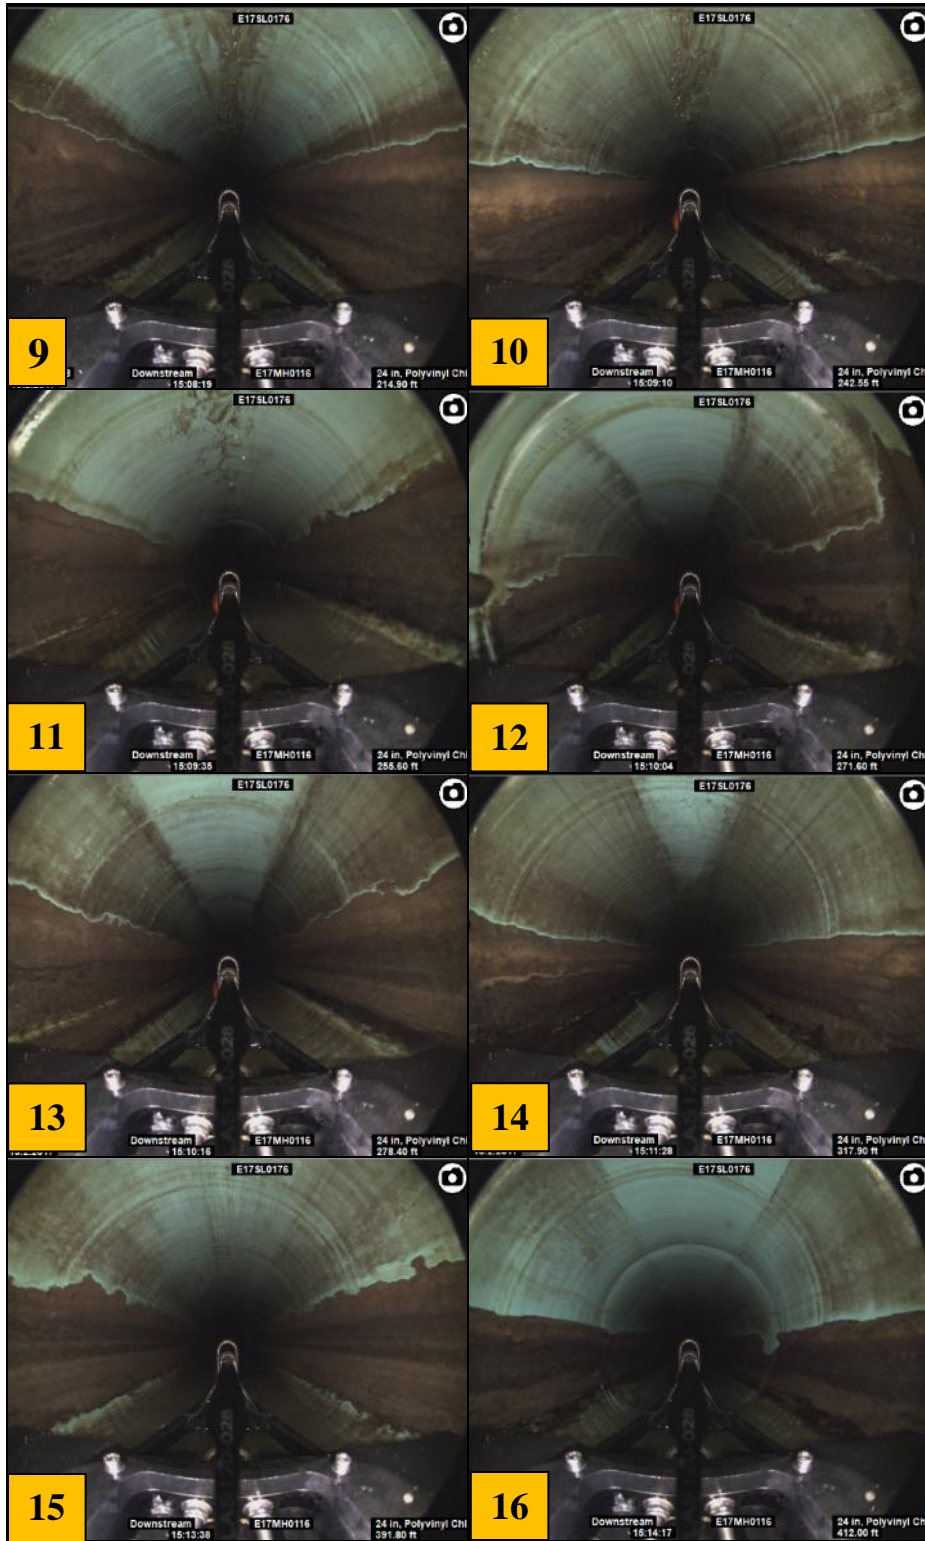
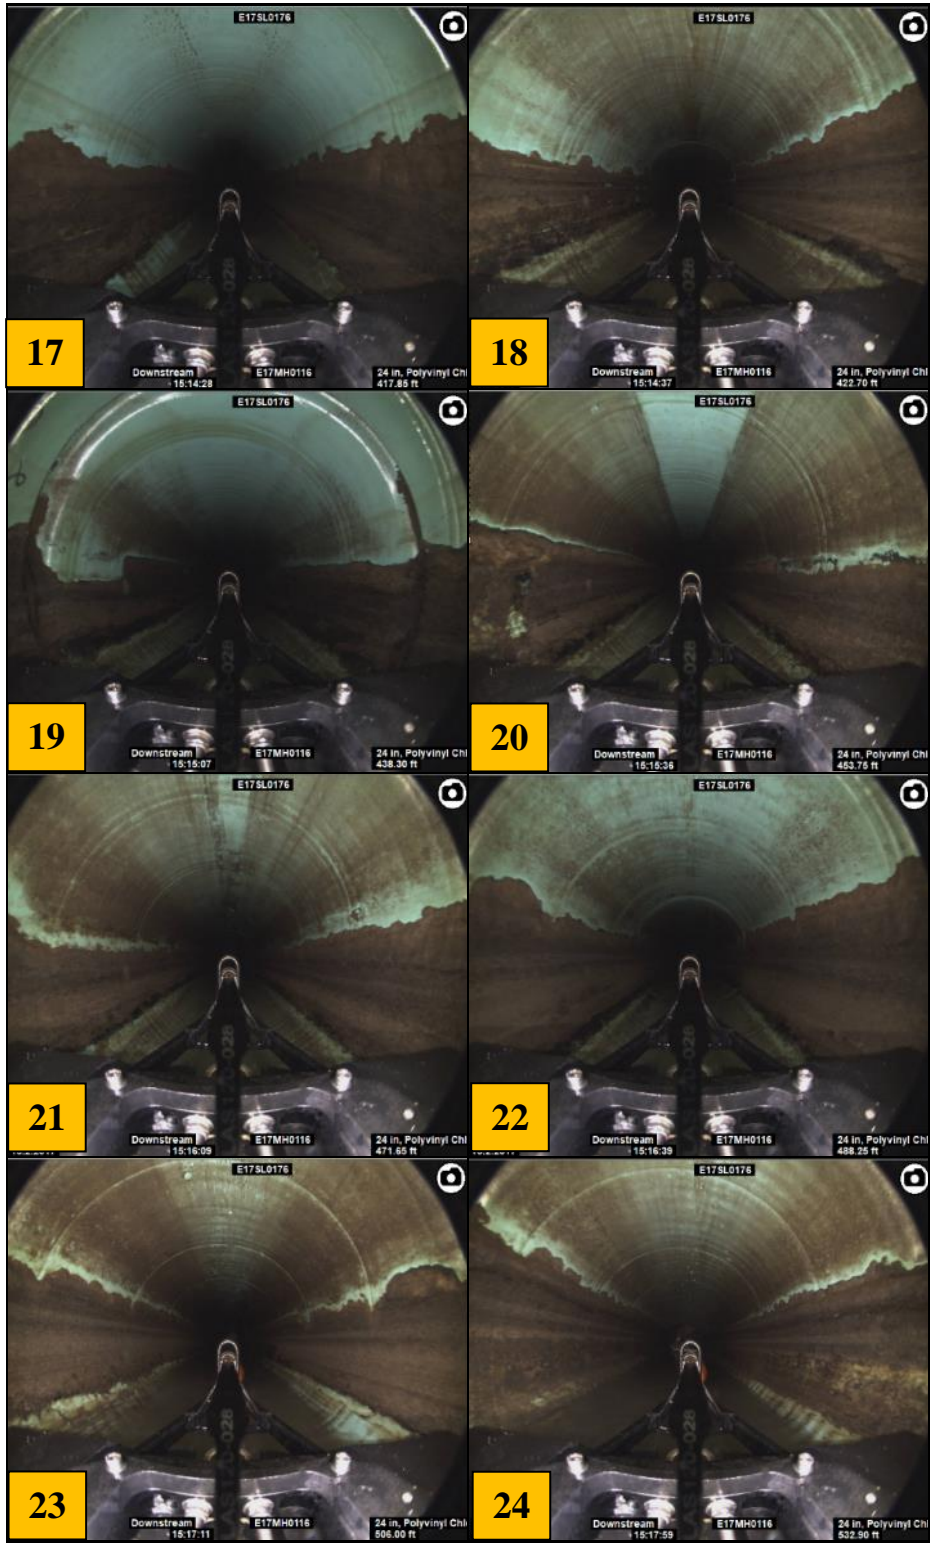
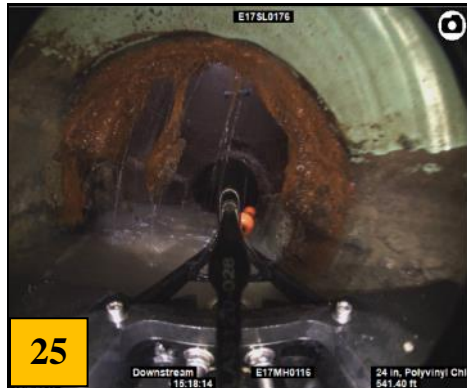
SN	Distance (feet)	Video Ref.	Code Group/ Descriptor/ Modifier	Continuous Defect	Value			Joint	Circumferential Location		Img Reference	Remarks
					Dimension		%		At/ From	To		
					1st	2nd						
1	0		AMH									
2	0		MWL				5%					
3	0		DAE				5%				1	
4	0.2		DAE	S01			5 TO 10%				2 TO 15	
5	142		MWL				10%				16	
6	155.55		MWL				5%				17	
7	255.6		MWL				10%				18	
8	271.6		MWL				5%				19	
9	391.8		MWL				10%				20	
10	412		MWL				5%				21	
11	422.7		MWL				10%				22	
12	438.3		MWL				5%				23	
13	506		MWL				10%				24	
14	541.4		DAE	F01								
15	541.4		RLJ								25	
16	541.4		MSA
