ALGORITHM DEVELOPMENT FOR SEWER PIPE SYSTEM CONDITION
ASSESSMENT USING MULTI-SENSOR (MSI) TECHNOLOGY

ALGORITHM DEVELOPMENT FOR SEWER PIPE SYSTEM CONDITION ASSESSMENT USING MULTI-SENSOR (MSI) TECHNOLOGY

This study investigates the performance of all the current large-diameter pipeline system of The City of Arlington (COA) sewer lines of 48 miles (24-inch inner diameter and above for rigid and flexible pipes). Proper inspection and rehabilitation plan for the city sewer pipeline system are better choice for the municipality and tax payers in terms of cost than dealing with pipe damage and collapsing problems when they happen.

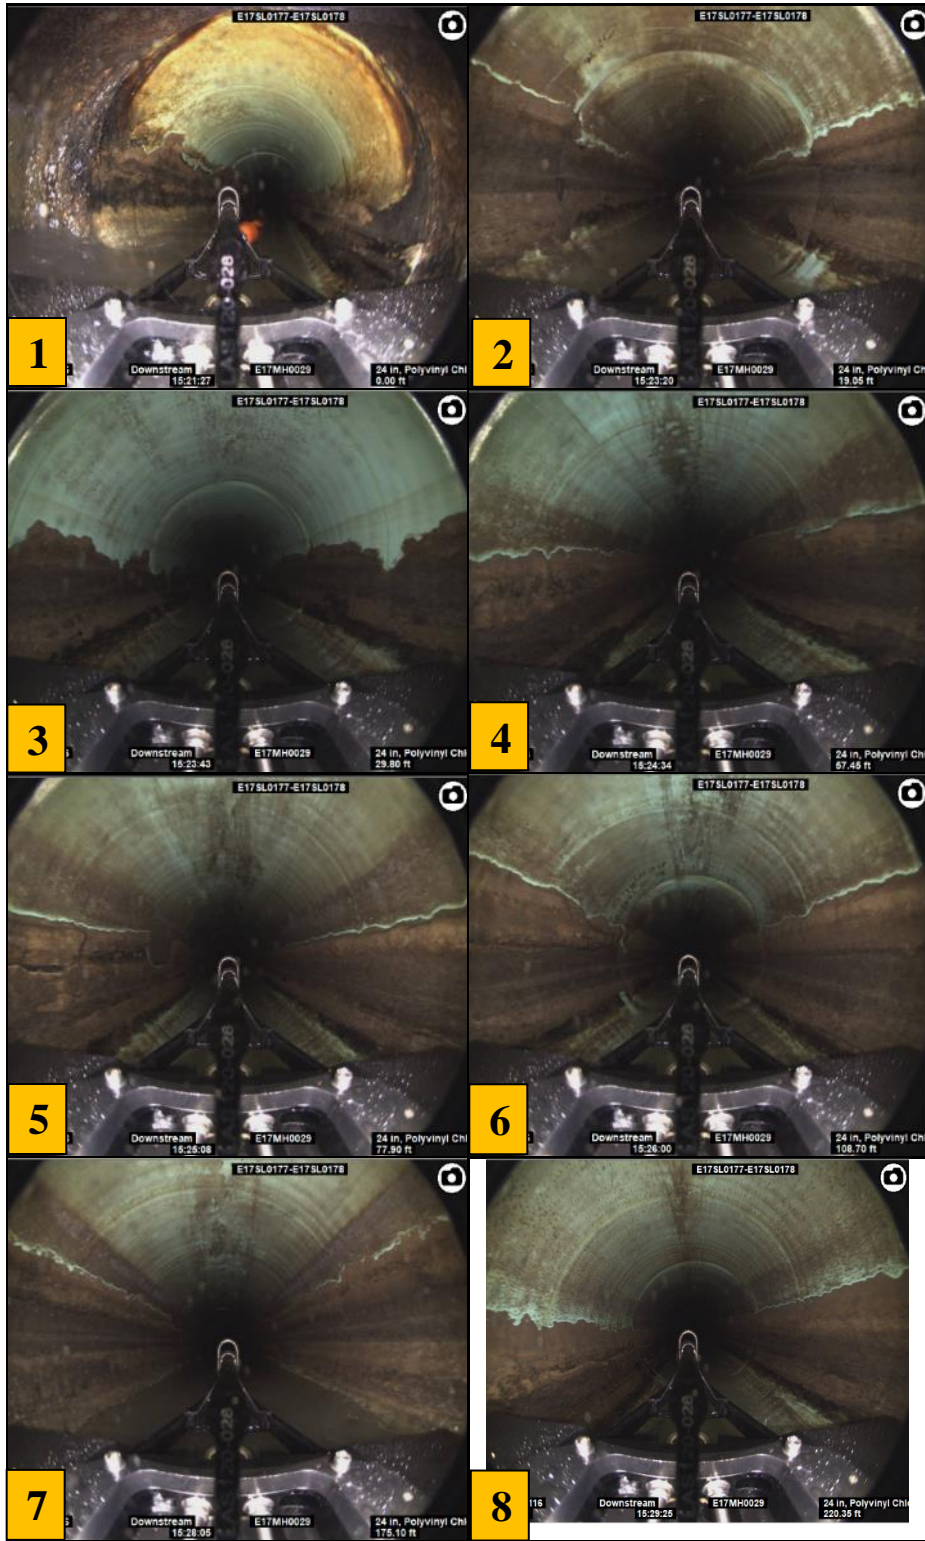
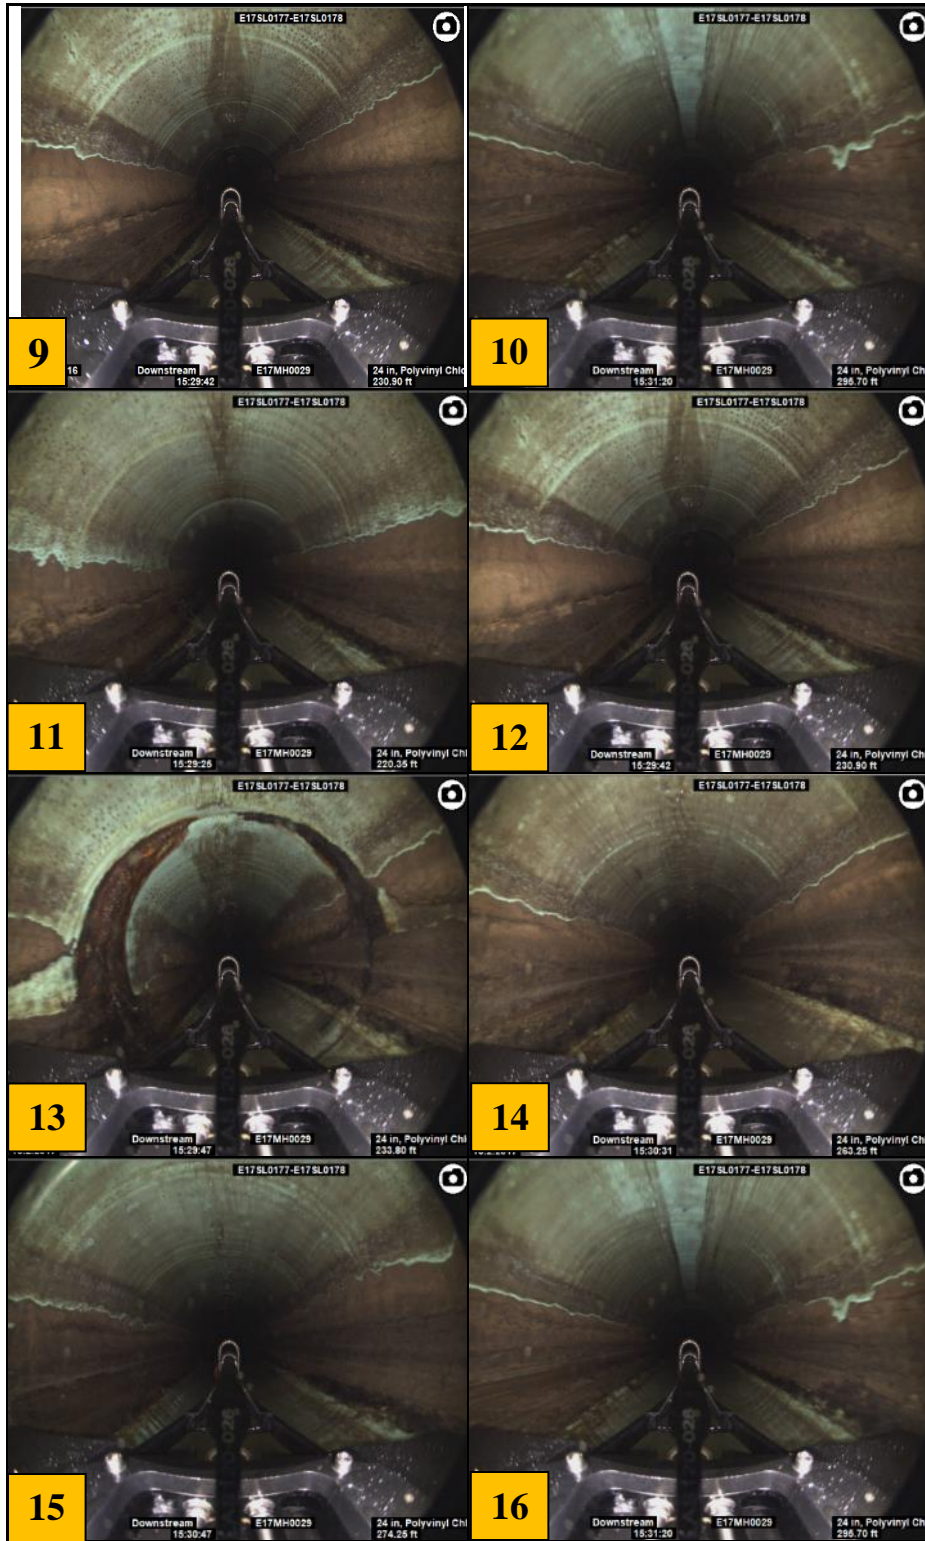
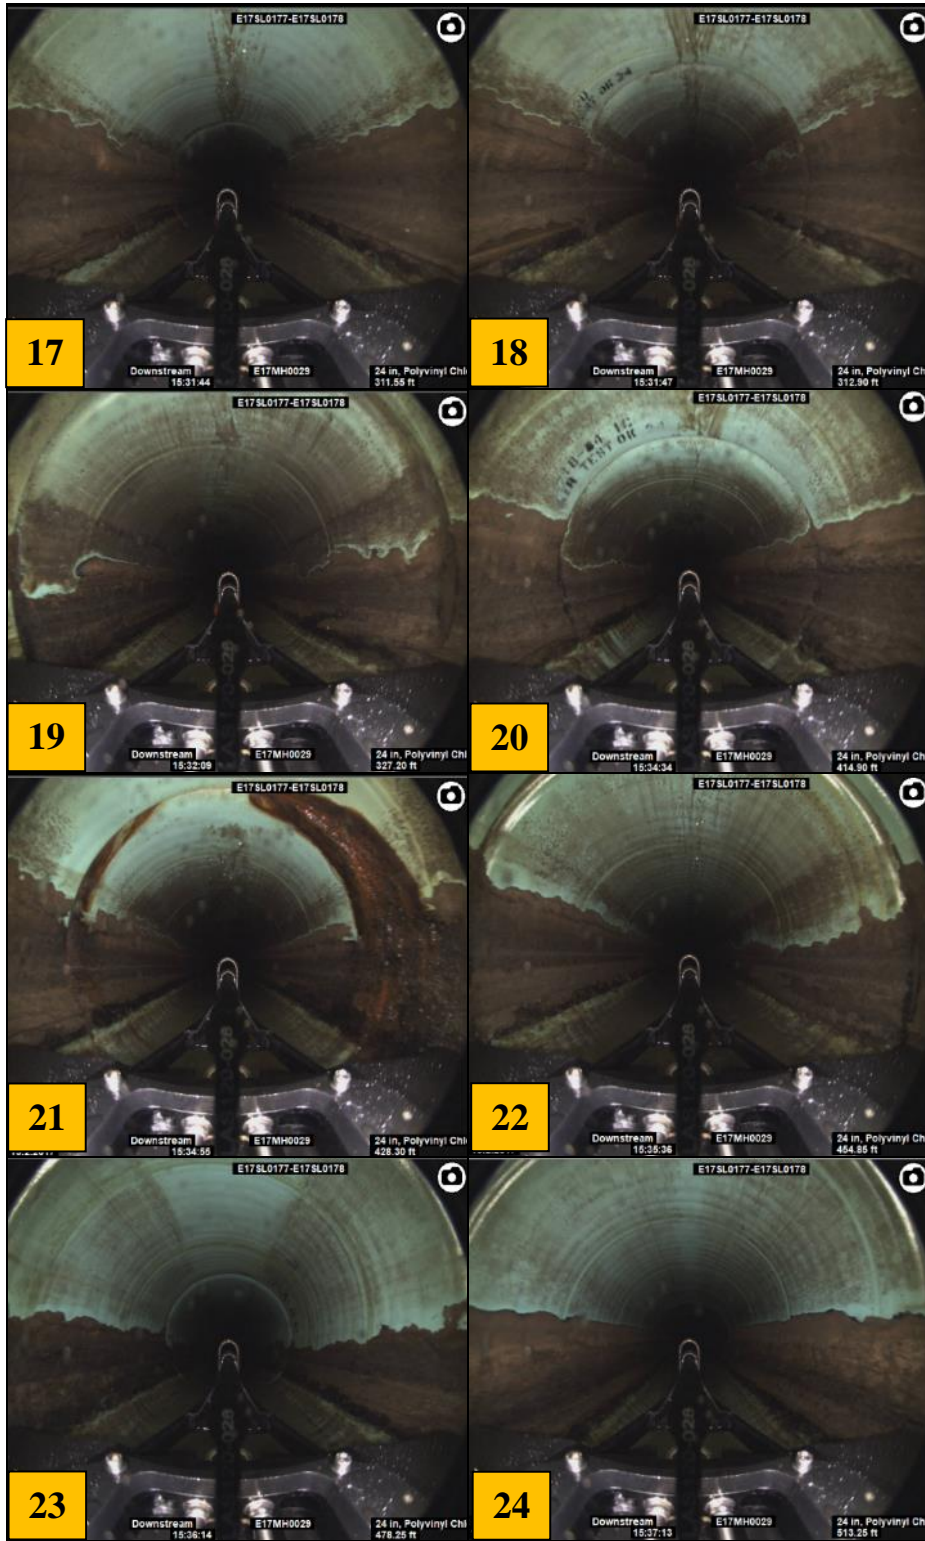
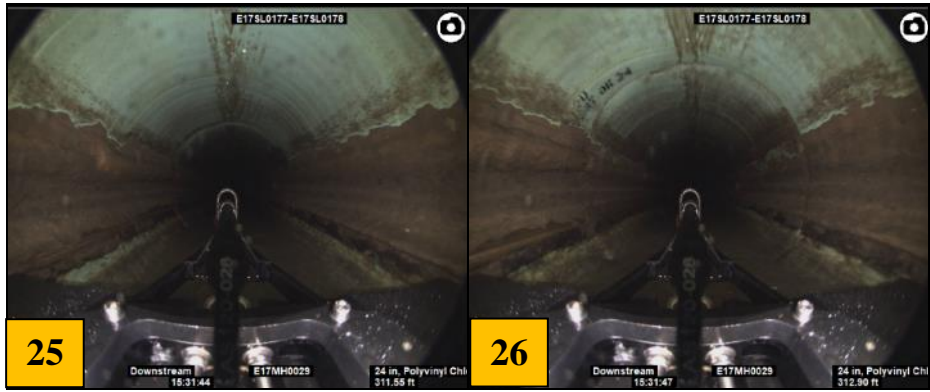
SN	Distance (feet)	Video Ref.	Code	Continuous Defect	Value			Joint	Circumferential Location		Img Reference	Remarks
			Group/ Descriptor/ Modifier		Dimension		%		At/ From	To		
					1st	2nd						
1	0		AMH									
2	0		MWL				10%					
3	0		DAE	S01			5 TO 10%			1, 3 TO 15		
4	29.8		MWL				5%			2		
5	137.6		MWL				10%			16		
6	185.15		MWL				5%			17		
7	195.65		MWL				10%			18		
8	233.8		MWL				5%			19		
9	263.25		MWL				10%			20		
10	274.25		MWL				5%			21		
11	312.9		MWL				10%			22		
12	327.2		MWL				5%			23		
13	428.3		RMJ							24		
14	454.85		MWL				10%			25		
15	478.25		MWL				5%			26		
16	621.3		DAE	F01								
17	621.3		MSA

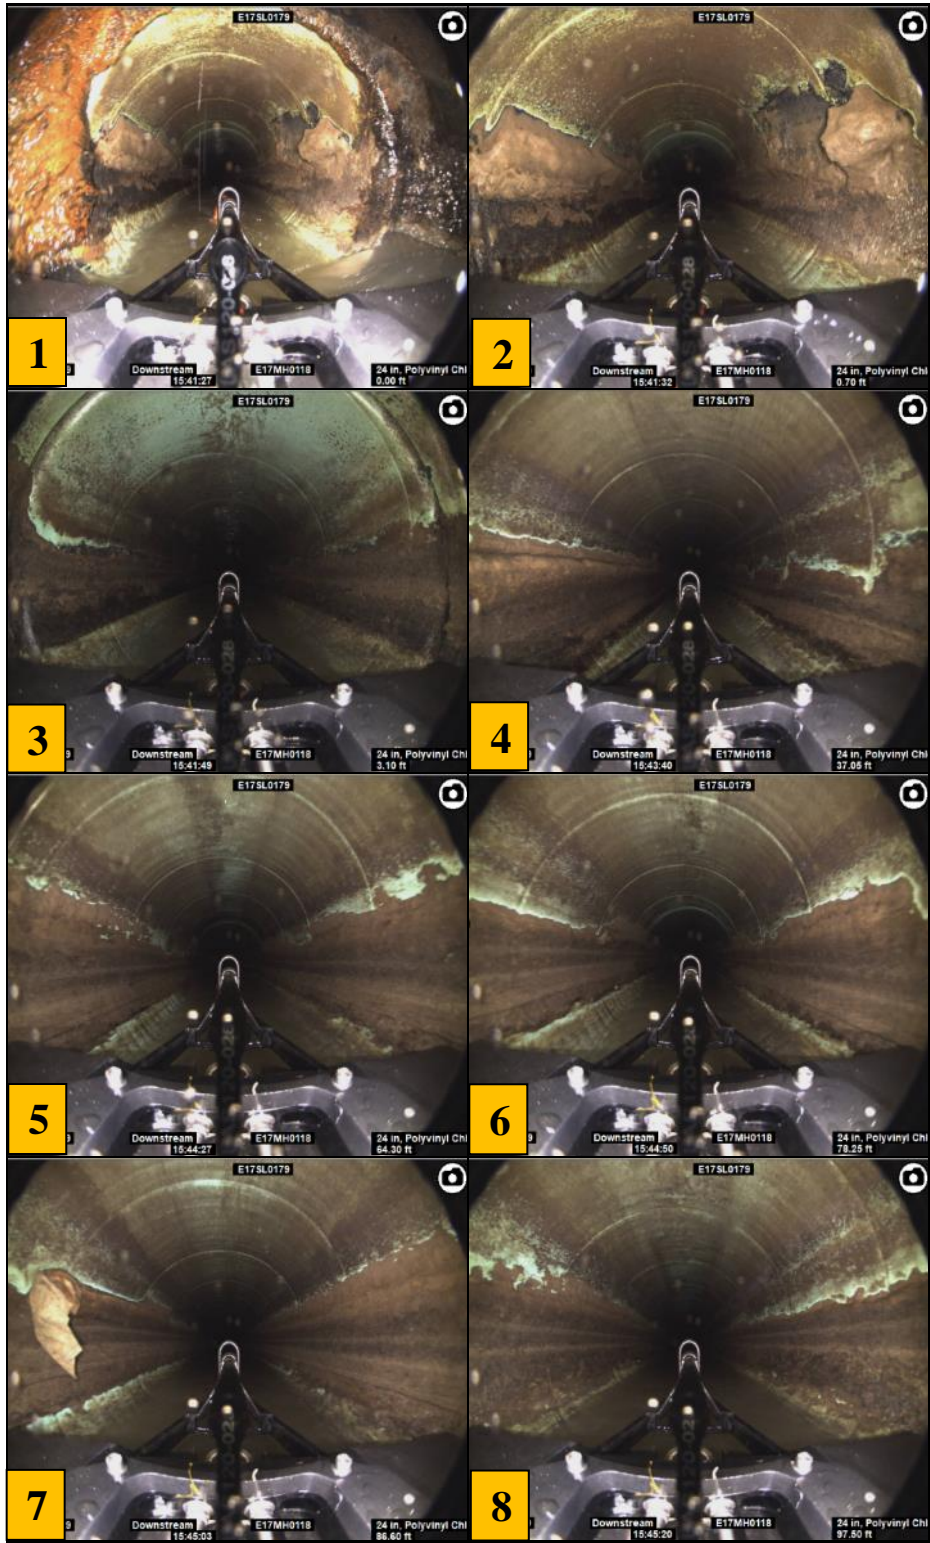
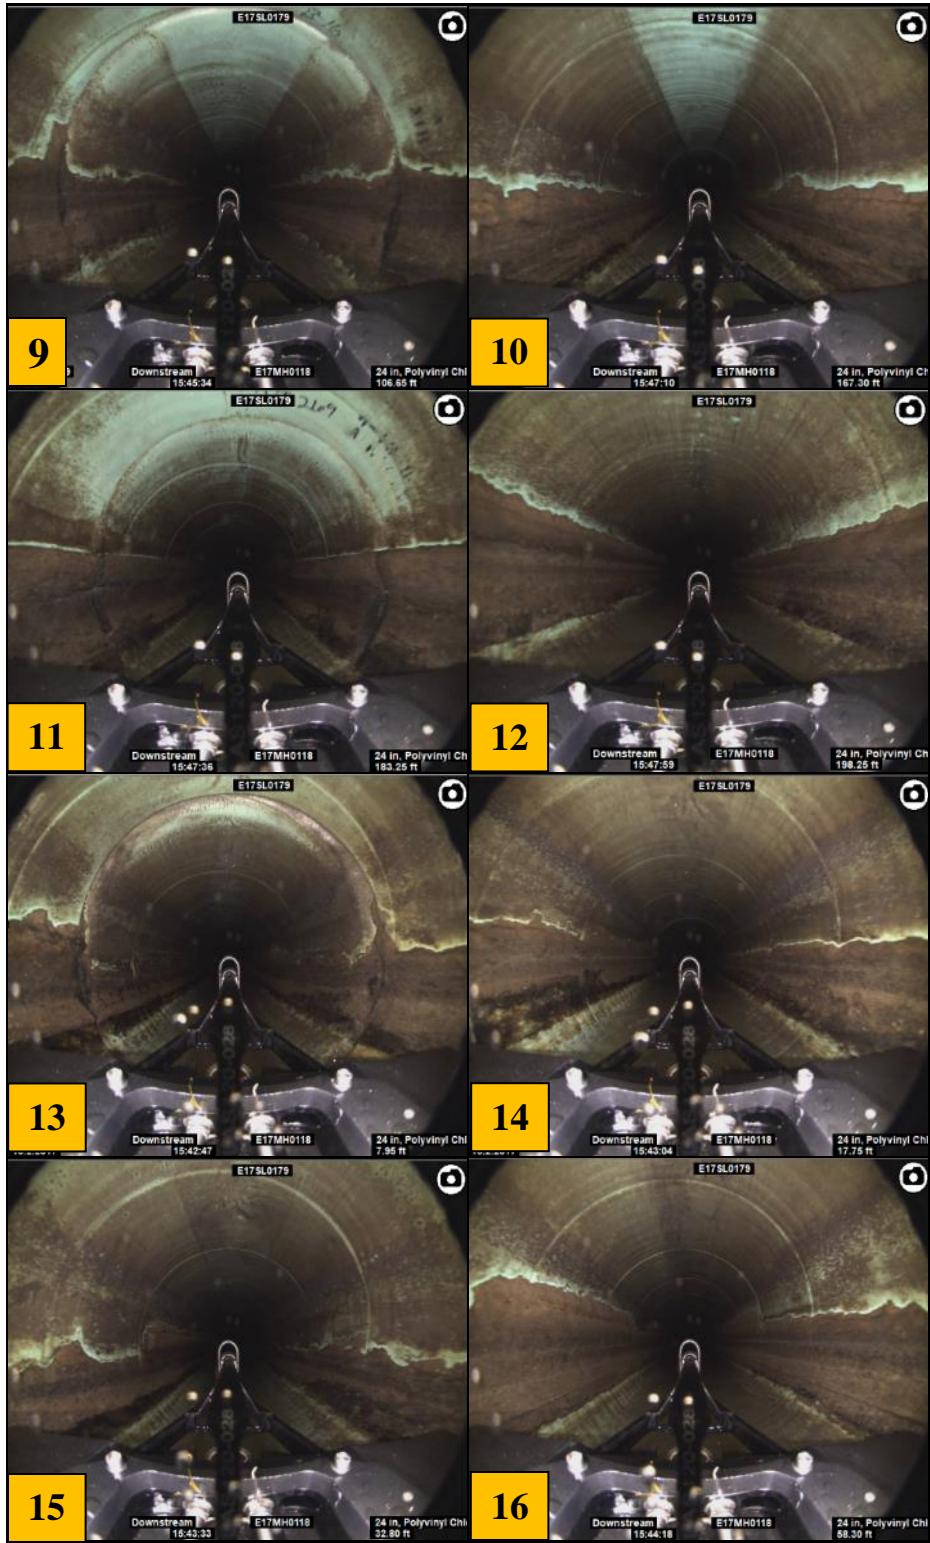
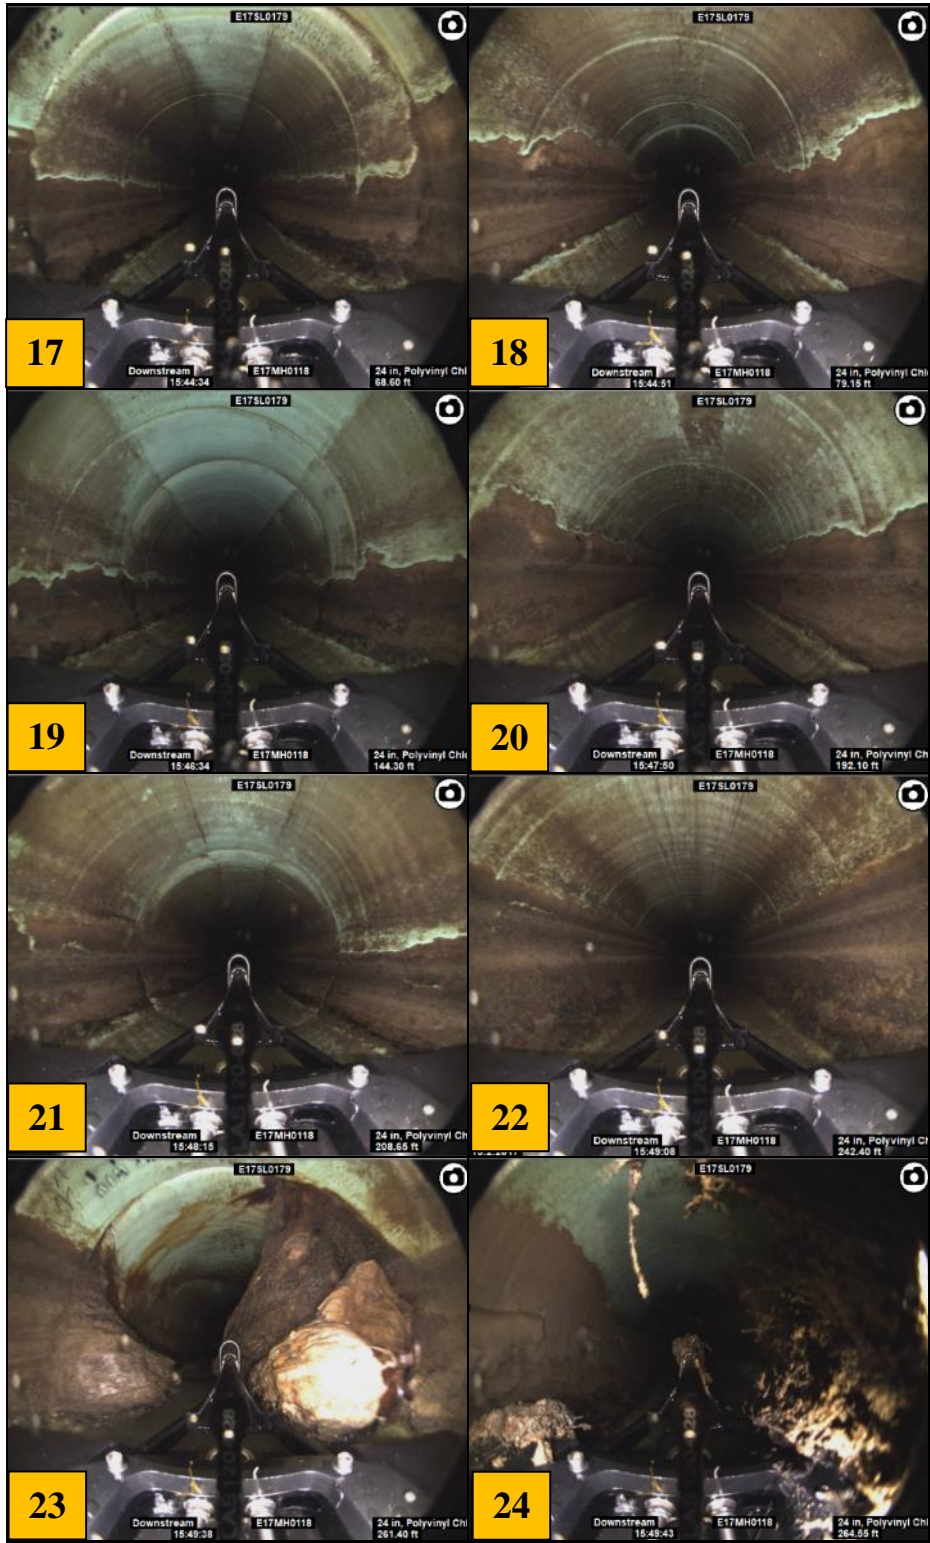
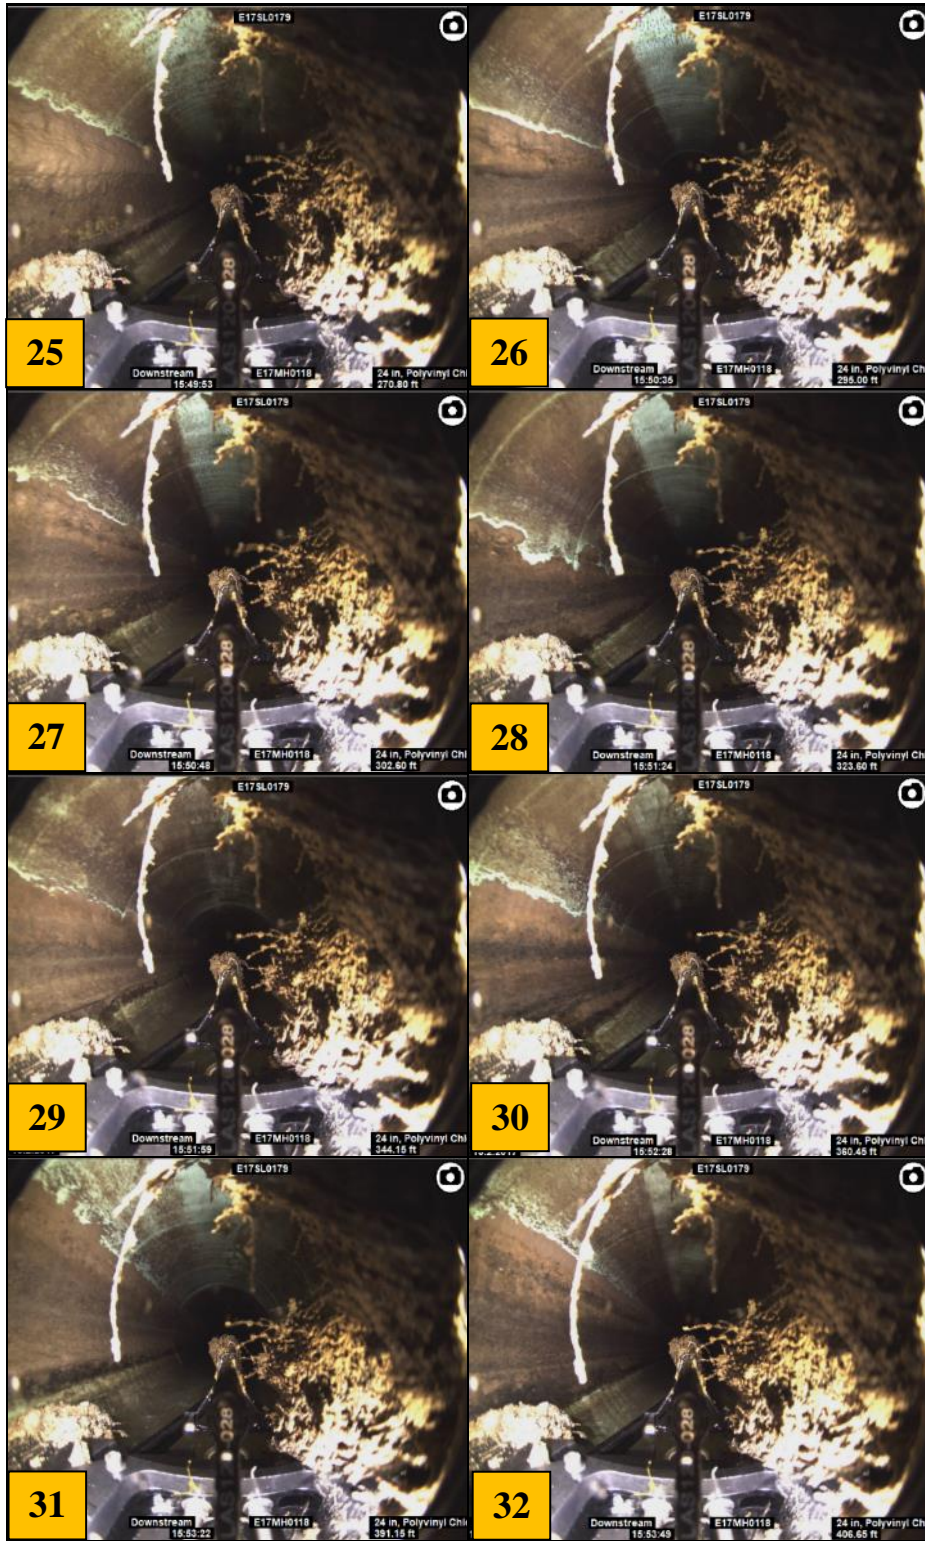
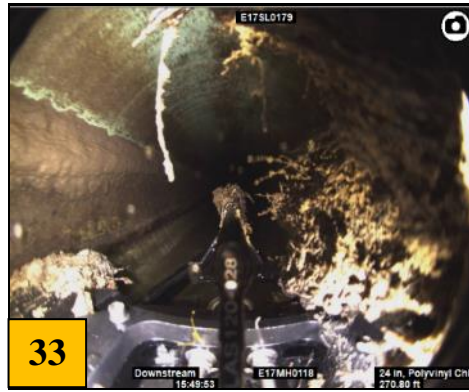
The device hit roots at 265 ft. Mud covered part of the laser ring. Video recording is obtained, and the laser profile is partially obtained.

SN	Distance (feet)	Video Ref.	Code Group/ Descriptor/ Modifier	Continuous Defect	Value		Joint	Circumferential Location		Img Reference	Remarks	
					Dimension			%	At/ From			To
					1st	2nd						
1	0		AMH									
2	0		MWL			10%						
3	0		DAG			10%				1		
4	0.7		DAE			5%				2		
5	3.1		DAE	S01		5 TO 10%				3 TO 12		
6	7.95		MWL			5%				13		
7	17.75		MWL			10%				14		
8	32.8		MWL			5%				15		
9	58.3		MWL			10%				16		
10	68.6		MWL			5%				17		
11	79.15		MWL			10%				18		
12	144.35		MWL			5%				19		
13	192.1		MWL			10%				20		
14	208.65		MWL			5%				21		
15	210.3		DAE	F01								
16	242.4		MWL			10%				22		
17	261.4		RLJ							23		
18	264.55		DAE	S02		5%				24,25		
19	295		MWL			5%				26		
20	302.6		MWL			10%				27		
21	323.6		MWL			5%				28		
22	344.15		MWL			10%				29		
23	360.45		MWL			5%				30		
24	391.15		MWL			10%				31		
25	406.65		MWL			5%				32		
26	482.45		MWL			10%				33		
27	485.65		DAE	F02								
28	485.65		MSA

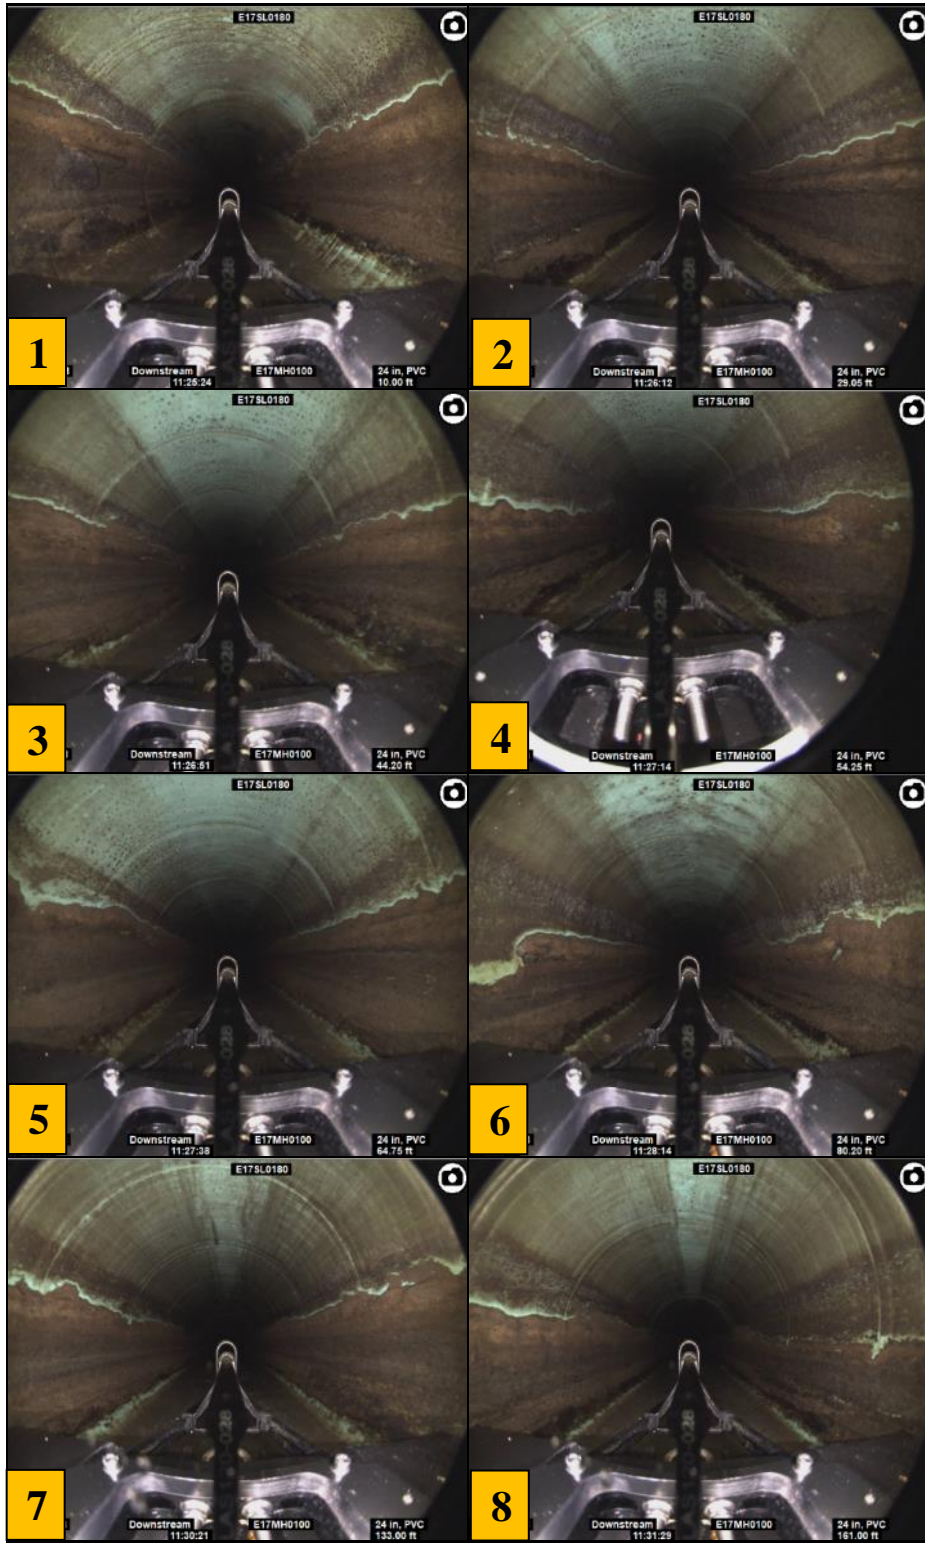
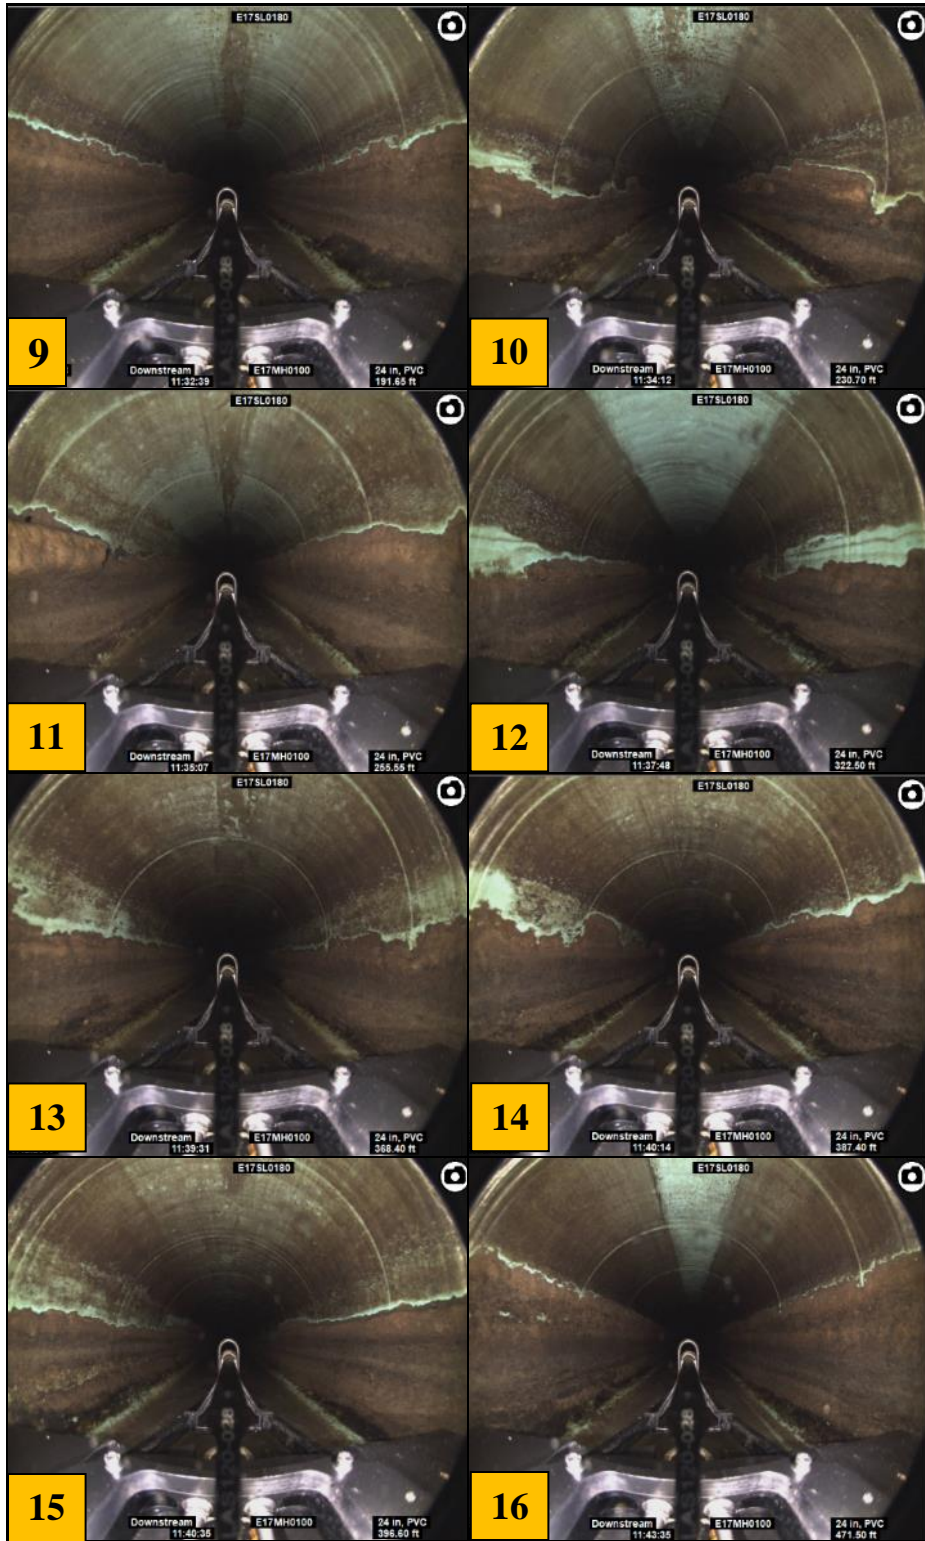
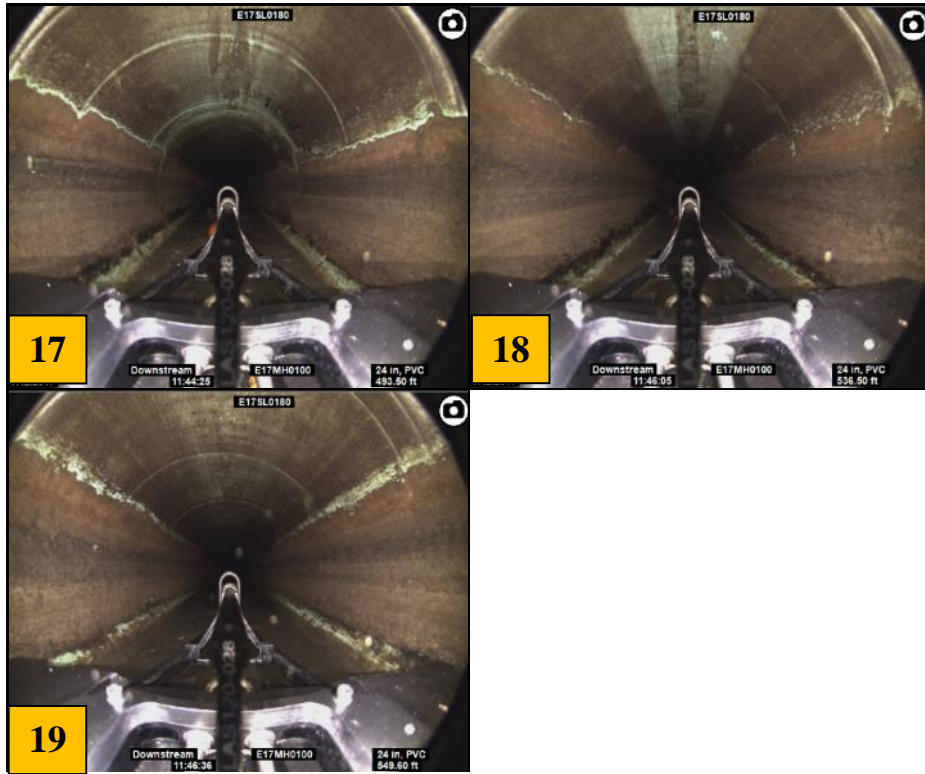
SN	Distance (feet)	Video Ref.	Code Group/ Descriptor/ Modifier	Continuous Defect	Value		Joint	Circumferential Location		Img Reference	Remarks	
					Dimension			%	At/ From			To
					1st	2nd						
1	0		AMH									
2	10		MWL				10%					
3	10		DAE	S01			5 TO 10%			1		
4	29.05		MWL				5%			2		
5	44.2		MWL				10%			3		
6	53.25		MWL				5%			4		
7	64.75		MWL				10%			5		
8	80.2		MWL				5%			6		
9	133		MWL				10%			7		
10	161		MWL				5%			8		
11	191.65		MWL				10%			9		
12	230.7		MWL				5%			10		
13	255.55		MWL				10%			11		
14	322.5		MWL				5%			12		
15	368.4		MWL				10%			13		
16	387.4		MWL				5%			14		
17	396.6		MWL				10%			15		
18	471.5		MWL				5%			16		
19	493.5		MWL				10%			17		
20	536.5		MWL				5%			18		
21	549.6		MWL				10%			19		
22	704.05		DAE	F01								
23	704.05		MSA

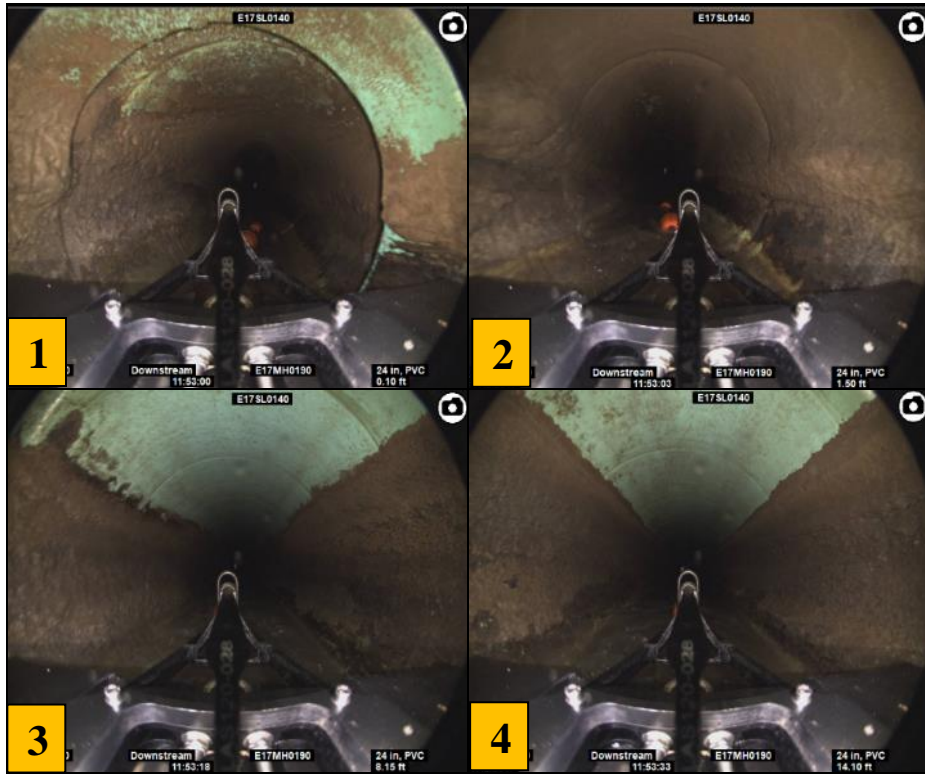
Figure A43-4 images from 1 through 4

SN	Distance (feet)	Video Ref.	Code	Continuous Defect	Value			Joint	Circumferential Location		Img Reference	Remarks
			Group/Descriptor/Modifier		Dimension		%		At/From	To		
					1st	2nd						
1	0		AMH									
2	0		MWL			5%						
3	0.1		DAE	S01		50%				1,2		
4	8.15		DAE	F01								
5	8.15		DAE	S02		20%				3		
6	14.1		MWL			10%				4		
7	78.4		DAE	F02								
8	79.75		MSA

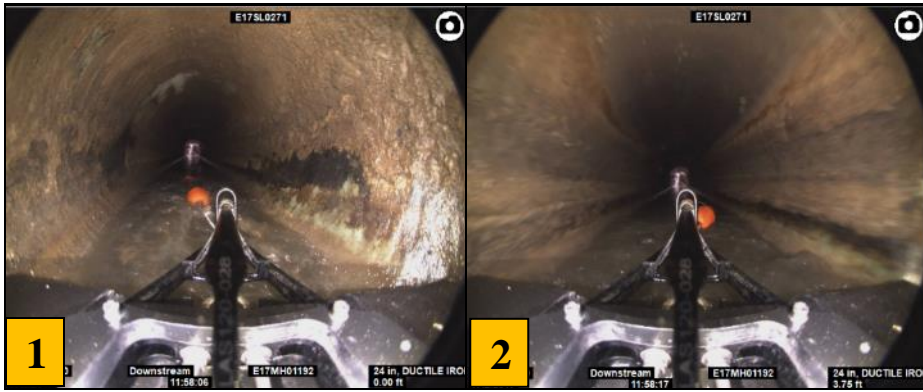
Figure A44-4 images from 1 through 2

SN	Distance (feet)	Video Ref.	Code	Continuous Defect	Value			Joint	Circumferential Location		Img Reference	Remarks
			Group/Descriptor/Modifier		Dimension		%		At/From	To		
					1st	2nd						
1	0		AMH									
2	0		MWL				10%					
3	0		DAE				15%			1	COVERED AS A LAYER	
4	3.75		DAE	S01			<5%			2		
5	18.65		DAE	F01								
6	18.65		MSA

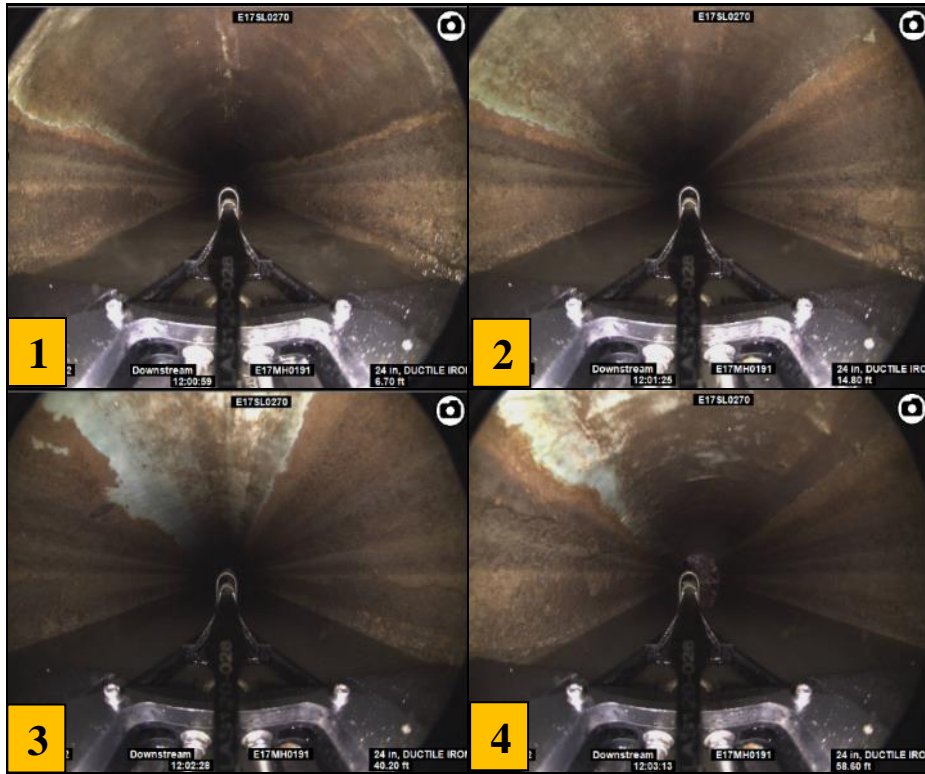
Figure A45-4 images from 1 through 4

SN	Distance (feet)	Video Ref.	Code Group/ Descriptor/ Modifier	Continuous Defect	Value			Joint	Circumferential Location		Img Reference	Remarks
					Dimension		%		At/ From	To		
					1st	2nd						
1	0		AMH								NO MUCH DEFECTS. VERY VERY LITTLE DEPOSITS THROUGHOUT THE LENGTH OF PIPE (<5%) IMAGES 1 TO 4	
2	0		MWL			10%						
3	65.15		MSA
