ALGORITHM DEVELOPMENT FOR SEWER PIPE SYSTEM CONDITION
ASSESSMENT USING MULTI-SENSOR (MSI) TECHNOLOGY

ALGORITHM DEVELOPMENT FOR SEWER PIPE SYSTEM CONDITION ASSESSMENT USING MULTI-SENSOR (MSI) TECHNOLOGY

This study investigates the performance of all the current large-diameter pipeline system of The City of Arlington (COA) sewer lines of 48 miles (24-inch inner diameter and above for rigid and flexible pipes). Proper inspection and rehabilitation plan for the city sewer pipeline system are better choice for the municipality and tax payers in terms of cost than dealing with pipe damage and collapsing problems when they happen.

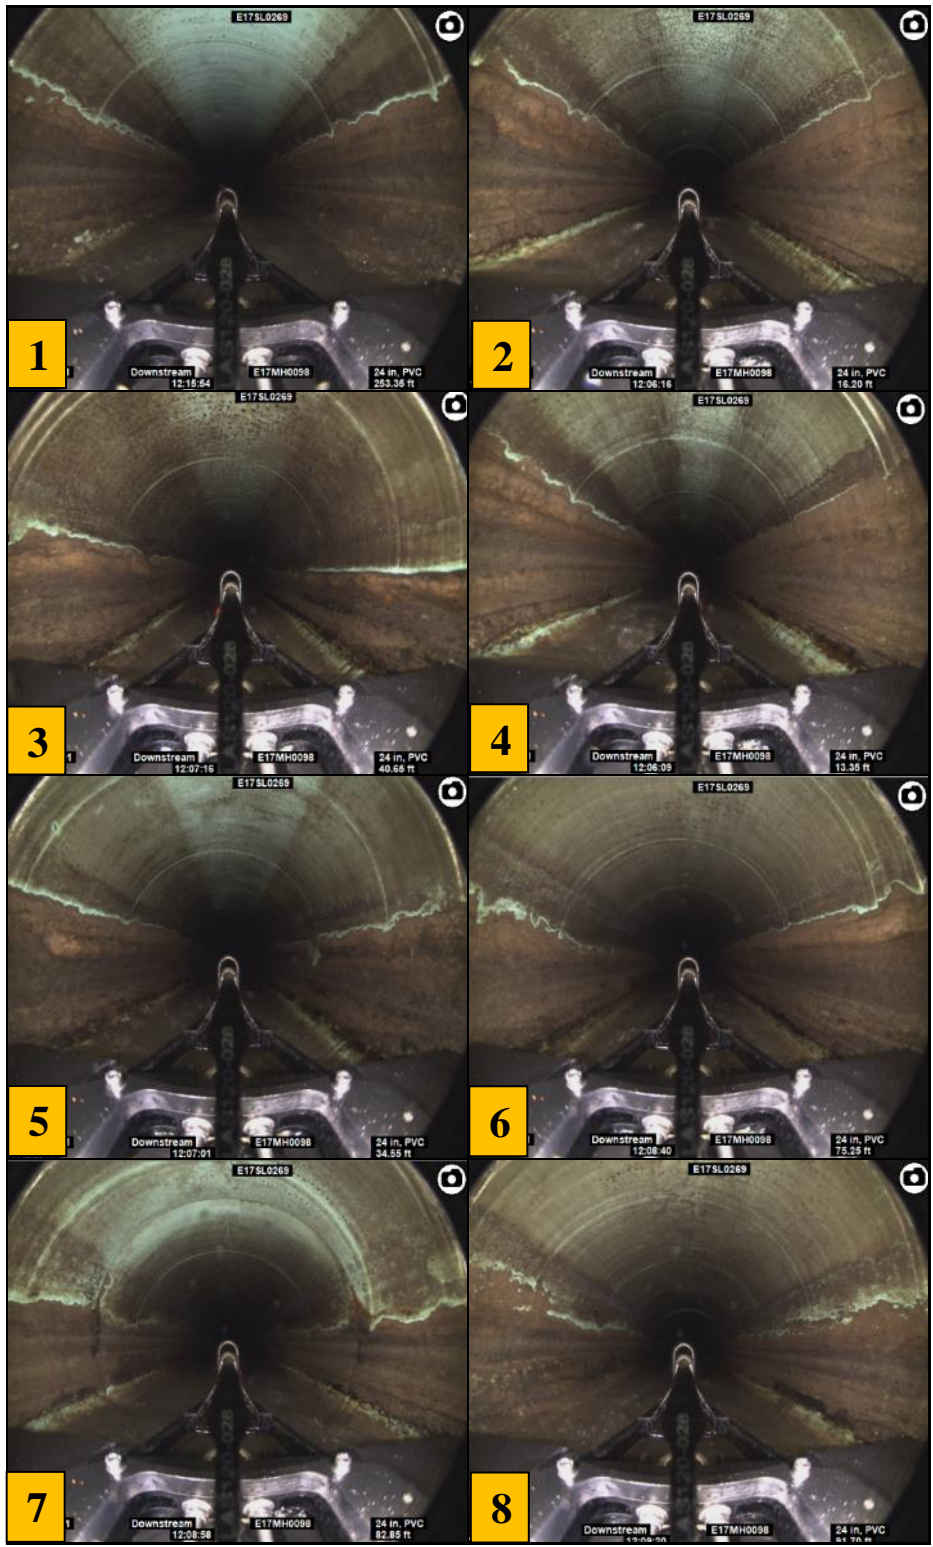
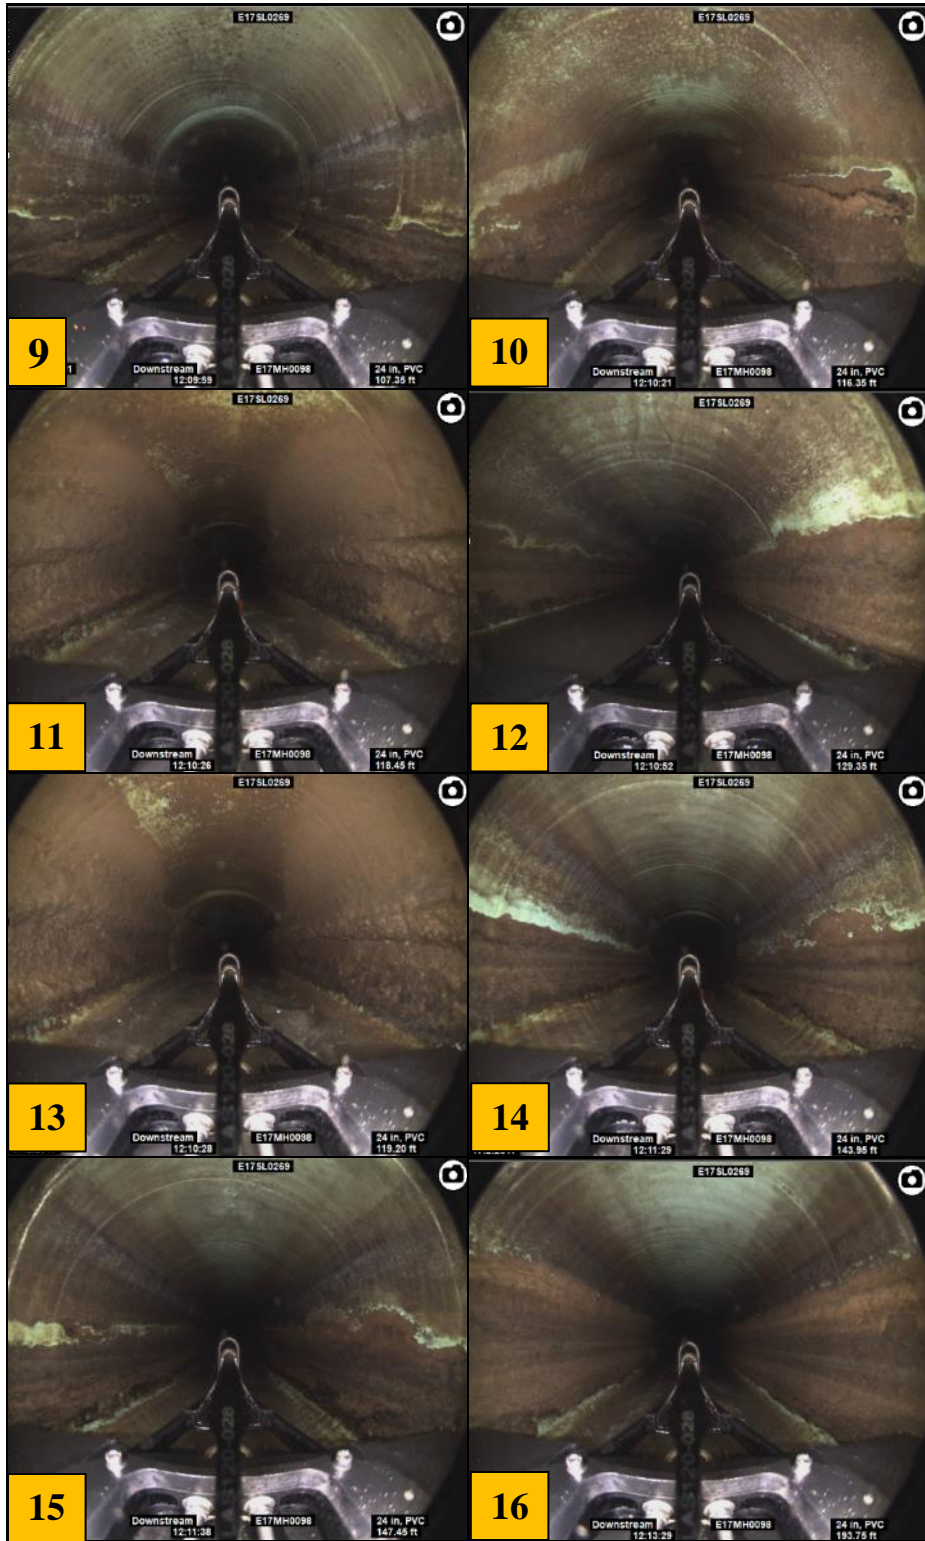
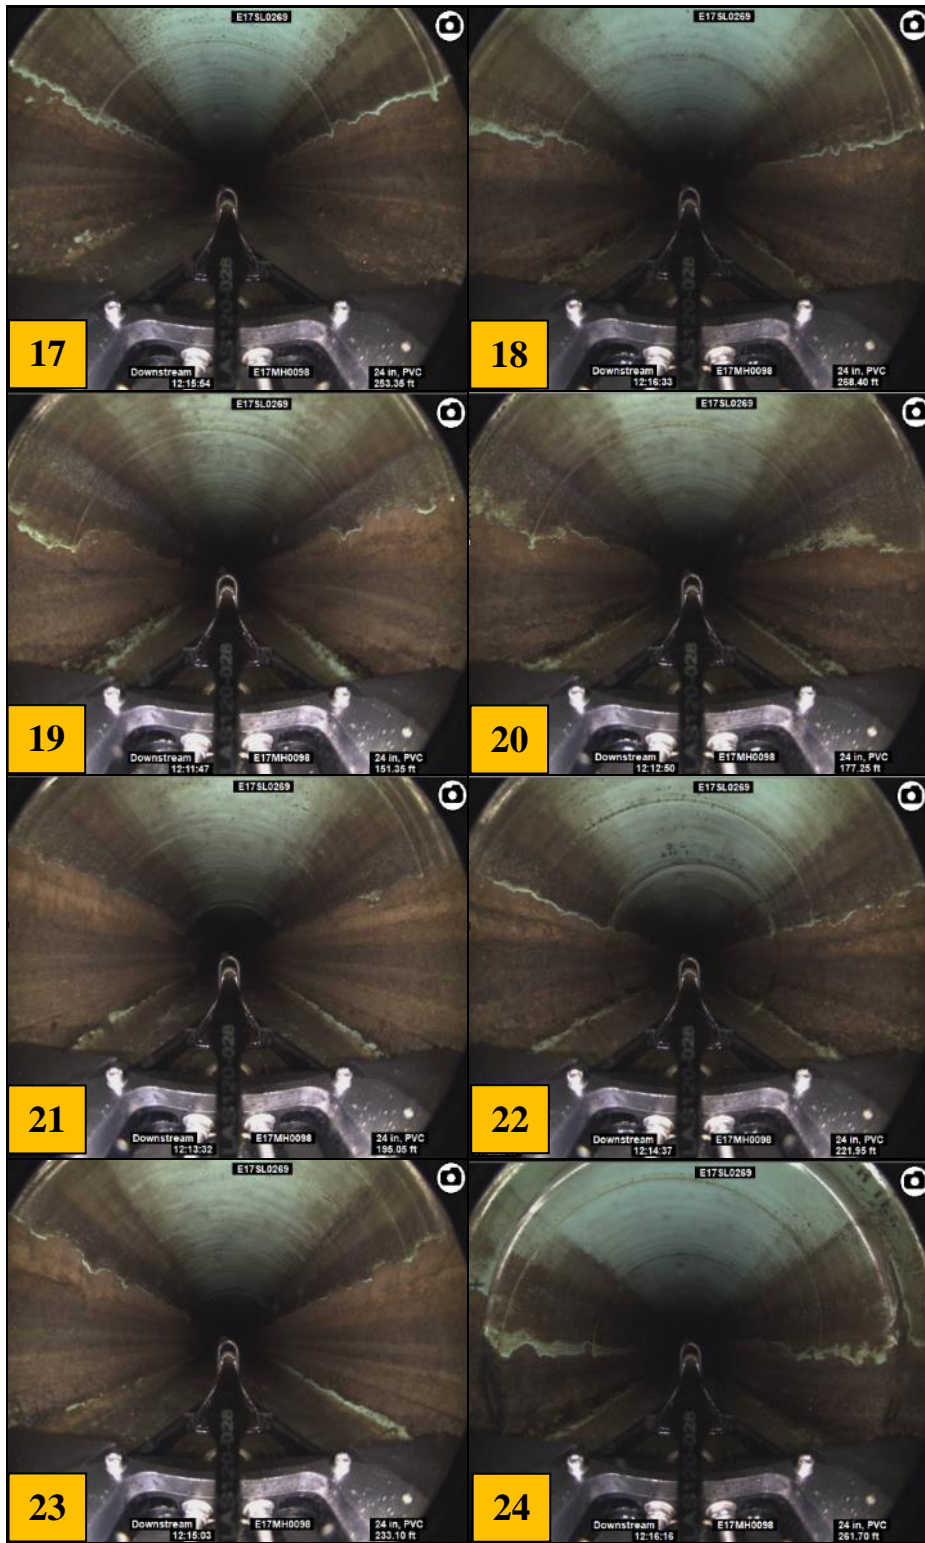
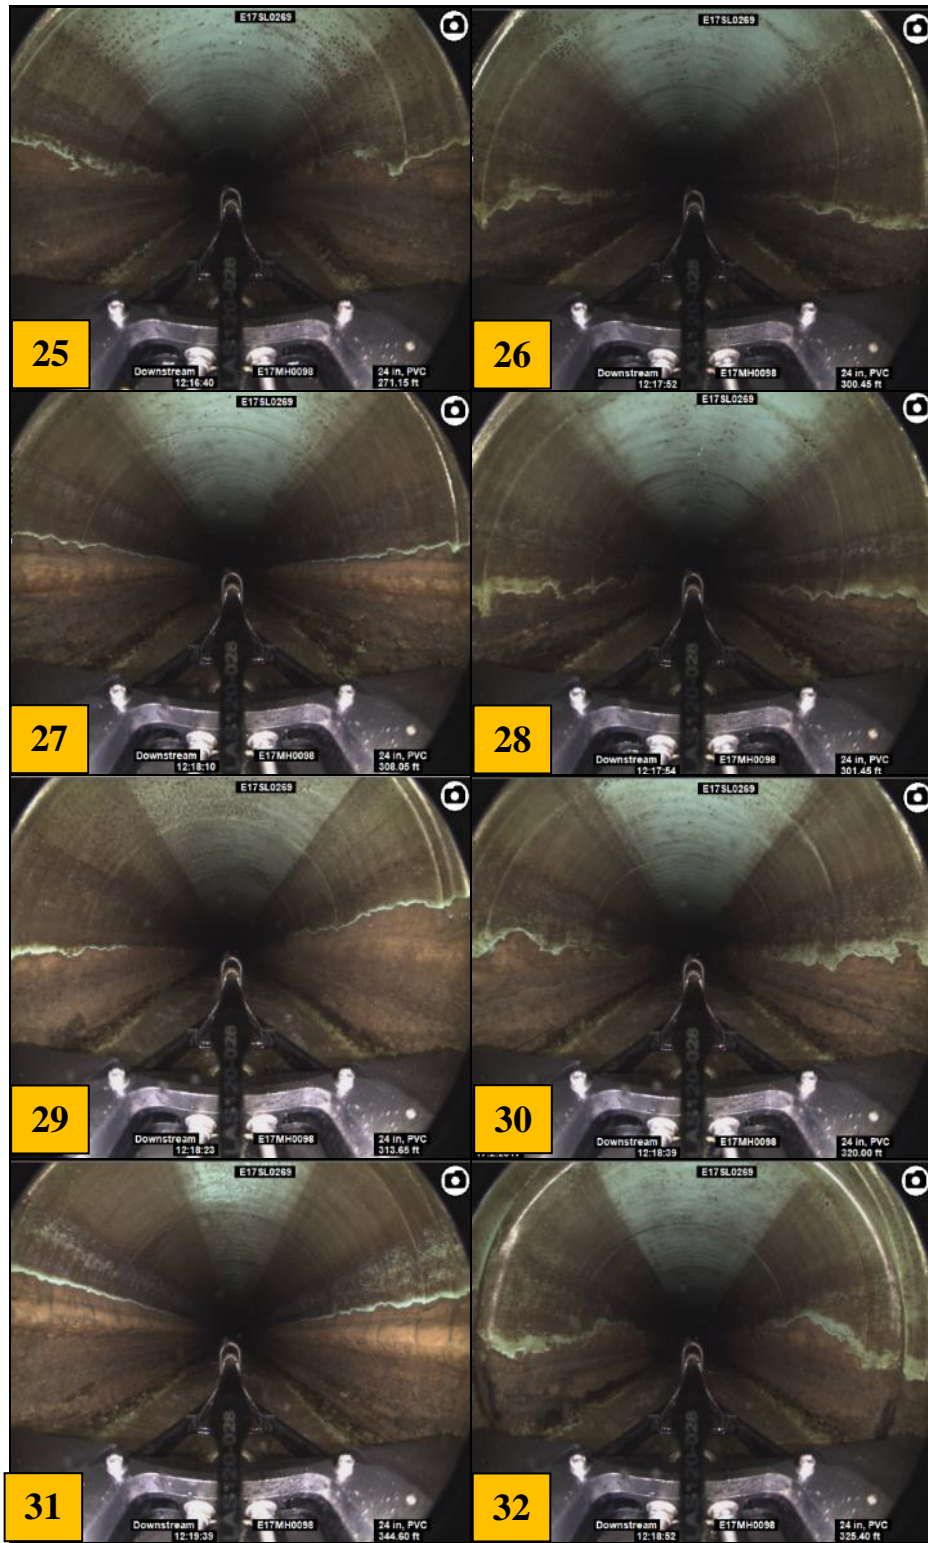
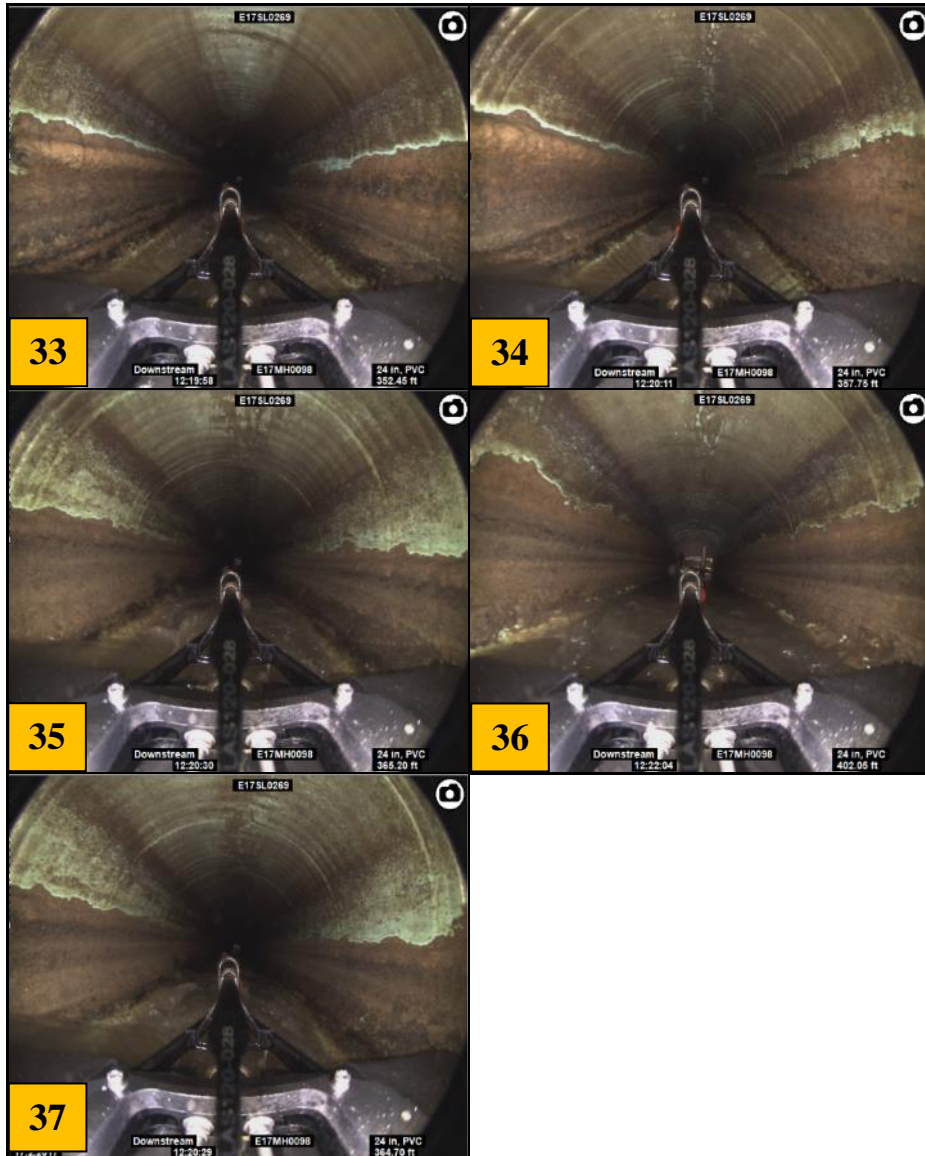
SN	Distance (feet)	Video Ref.	Code Group/ Descriptor/ Modifier	Continuous Defect	Value			Joint	Circumferential Location		Img Reference	Remarks
					Dimension		%		At/ From	To		
					1st	2nd						
1	0		AMH									
2	6		MWL			5%						
3	6		DAE	S01		10%				1,2,3		
4	13.35		MWL			10%				4		
5	34.55		MWL			5%				5		
6	75.25		MWL			10%				6		
7	82.85		DAE	F01								
8	82.85		DAE	S02		5%				7,8		
9	107.35		MWL			5%				9		
10	116.35		DAE	F02								
11	116.35		DAE	S03		10 TO 15%				10,11,12		
12	119.2		MWL			15%				13		
13	143.95		MWL			5%				14		
14	147.45		DAE	F03								
15	147.45		DAE	S04		5%				15,16,17,18		
16	151.35		MWL			10%				19		
17	177.25		MWL			5%				20		
18	195.05		MWL			10%				21		
19	221.95		MWL			5%				22		
20	233.1		MWL			10%				23		
21	261.7		MWL			5%				24		
22	271.15		MWL			10%				25		
23	300.45		DAE	F04		5%						
24	300.45		DAE	S05		10%				26,27		
25	301.45		MWL			5%				28		
26	313.65		MWL			10%				29

27	320		DAE	F05								
28	320		DAE	S06		10%				30,31		
29	325.4		MWL			5%				32		
30	351.35		DAE	F06								
31	352.45		DAE	S07		5%				33,34,35,36		
32	364.7		MWL			10%				37		
33	410.55		DAE	F07								
34	410.55		MSA

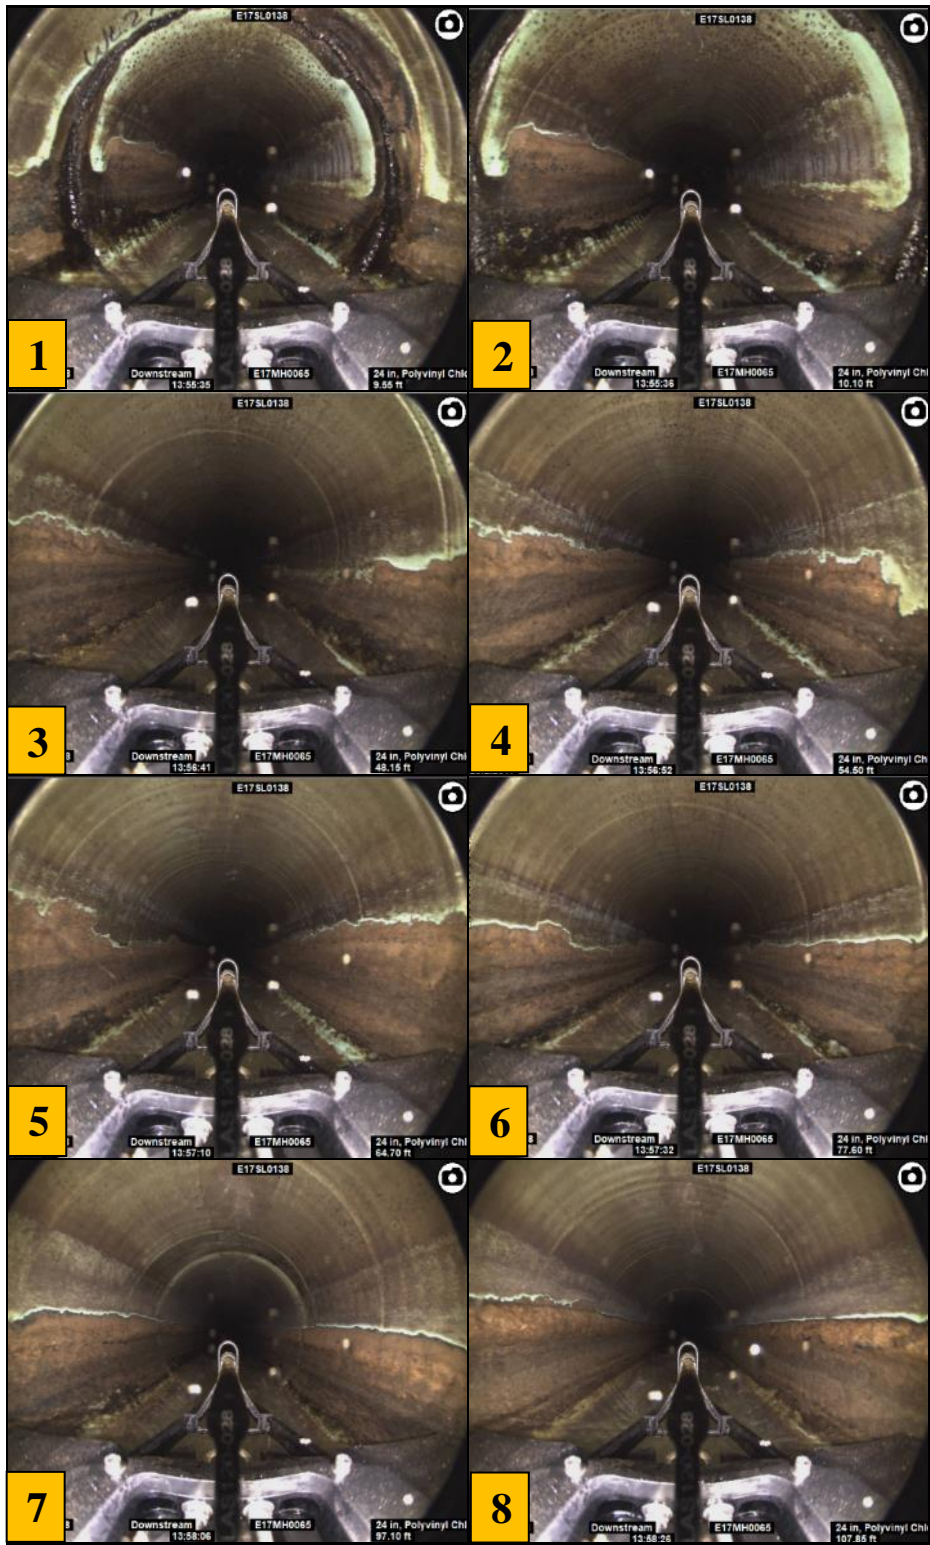
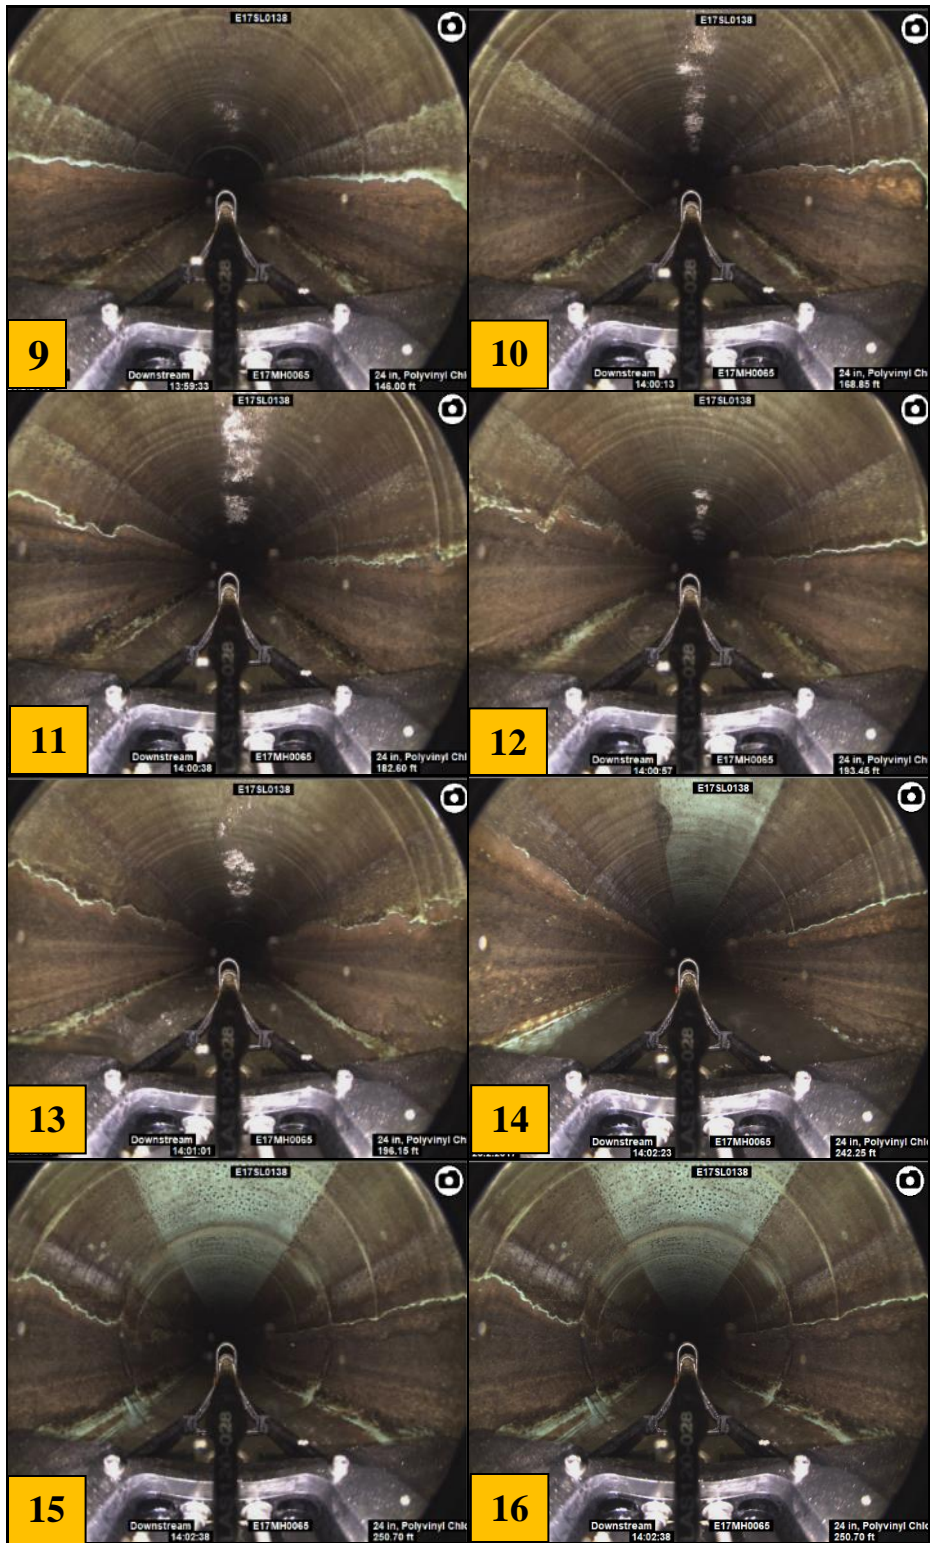
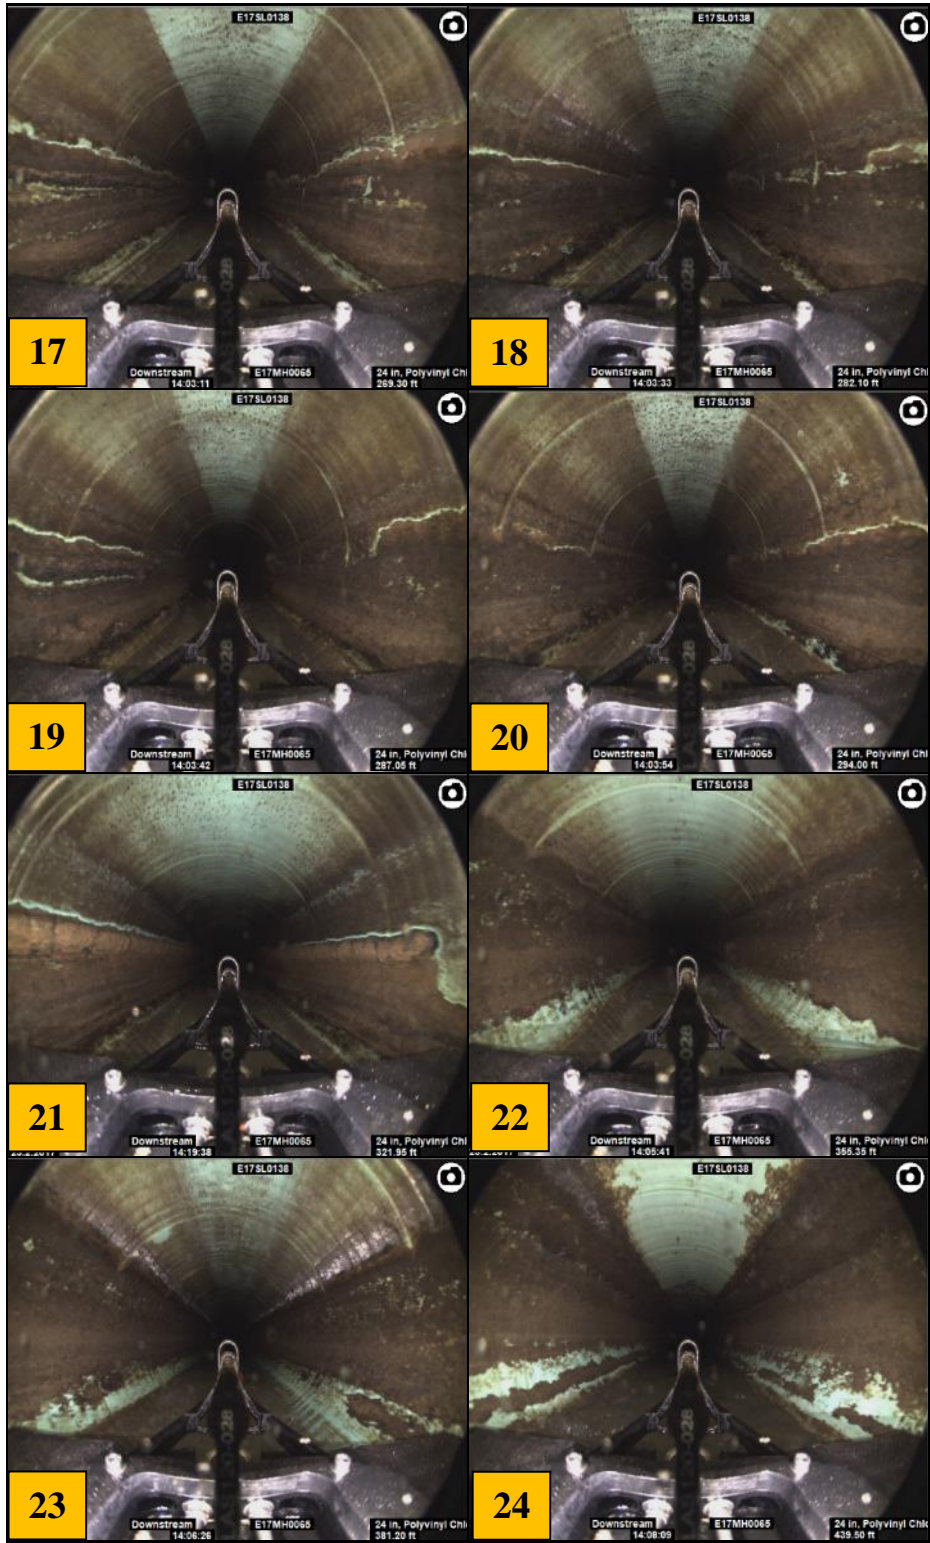
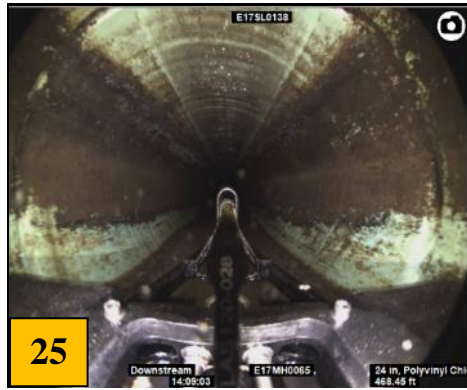
SN	Distance (feet)	Video Ref.	Code Group/ Descriptor/ Modifier	Continuous Defect	Value		Joint	Circumferential Location		Img Reference	Remarks	
					Dimension			%	At/ From			To
					1st	2nd						
1	0		AMH									
2	7		MWL			5%						
3	9.55		DAG			10%	J			1		
4	10.1		DAE			5%				2		
5	48.15		DAE	S01		5%				3,4,5,6		
6	86.55		DAE	F01								
7	97.1		DAE	S02		5%				7,8		
8	124.45		DAE	F02								
9	146		DAE	S03		5%				9		
10	162.75		DAE	F03								
11	168.85		DAE	S04		5%				10		
12	175.05		DAE	F04								
13	182.6		DAE	S05		5%				11		
14	187.5		DAE	F05								
15	193.45		DAE			5%				12		
16	196.15		MWL			10%				13		
17	242.25		DAE			5%				14		
18	250.7		DAE	S06		5%				15		
19	253.2		MWL			5%				16		
20	264.8		DAE	F06								
21	269.3		DAE	S07		5%				17		
22	276.35		DAE	F07								
23	282.1		DAE			5%				18		
24	287.05		DAE			5%				19		
25	294		DAE	S08		10%				20		
26	321.95		DAE			5%				21		
27	355.35		MWL			10%				22		
28	381.2		MWL			5%				23

29	439.5		MWL			10%				24		
30	468.45		MWL			5%				25		
31	489.4		DAE	F08								
32	489.4		MSA

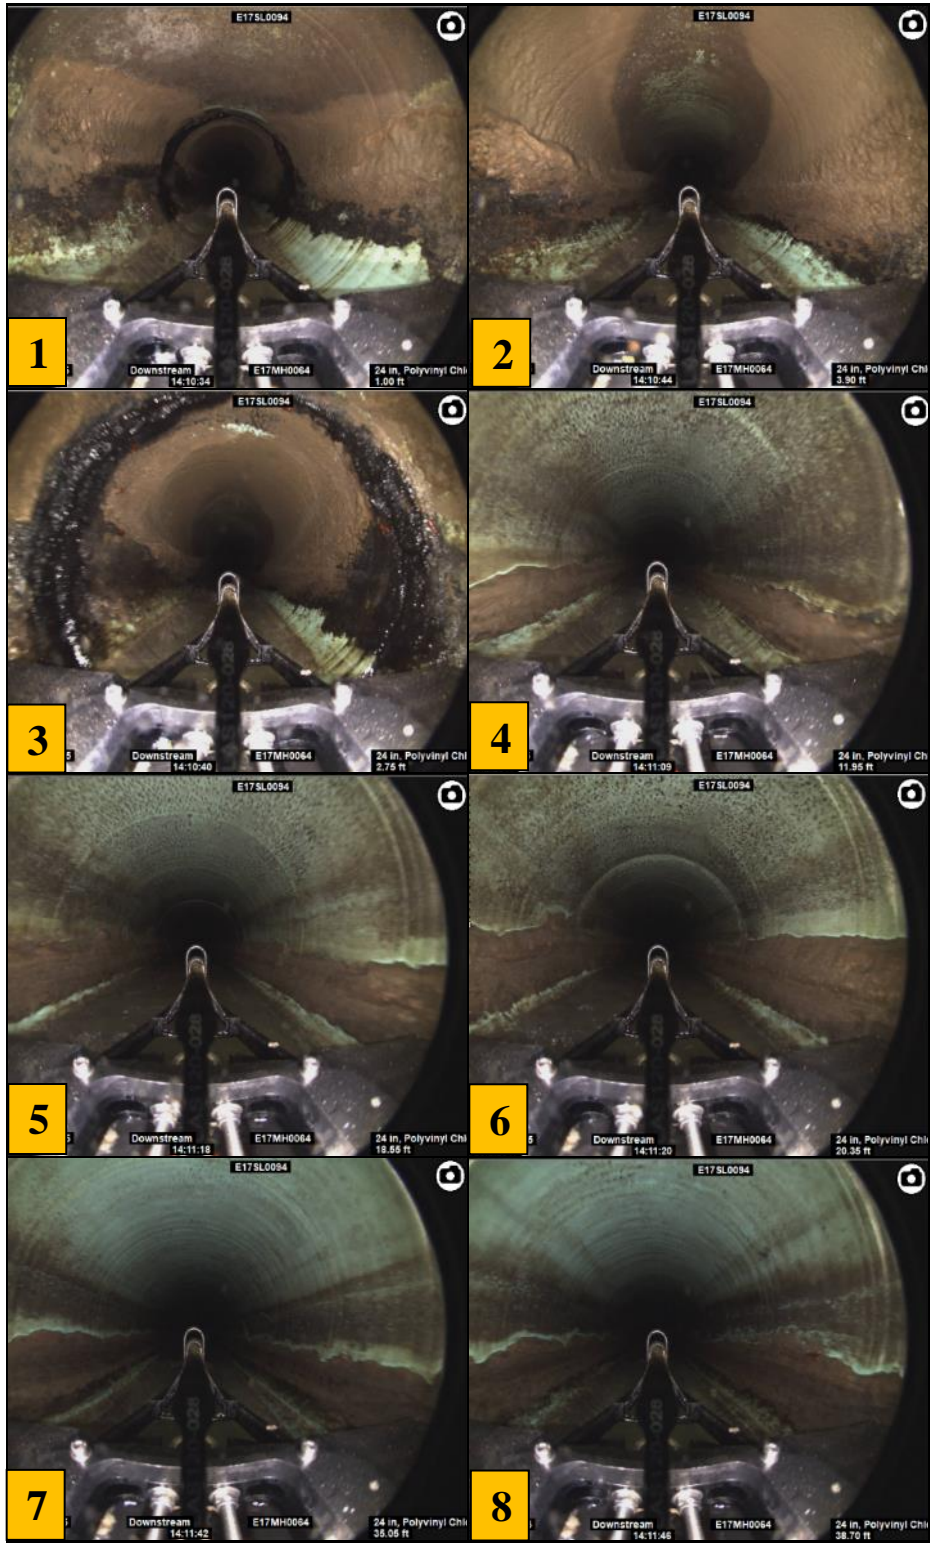
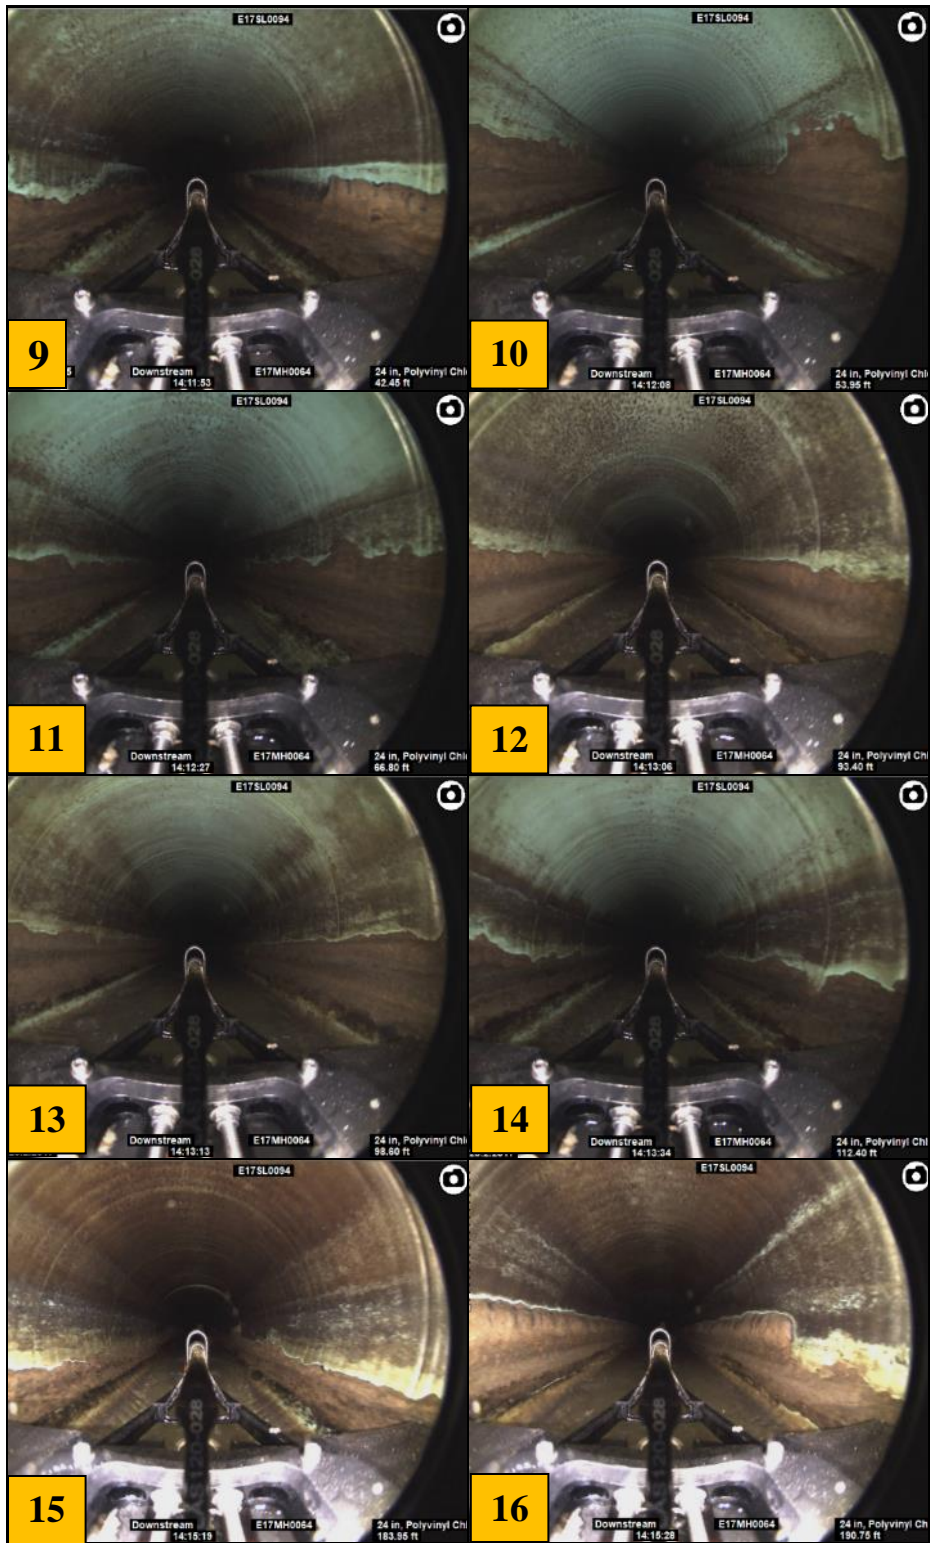
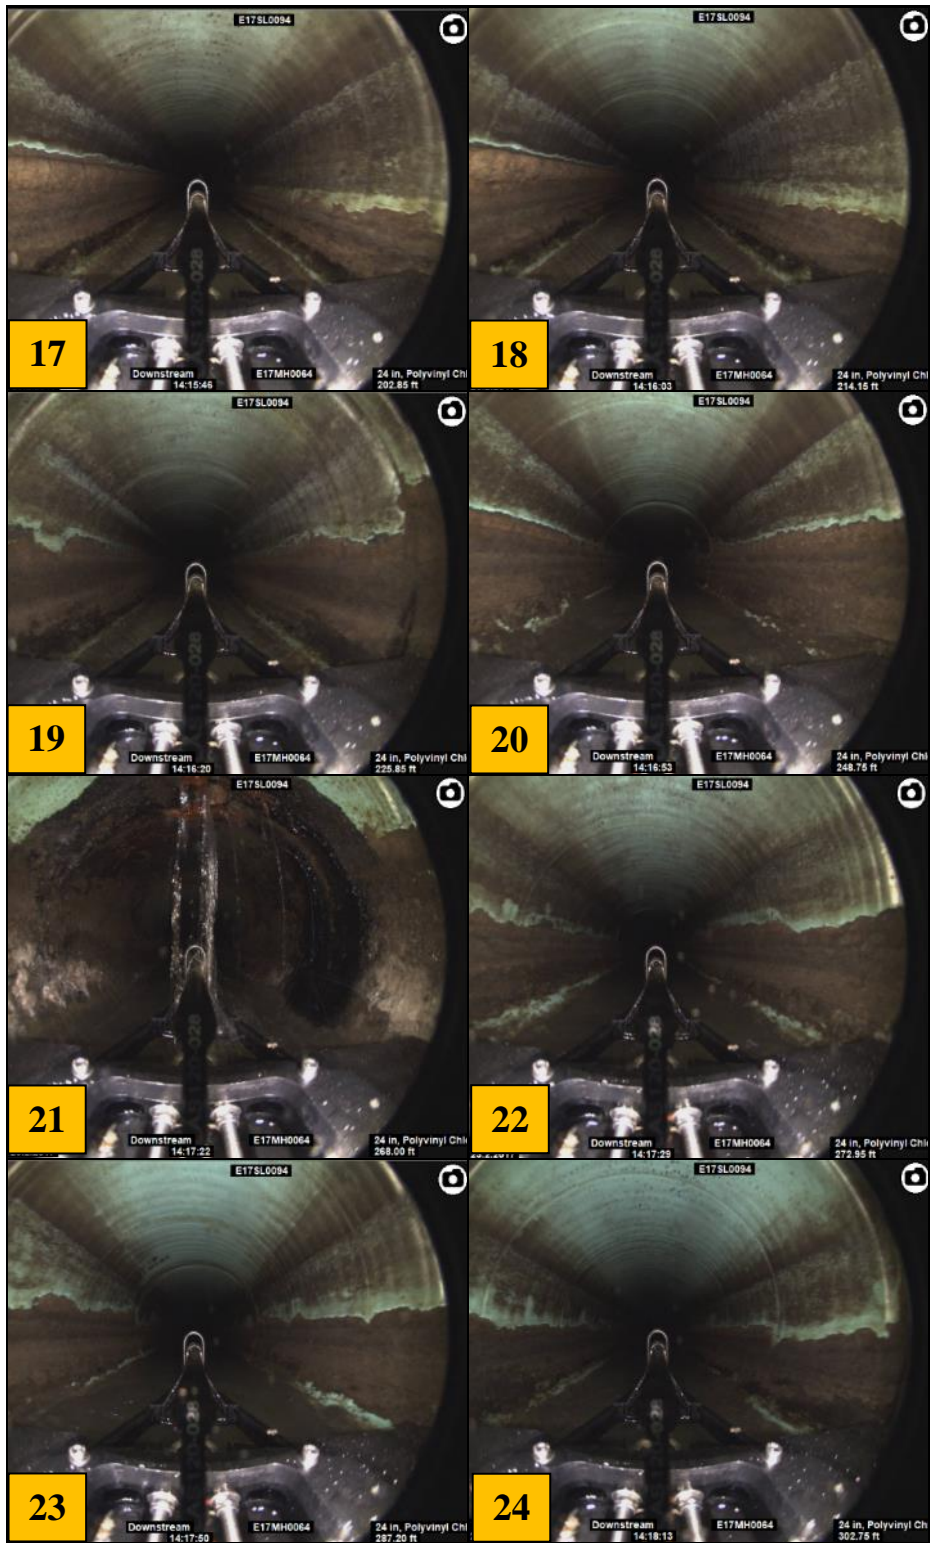
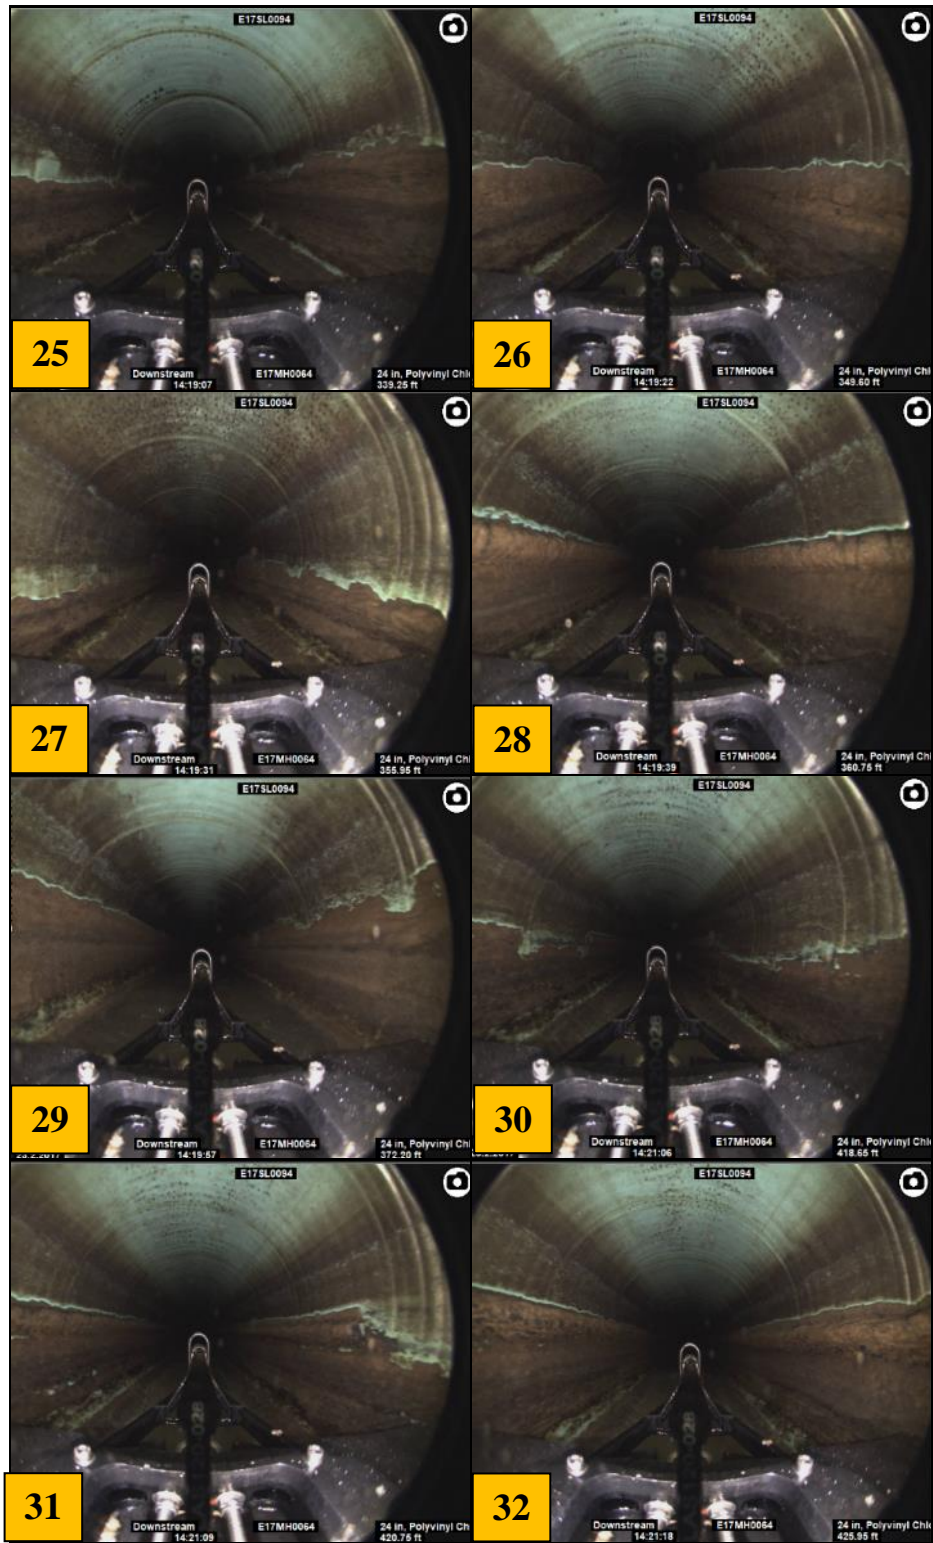
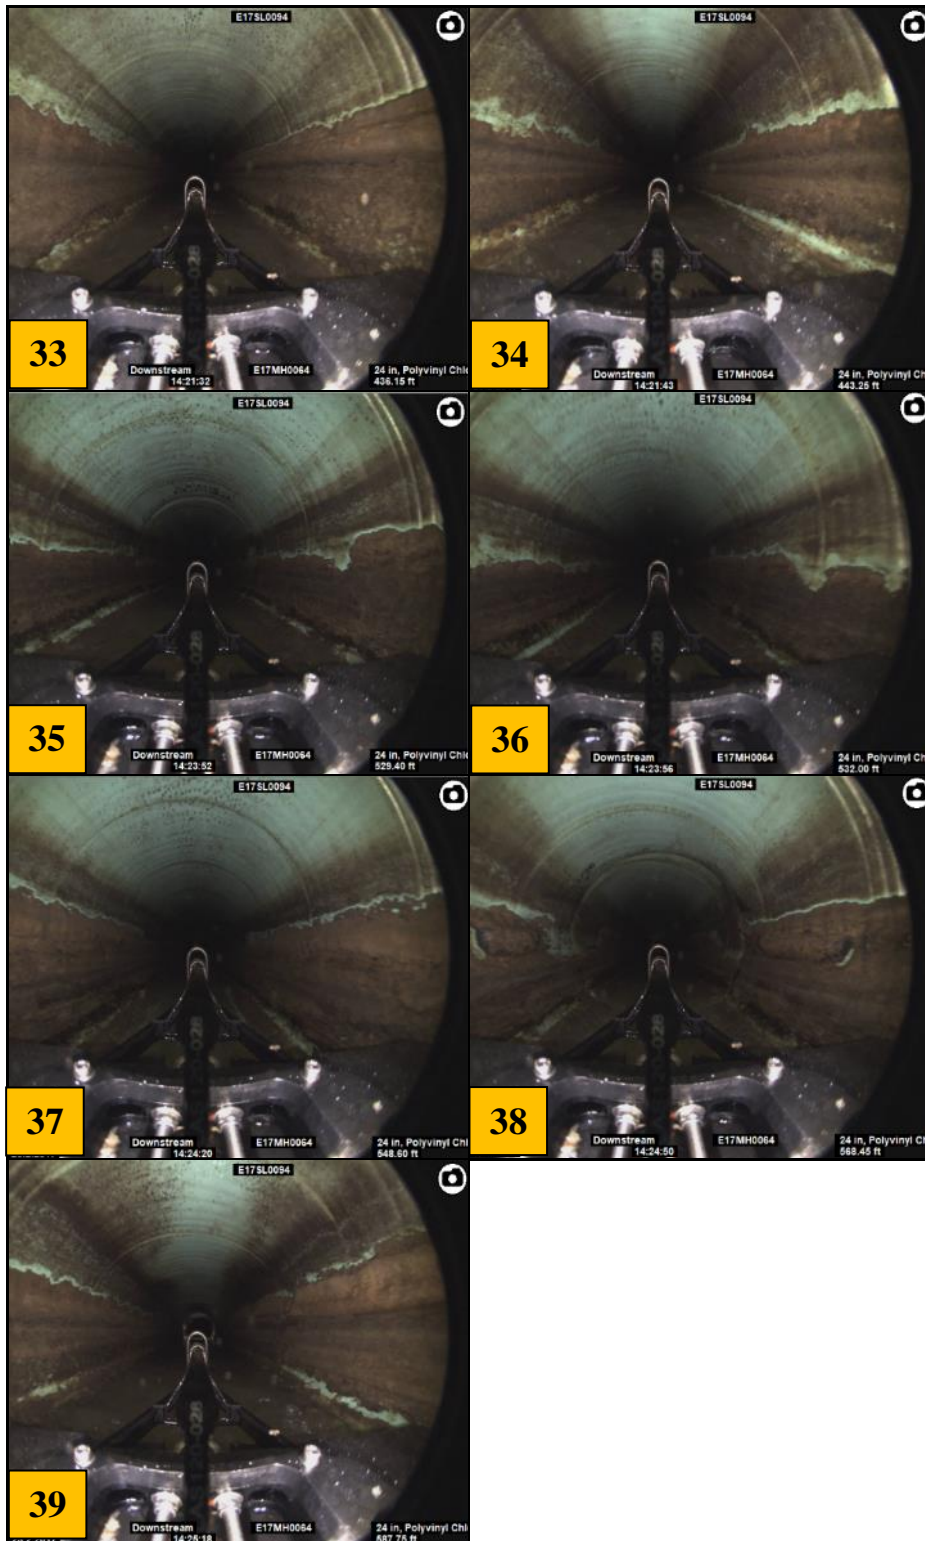
SN	Distance (feet)	Video Ref.	Code		Value			Joint	Circumferential Location		Img Reference	Remarks
			Group/Descriptor/Modifier	Continuous Defect	Dimension		%		At/From	To		
					1st	2nd						
1	0		AMH									
2	0		MWL			<5%						
3	1		DAE	S01			20%				1,2	
4	2.75		DAG				15%	J			3	
5	9		DAE	F01								
6	11.95		DAE	S02			10%				4,6	
7	18.55		MWL				10%				5	
8	33.55		DAE	F02								
9	35.05		MWL				5%				7	
10	35.05		DAE	S03			15%				7,8,9,10	
11	53.95		MWL				10%				10	
12	66.8		MWL				5%				11	
13	91.2		DAE	F03								
14	93.4		DAE	S04			5%				12	
15	98.6		MWL				10%				13	
16	112.4		MWL				5%				14	
17	159.7		DAE	F04								
18	183.95		DAE	S05			15%				15,16	
19	199.35		DAE	F05								
20	202.85		DAE	S06			5%				17

21	212.9		DAE	F06								
22	214.15		DAE	S07			5%				18	
23	225.85		DAE	F07								
24	225.85		DAE	S08			10%				19	
25	248.75		MWL				10%				20	
26	268		IDJ								21	
27	270.85		DAE	F08								
28	272.95		DAE	S09			10%				22,23,25,26	
29	302.75		MWL				5%				24	
30	354		DAE	F09								
31	355.95		DAE	S10			10%				27,28,	
32	372.2		MWL				10%				29	
33	416.95		DAE	F10								
34	418.65		MWL				5%				30	
35	420.75		DAE	S11			10%				31,32	
36	436.15		MWL				10%				33	
37	442.6		DAE	F11			10%					
38	443.25		DAE	S12			5%				34,35	
39	529.4		DAE	F12								
40	532		MWL				5%				36	
41	548.6		DAE	S13			5 TO 10%				37	
42	565.25		DAE	F13								
43	568.45		DAE	S14			5%				38,40	
44	587.75		MWL				10%				39	
45	596.15		DAE	F14								
46	596.15		MSA

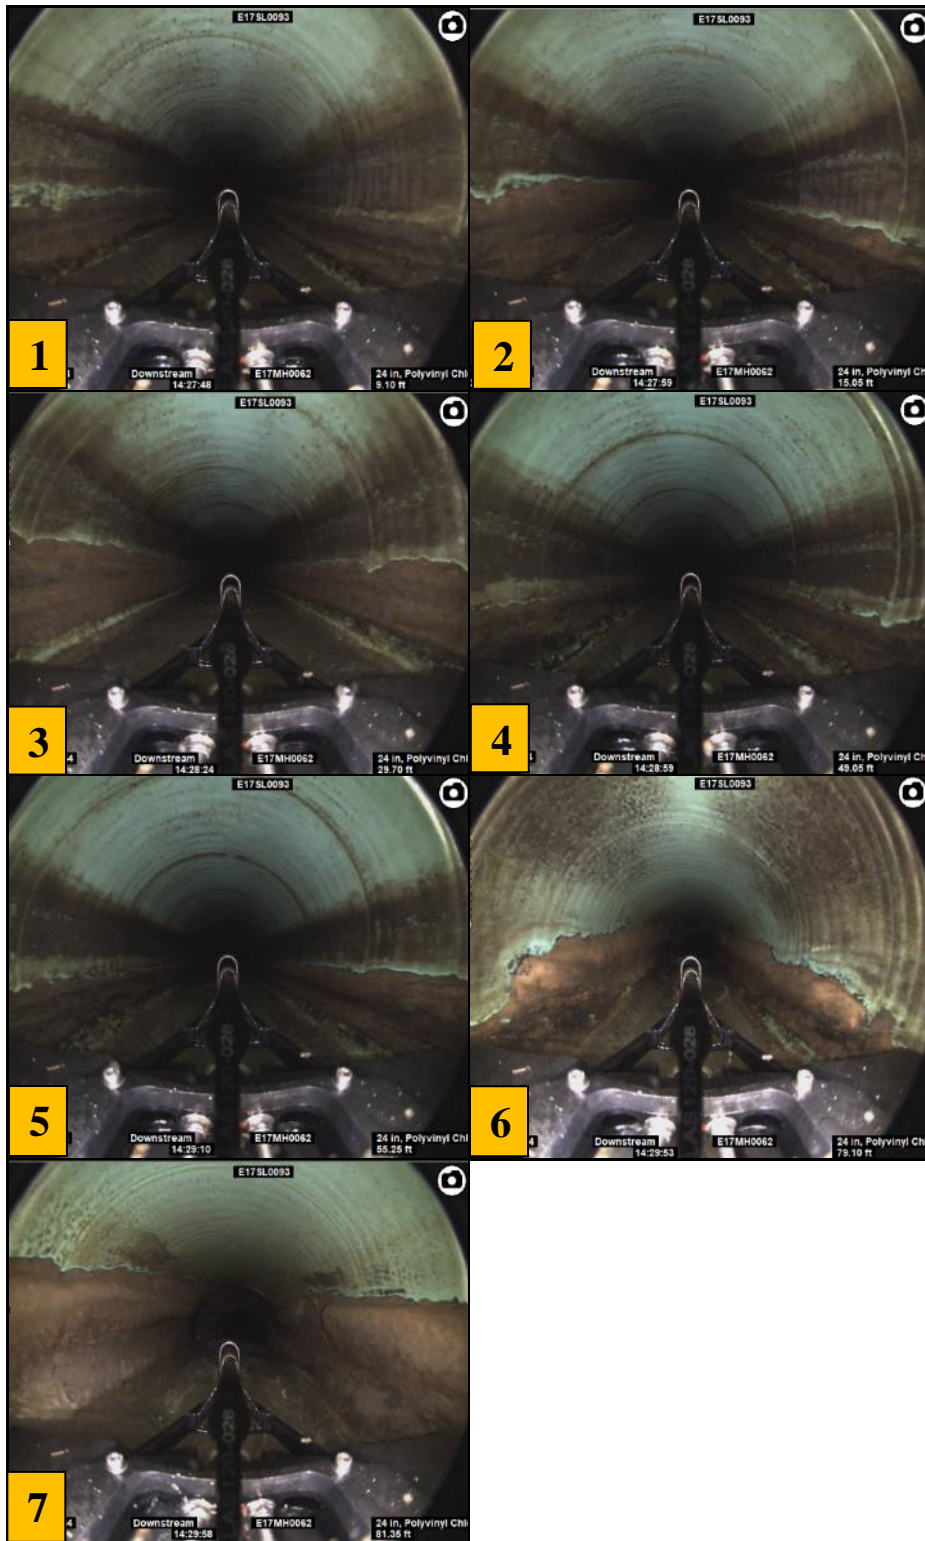
Figure A49-1 images from 1 through 7

SN	Distance (feet)	Video Ref.	Code	Continuous Defect	Value			Joint	Circumferential Location		Img Reference	Remarks
			Group/Descriptor/Modifier		Dimension		%		At/From	To		
					1st	2nd						
1	0		AMH									
2	0		MWL			10%						
3	9.1		MWL			5%				1		
4	15.05		DAE	S01		5 TO 10%				2		
5	29.7		MWL			10%				3		
6	46.65		DAE	F01								
7	49.05		MWL			5%				4		
8	55.25		DAE			5%				5		
9	79.1		DAE	S02		15%				6,7		
10	84		DAE	F02								
11	84		MSA
