ALGORITHM DEVELOPMENT FOR SEWER PIPE SYSTEM CONDITION
ASSESSMENT USING MULTI-SENSOR (MSI) TECHNOLOGY

ALGORITHM DEVELOPMENT FOR SEWER PIPE SYSTEM CONDITION ASSESSMENT USING MULTI-SENSOR (MSI) TECHNOLOGY

This study investigates the performance of all the current large-diameter pipeline system of The City of Arlington (COA) sewer lines of 48 miles (24-inch inner diameter and above for rigid and flexible pipes). Proper inspection and rehabilitation plan for the city sewer pipeline system are better choice for the municipality and tax payers in terms of cost than dealing with pipe damage and collapsing problems when they happen.

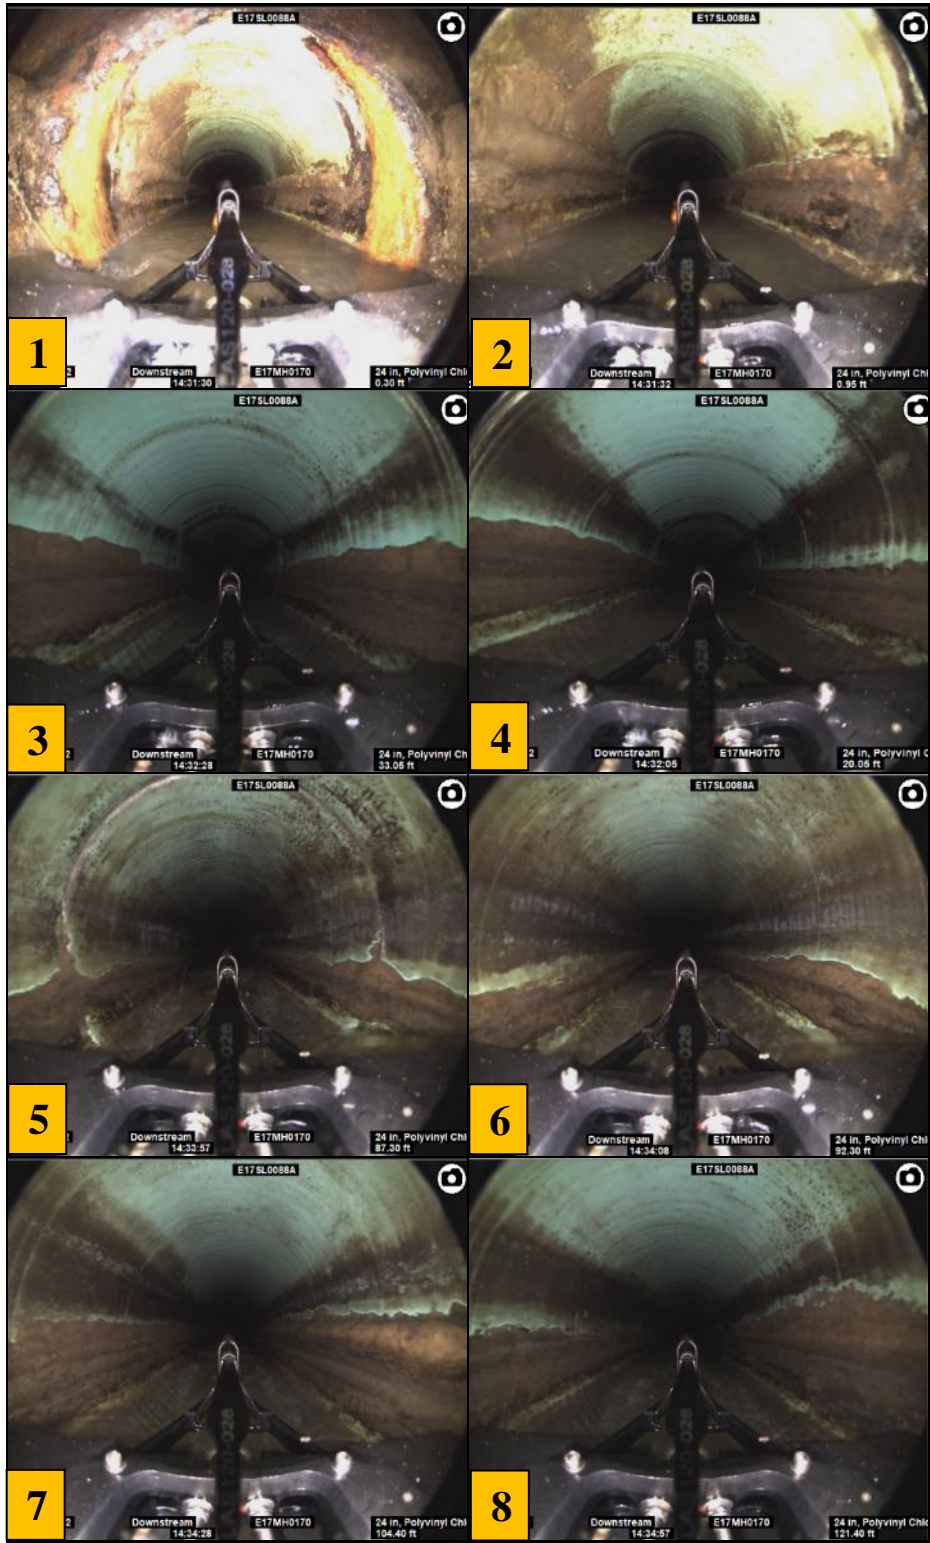
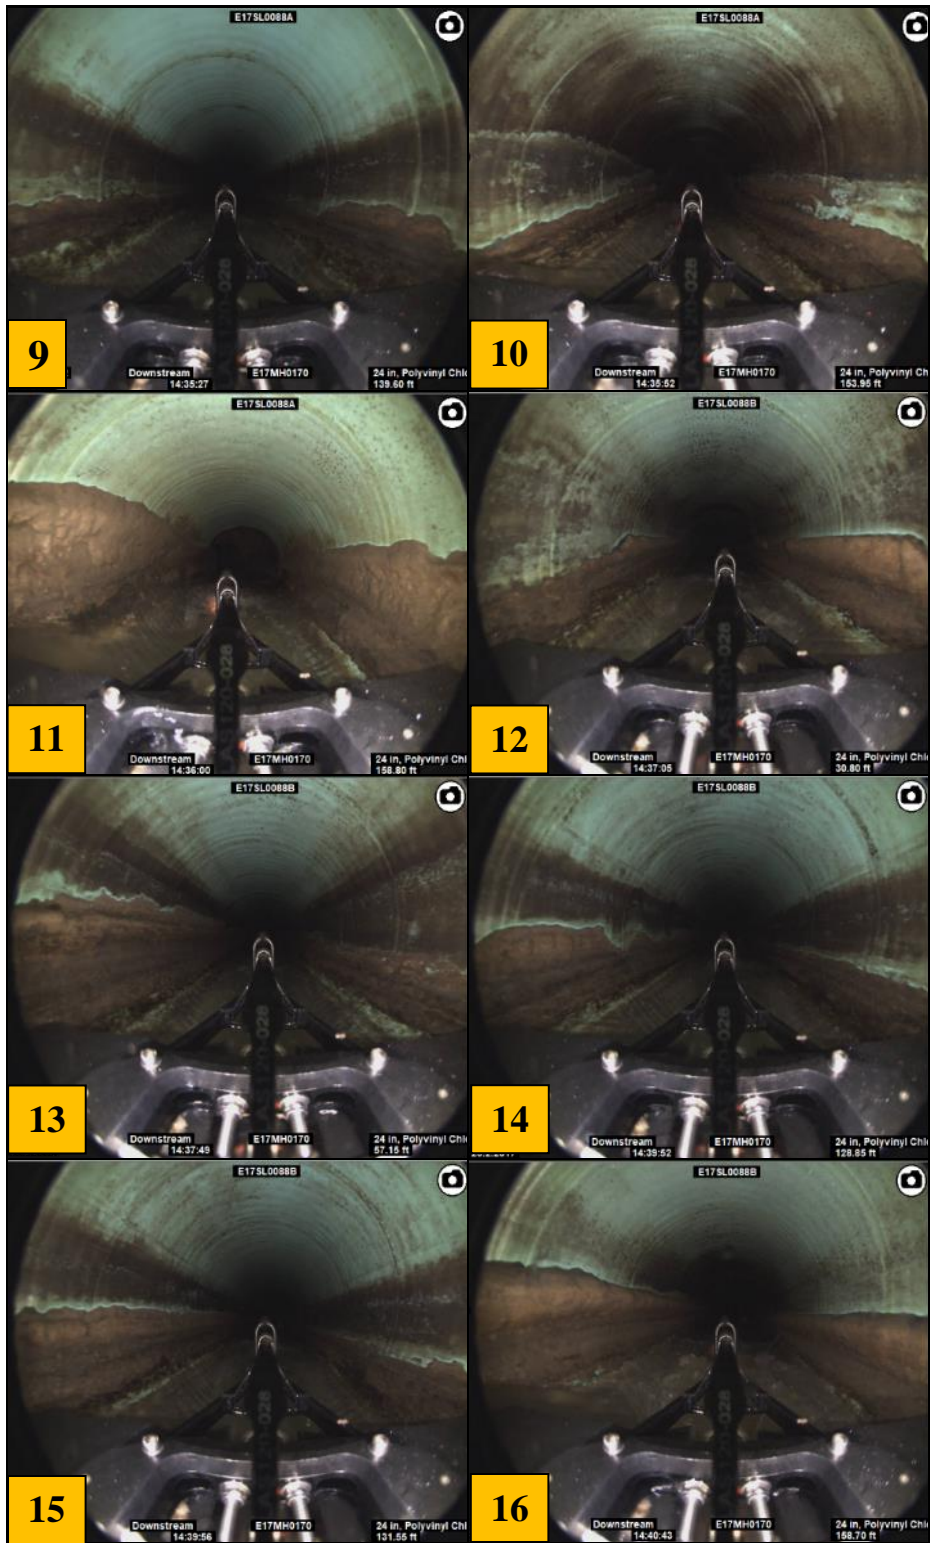
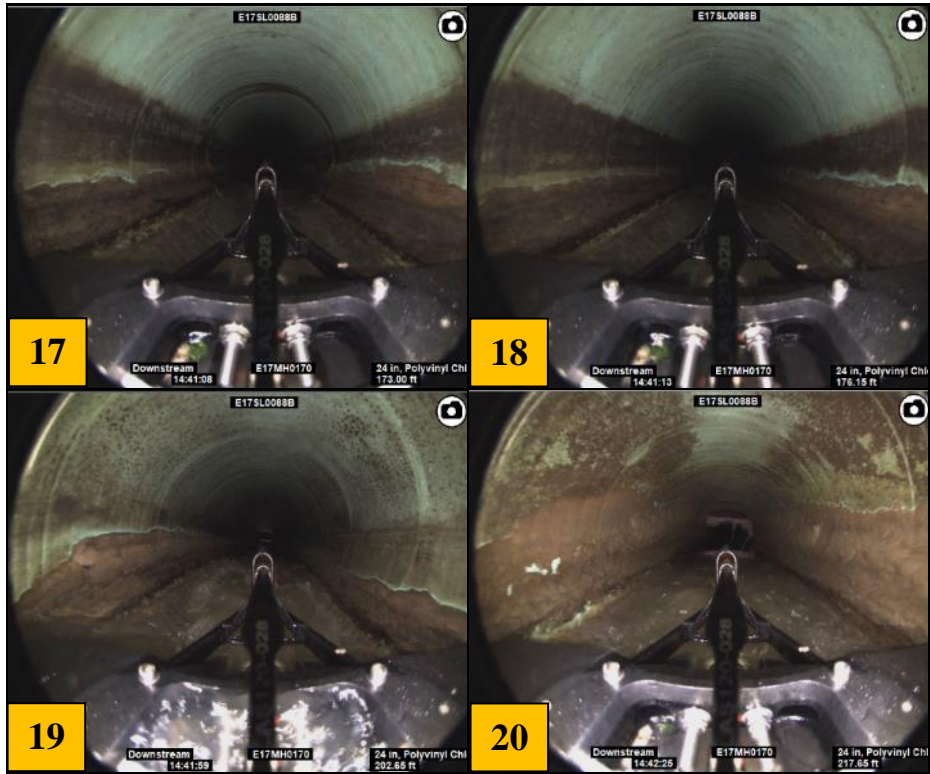
SN	Distance (feet)	Video Ref.	Code		Continuous Defect	Value		Joint	Circumferential Location		Img Reference	Remarks	
			Group/ Descriptor/ Modifier			Dimension			%	At/ From			To
						1st	2nd						
1	0		AMH										
2	0		MWL				10%						
3	0.3		DAG				10%				1		
4	0.95		DAE	S01			5%				2,3		
5	20.05		MWL				5%				4		
6	62.9		DAE	F01									
7	87.3		DAE				5%				5		
8	92.3		DAE				5%				6		
9	104.4		DAE	S02			5%				7		
10	109		DAE	F02									
11	121.4		DAE	S03			5%				8		
12	137.5		DAE	F03									
13	139.6		DAE				5%				10		
14	153.95		DAE	S04			10%				11,12		
15	161.95		DAE	F04									
												FOUND UNNAMED MANHOLE	
16	30.8		DAE	S05			5%				13,14		
17	120.2		DAE	F05									
18	128.85		DAE	S06			5 TO 10%				15,16,17		
19	168.45		DAE	F06									
20	173		DAE				5%				18		
21	176.15		DAE	S07			5%						
22	200.6		DAE	F07									
23	202.65		DAE	S08			5 TO 10%				19,20		
24	221.3		DAE	F08									
25	383.25		MSA

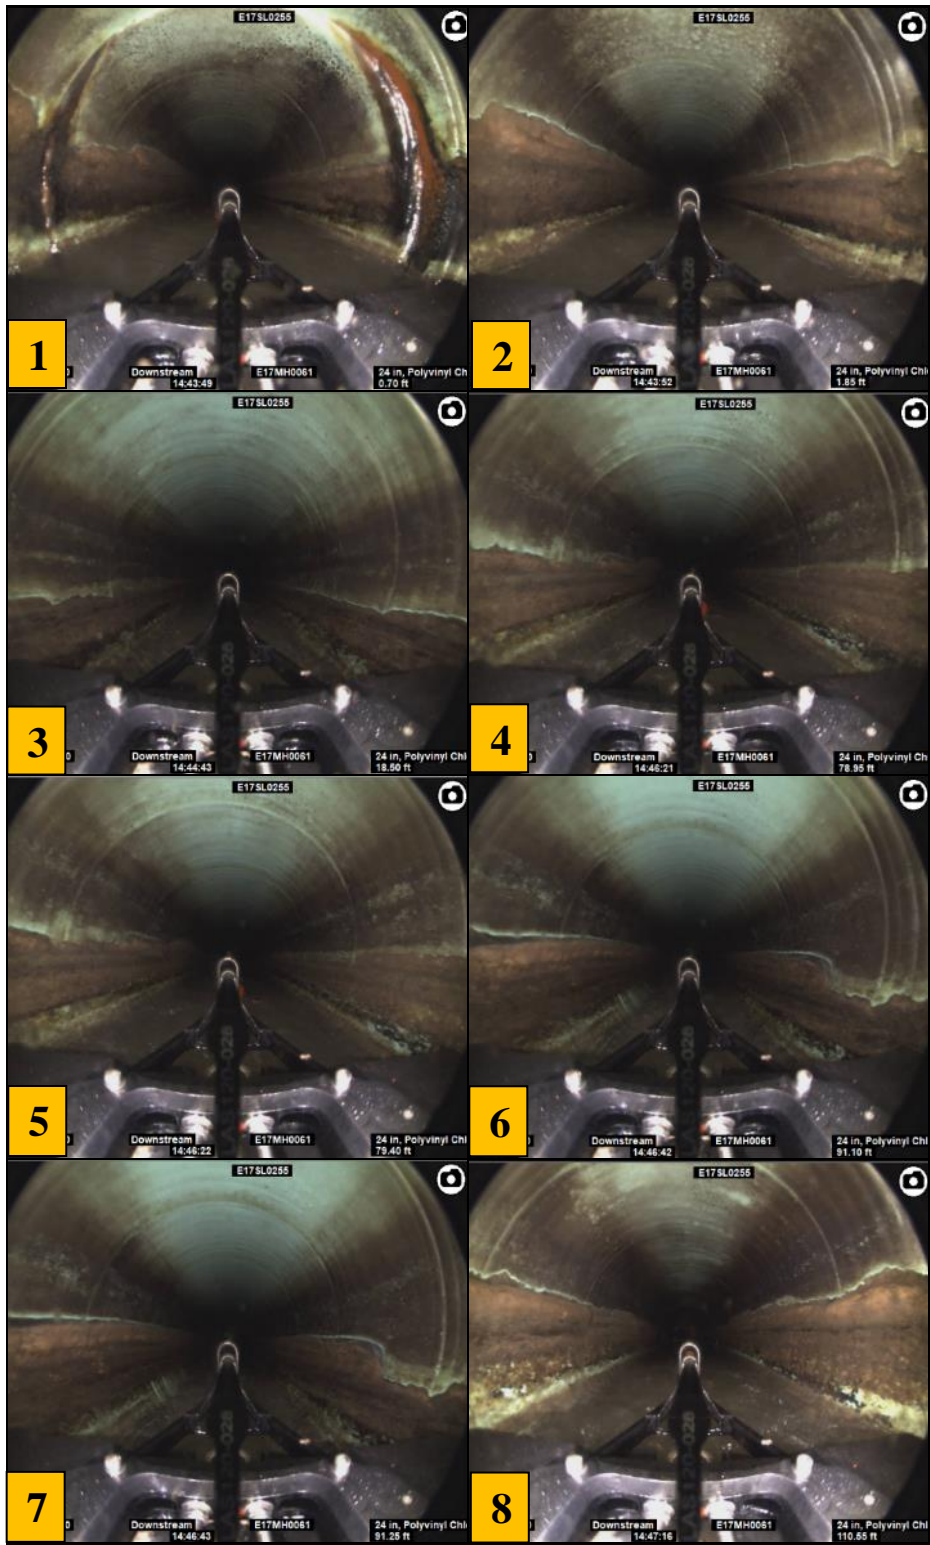
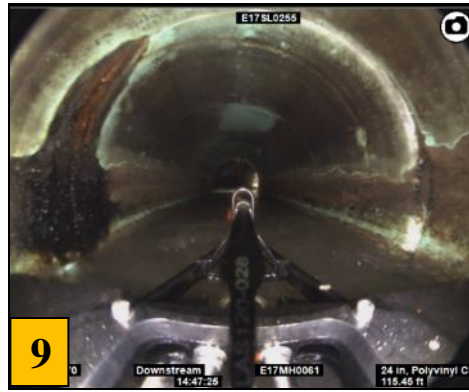
SN	Distance (feet)	Video Ref.	Code	Continuous Defect	Value		Joint	Circumferential Location		Img Reference	Remarks
					Dimension			%	At/ From		
			1st		2nd						
1	0		AMH								
2	0		MWL			10%					
3	0.7		DAG			5%	J			1	
4	1.85		DAE	S01		5 TO 10%				2	
5	77.75		DAE	F01							
6	18.5		MWL			5%				3	
7	78.95		DAE	S02		5%				4	
8	90.45		DAE	F02							
9	79.4		MWL			10%				5	
10	91.1		MWL			5%				6	
11	91.25		DAE	S03		5 TO 10%				7	
12	121.7		DAE	F03							
13	110.55		MWL			10%				8	
14	115.45		DAG			5%	J			9	
15	121.7		MSA

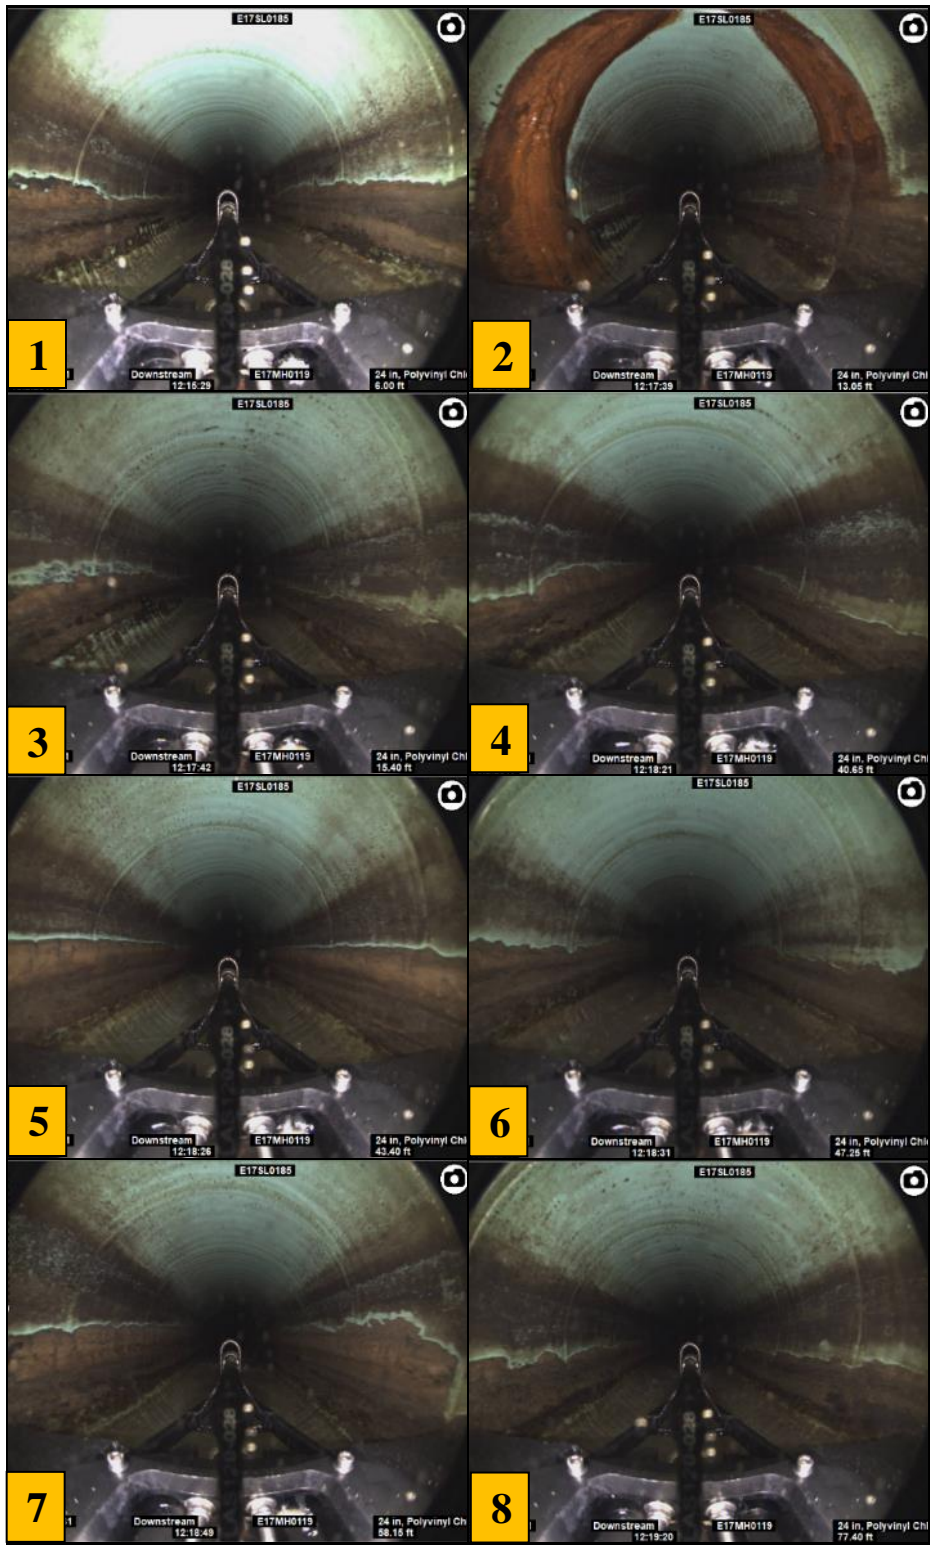
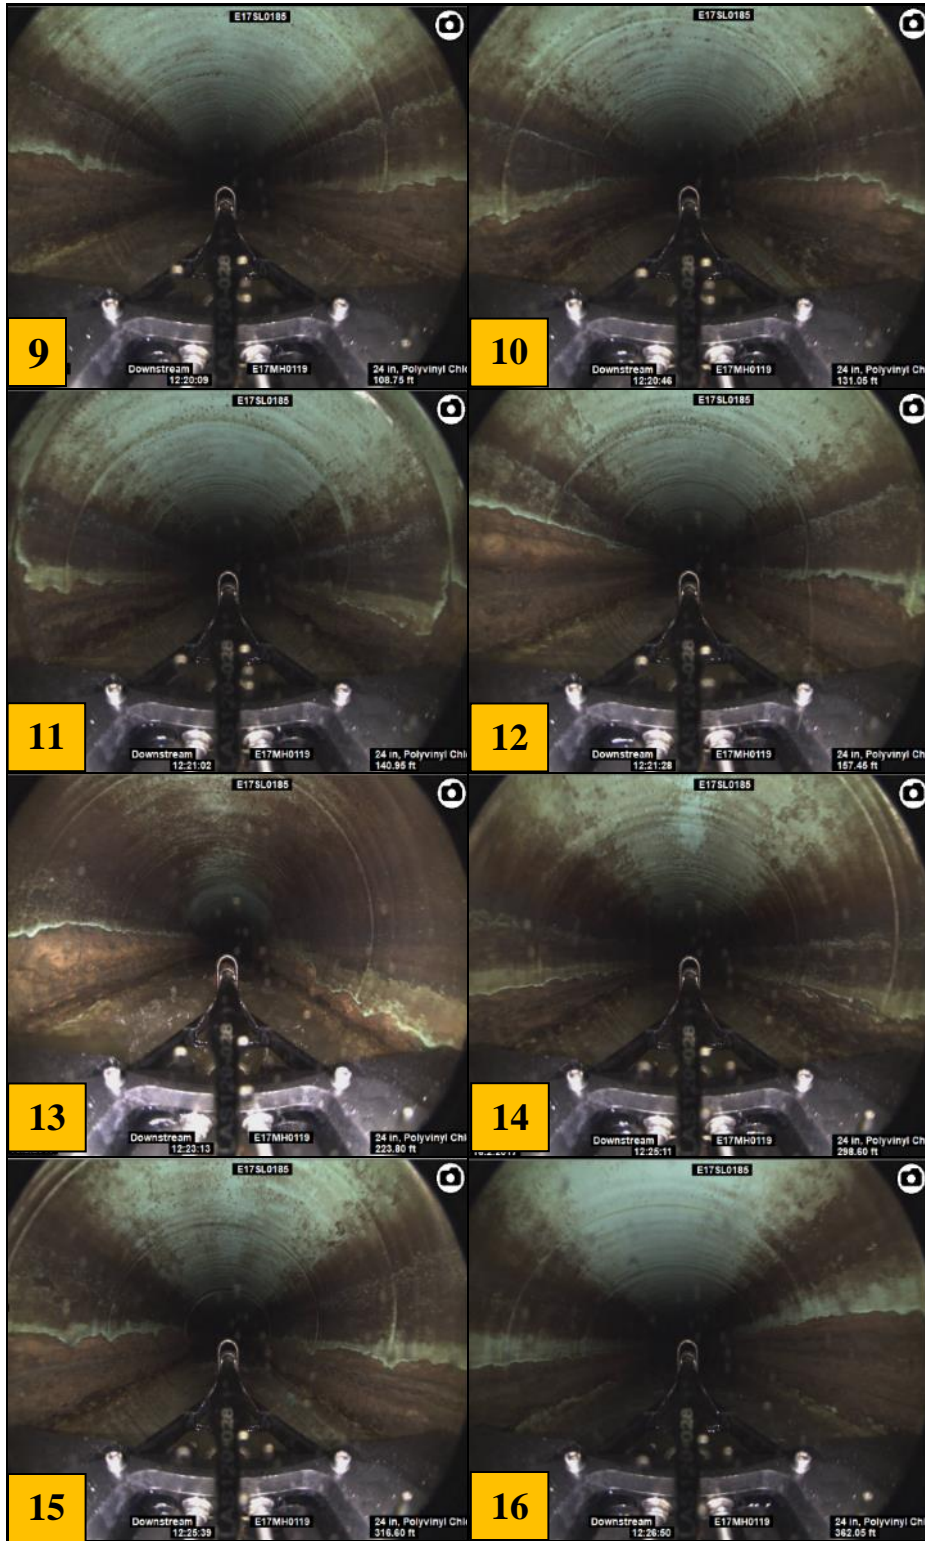
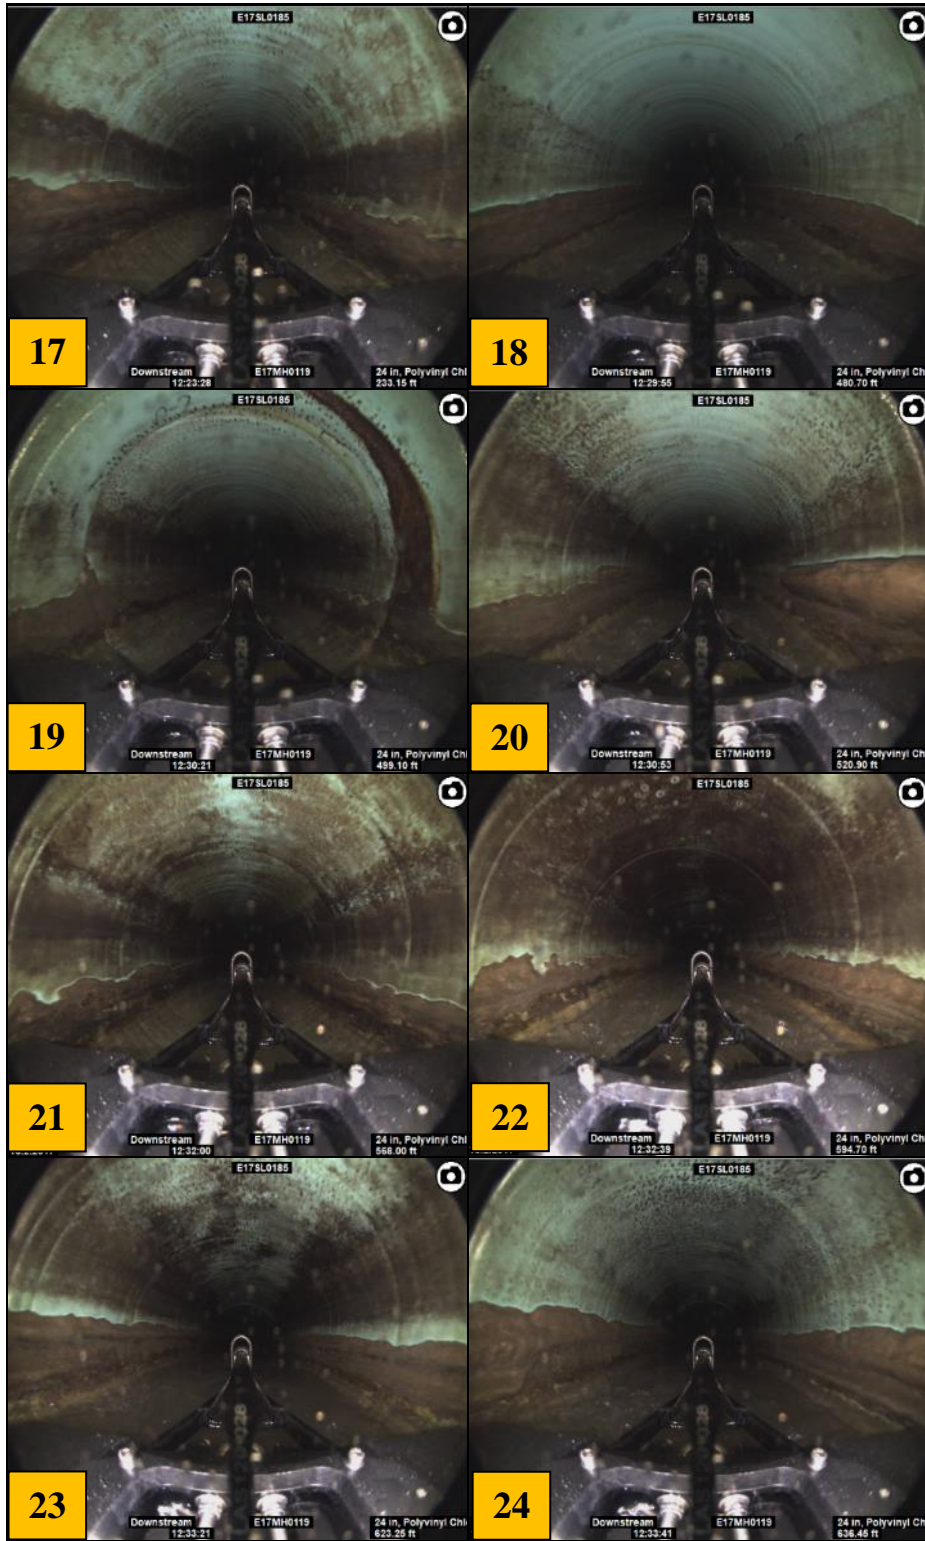
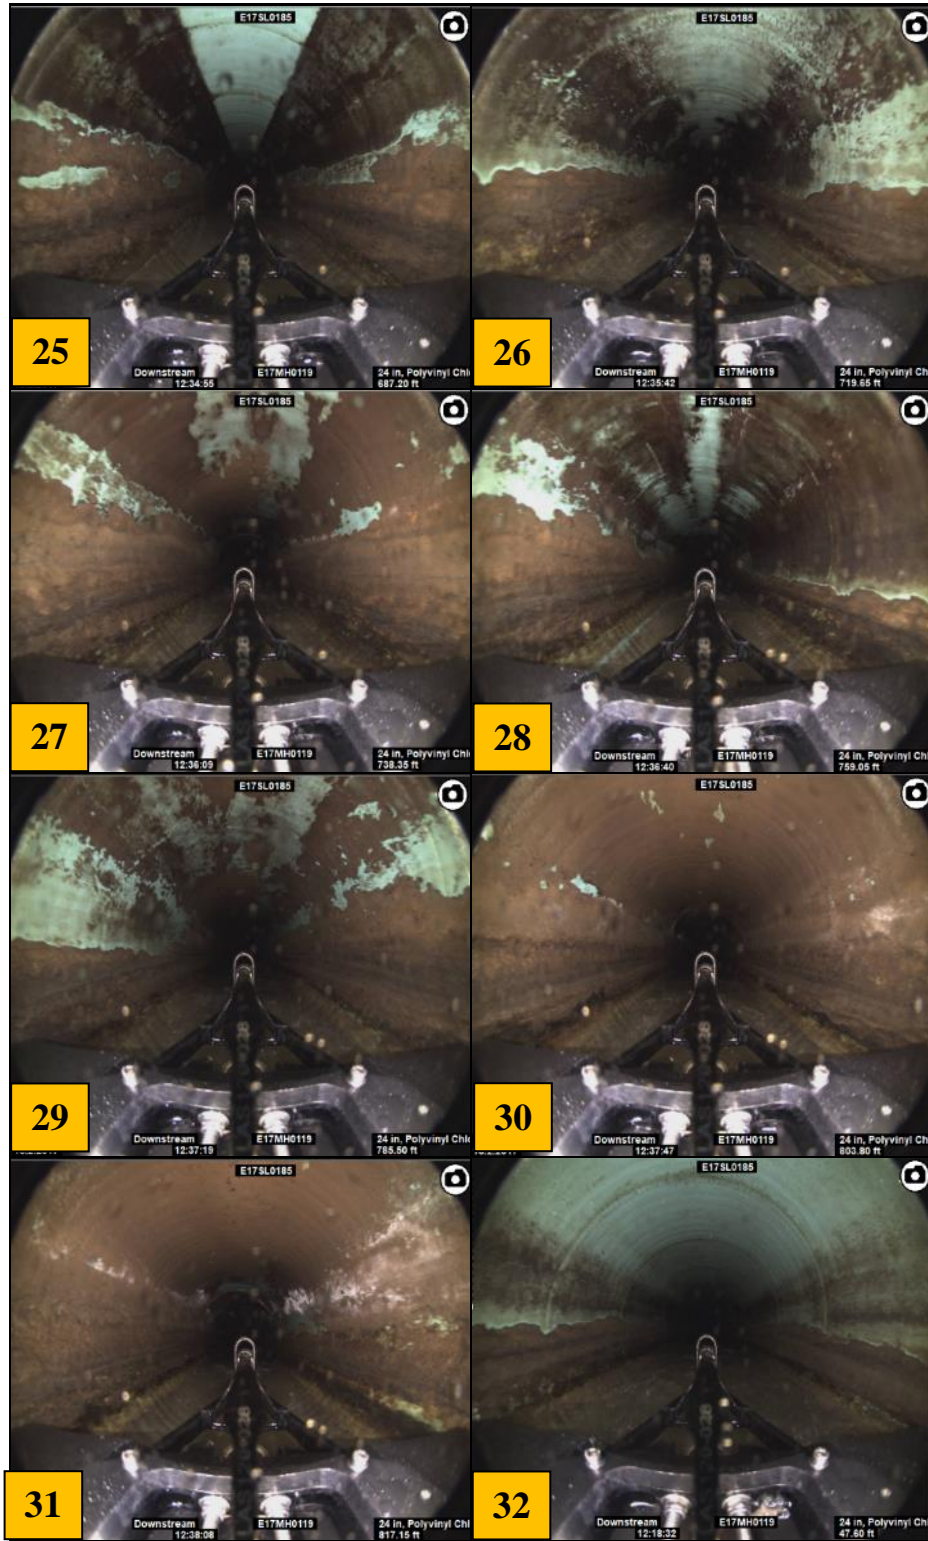
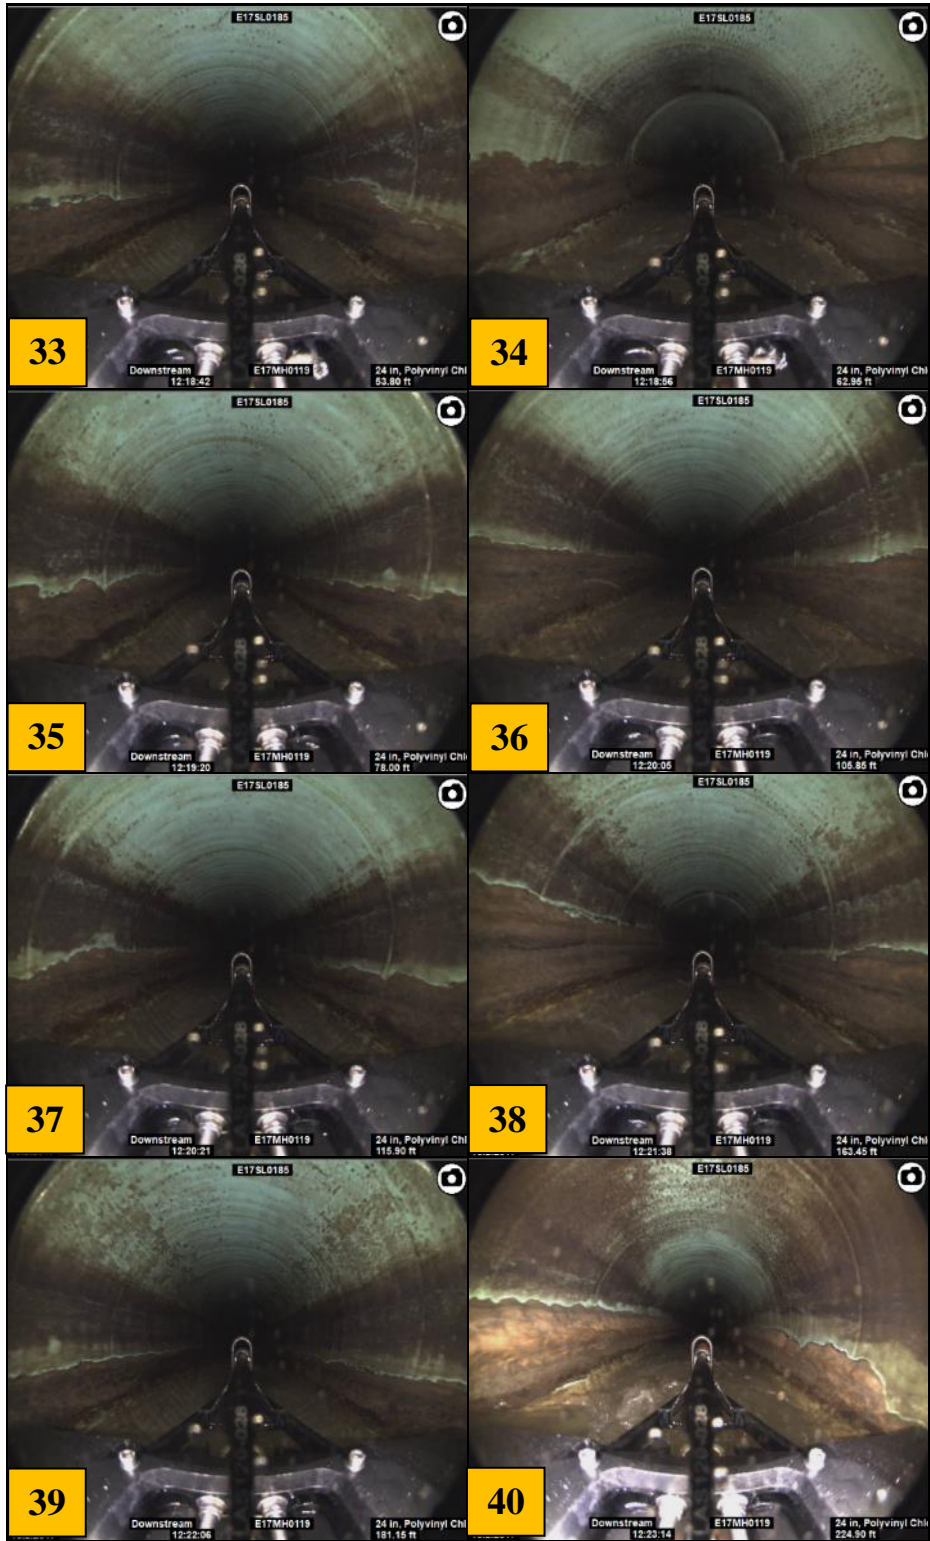
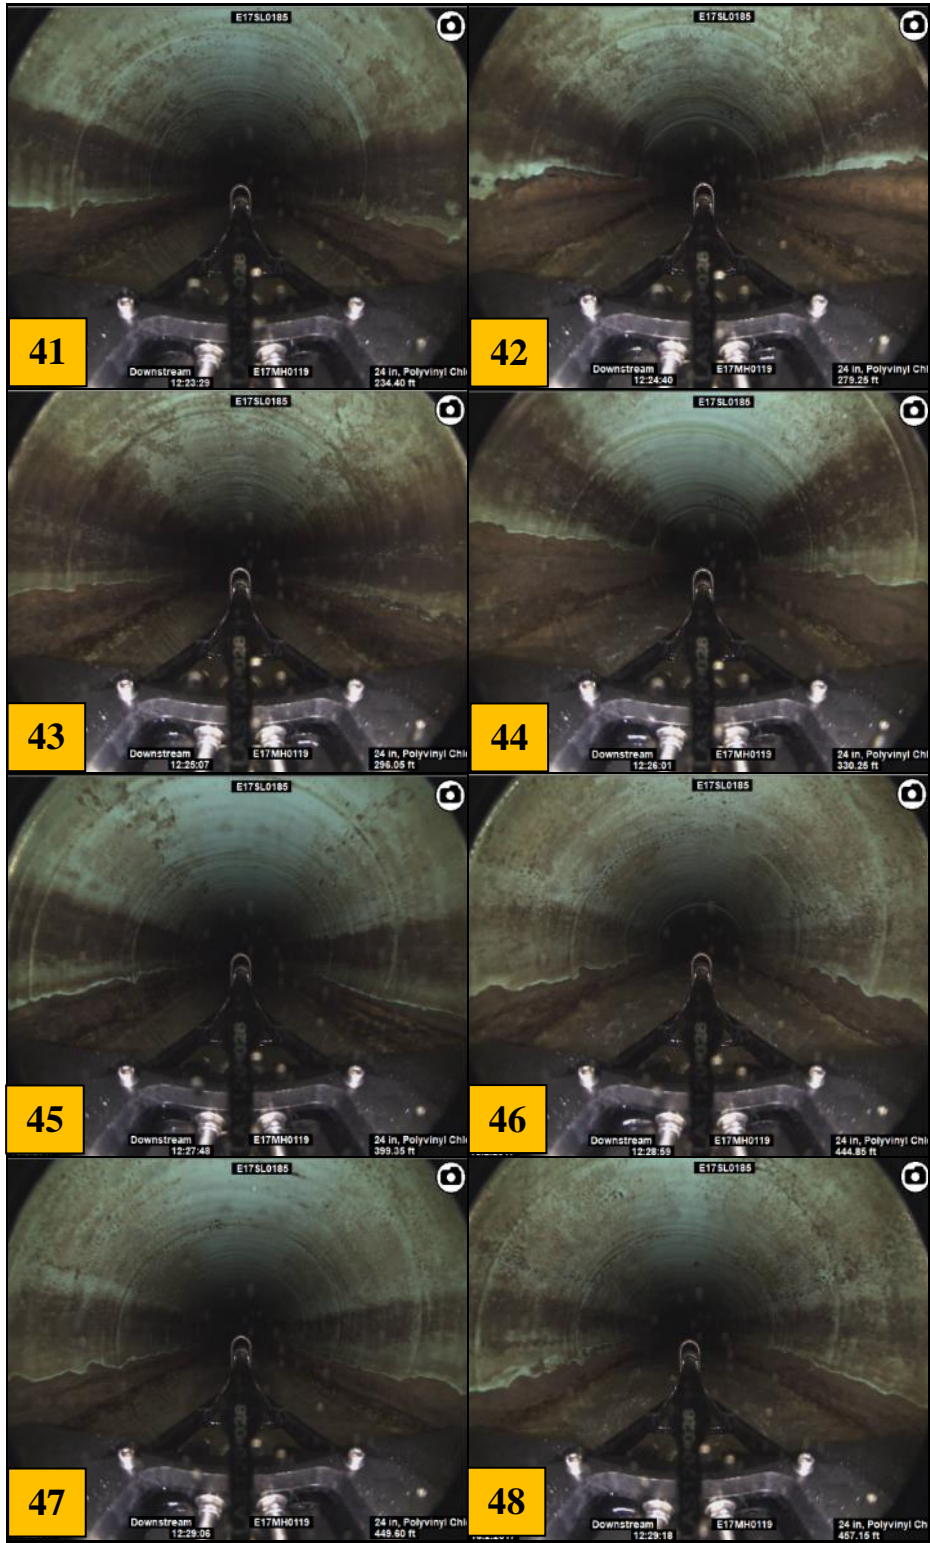
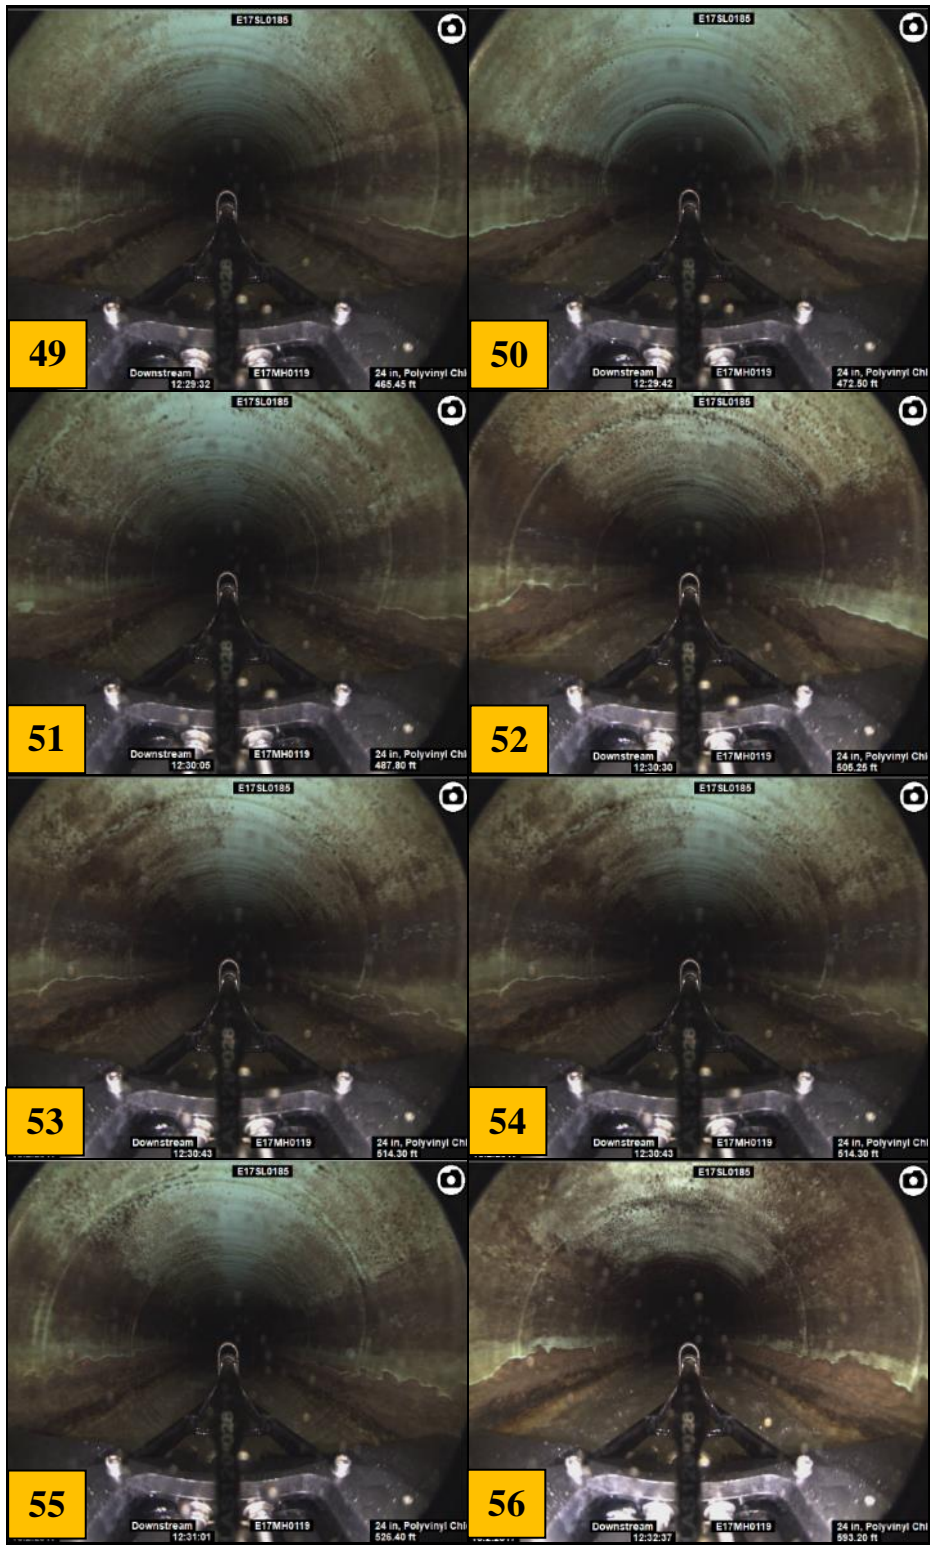
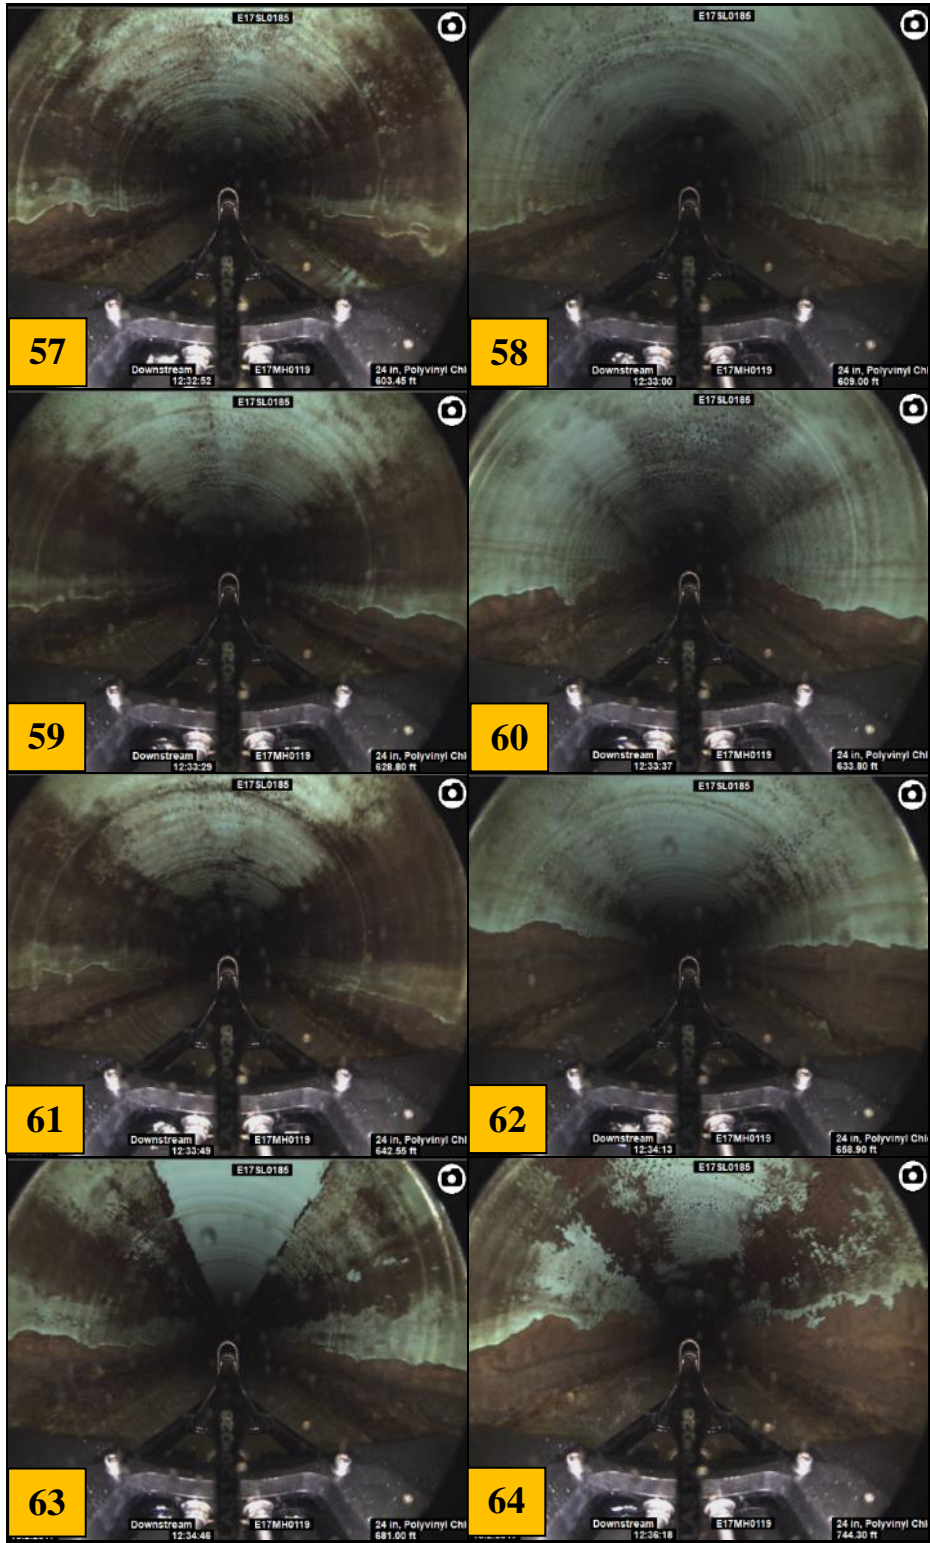
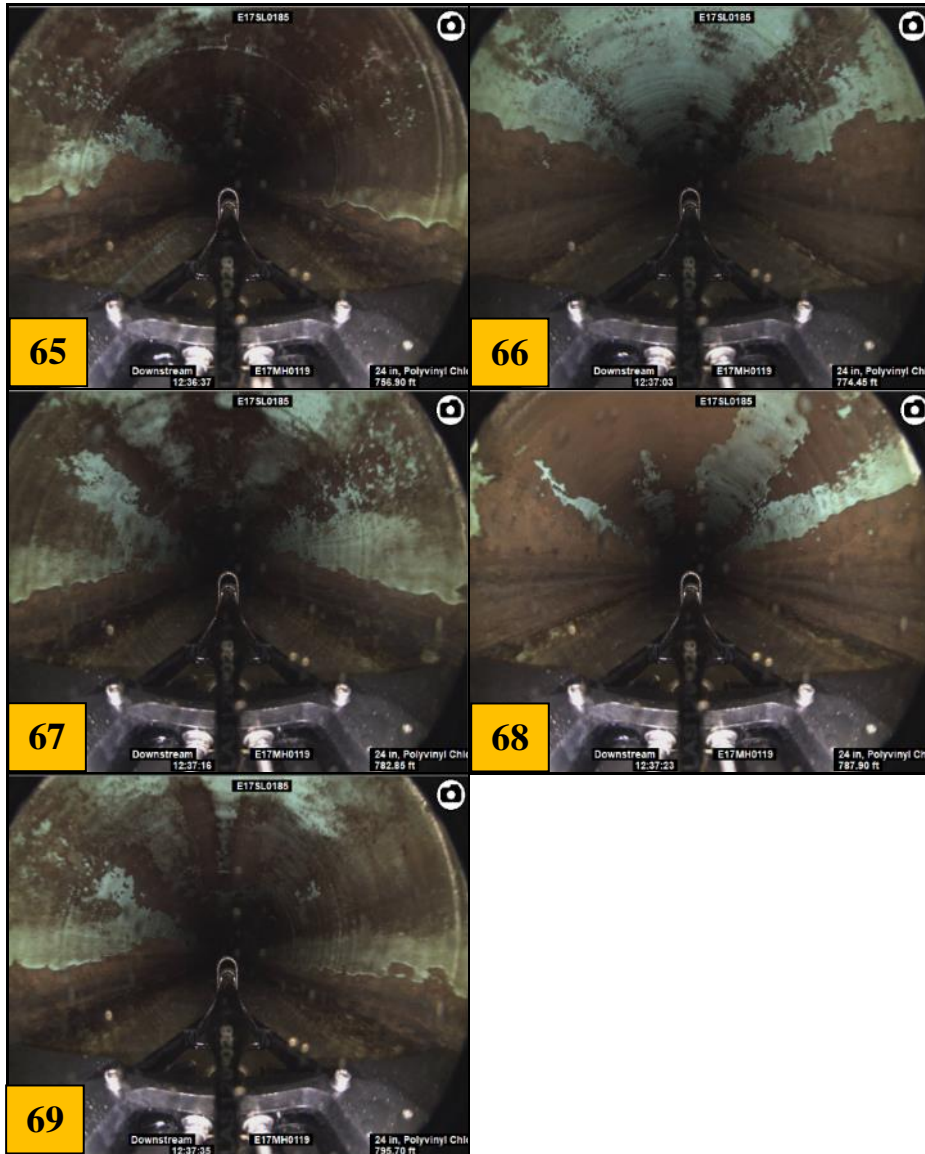
SN	Distance (feet)	Video Ref.	Code Group/ Descriptor/ Modifier	Continuous Defect	Value			Joint	Circumferential Location		Img Reference	Remarks
					Dimension		%		At/ From	To		
					1st	2nd						
1	0		AMH									
2	6		MWL				5%					
3	6		DAE	S01			10%			1 TO 31		
4	13.05		DAG				10%	J		2		PIPE IS COVERED WITH DEPOSIT ON BOTH SIDES THROUGH OUT THE LENGTH OF THE PIPE. (<5%)
5	499.1		DAG				5%	J		19		
6	47.6		MWL				10%			32		
7	53.8		MWL				5%			33		
8	62.95		MWL				10%			34		
9	78		MWL				5%			35		
10	105.85		MWL				10%			36		
11	115.9		MWL				5%			37		
12	163.45		MWL				10%			38		
13	181.15		MWL				5%			39		
14	224.9		MWL				10%			40		
15	234.4		MWL				5%			41		
16	279.25		MWL				10%			42		
17	296.05		MWL				5%			43		
18	330.25		MWL				10%			44		
19	339.35		MWL				5%			45		
20	444.85		MWL				10%			46		
21	449.6		MWL				5%			47		
22	457.15		MWL				10%			48		
23	465.45		MWL				5%			49		
24	472.5		MWL				10%			50		
25	487.8		MWL				5%			51

26	505.25		MWL				10%			52		
27	514.3		MWL				5%			53		
28	520.45		MWL				10%			54		
29	526.4		MWL				5%			55		
30	593.2		MWL				10%			56

31	603.45		MWL					5%			57	
32	609		MWL					10%			58	
33	628.8		MWL					5%			59	
34	633.8		MWL					10%			60	
35	642.55		MWL					5%			61	
36	658.9		MWL					10%			62	
37	681		MWL					5%			63	
38	744.3		MWL					10%			64	
39	756.9		MWL					5%			65	
40	774.45		MWL					10%			66	
41	782.85		MWL					5%			67	
42	787.9		MWL					10%			68	
43	795.9		MWL					5%			69	
44	844.3		DAE	F01								
45	844.3		MSA

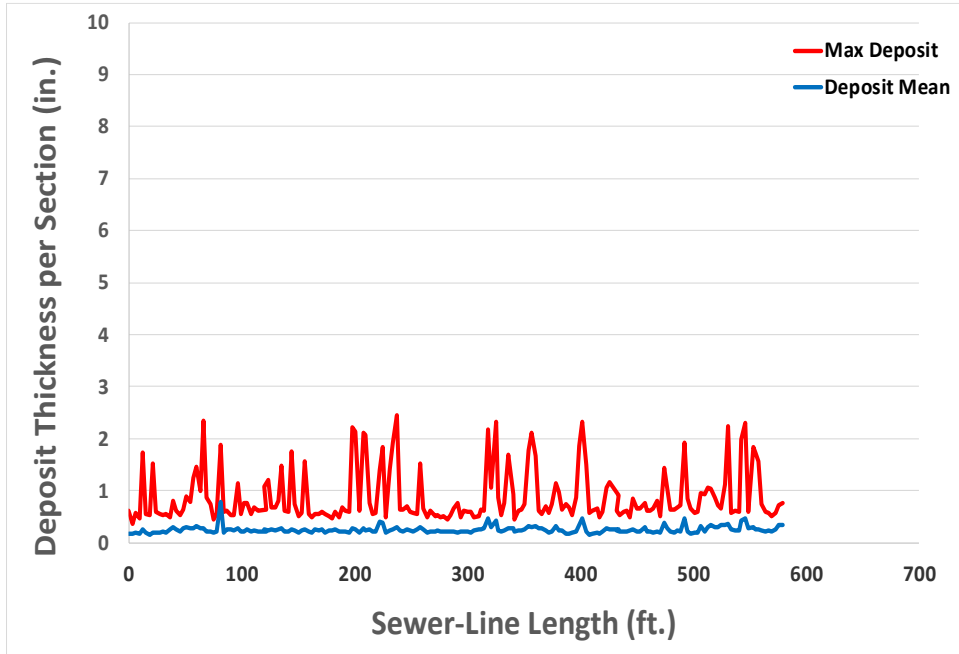
Figure A53-1 Deposit thickness per cross-section

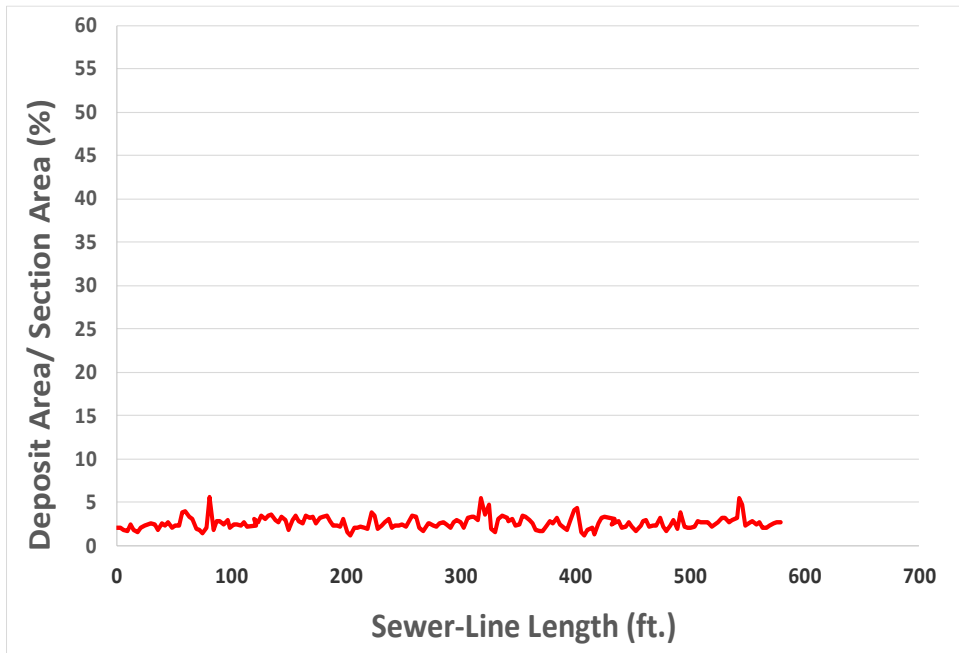
Figure A53-2 Deposit area percentage of the pipe cross section area

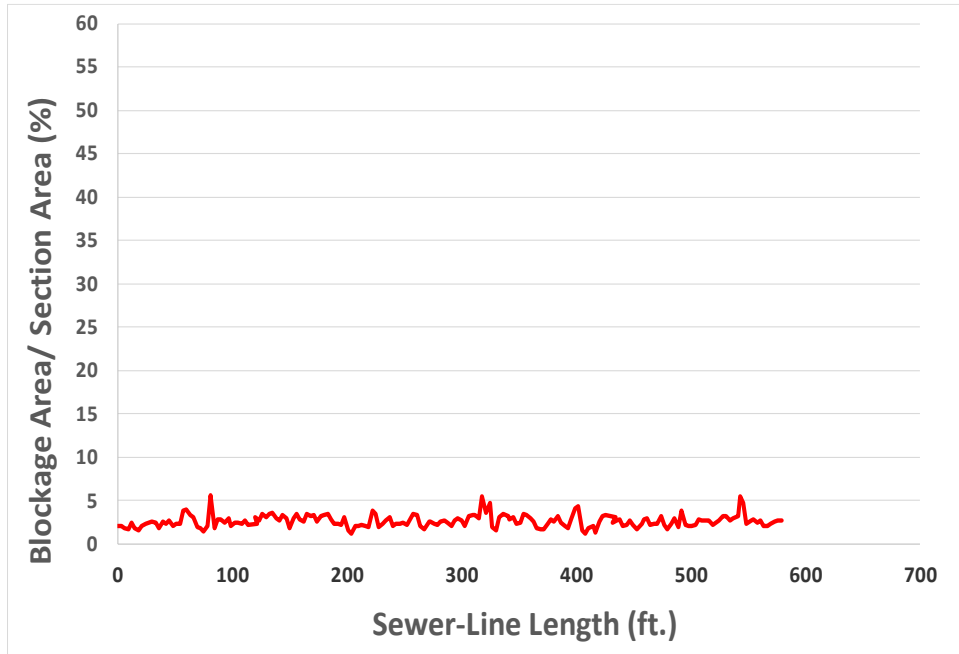
Figure A53-3 Blockage area (deposits and debris areas) percentage of pipe cross section area
