ALGORITHM DEVELOPMENT FOR SEWER PIPE SYSTEM CONDITION
ASSESSMENT USING MULTI-SENSOR (MSI) TECHNOLOGY

ALGORITHM DEVELOPMENT FOR SEWER PIPE SYSTEM CONDITION ASSESSMENT USING MULTI-SENSOR (MSI) TECHNOLOGY

This study investigates the performance of all the current large-diameter pipeline system of The City of Arlington (COA) sewer lines of 48 miles (24-inch inner diameter and above for rigid and flexible pipes). Proper inspection and rehabilitation plan for the city sewer pipeline system are better choice for the municipality and tax payers in terms of cost than dealing with pipe damage and collapsing problems when they happen.

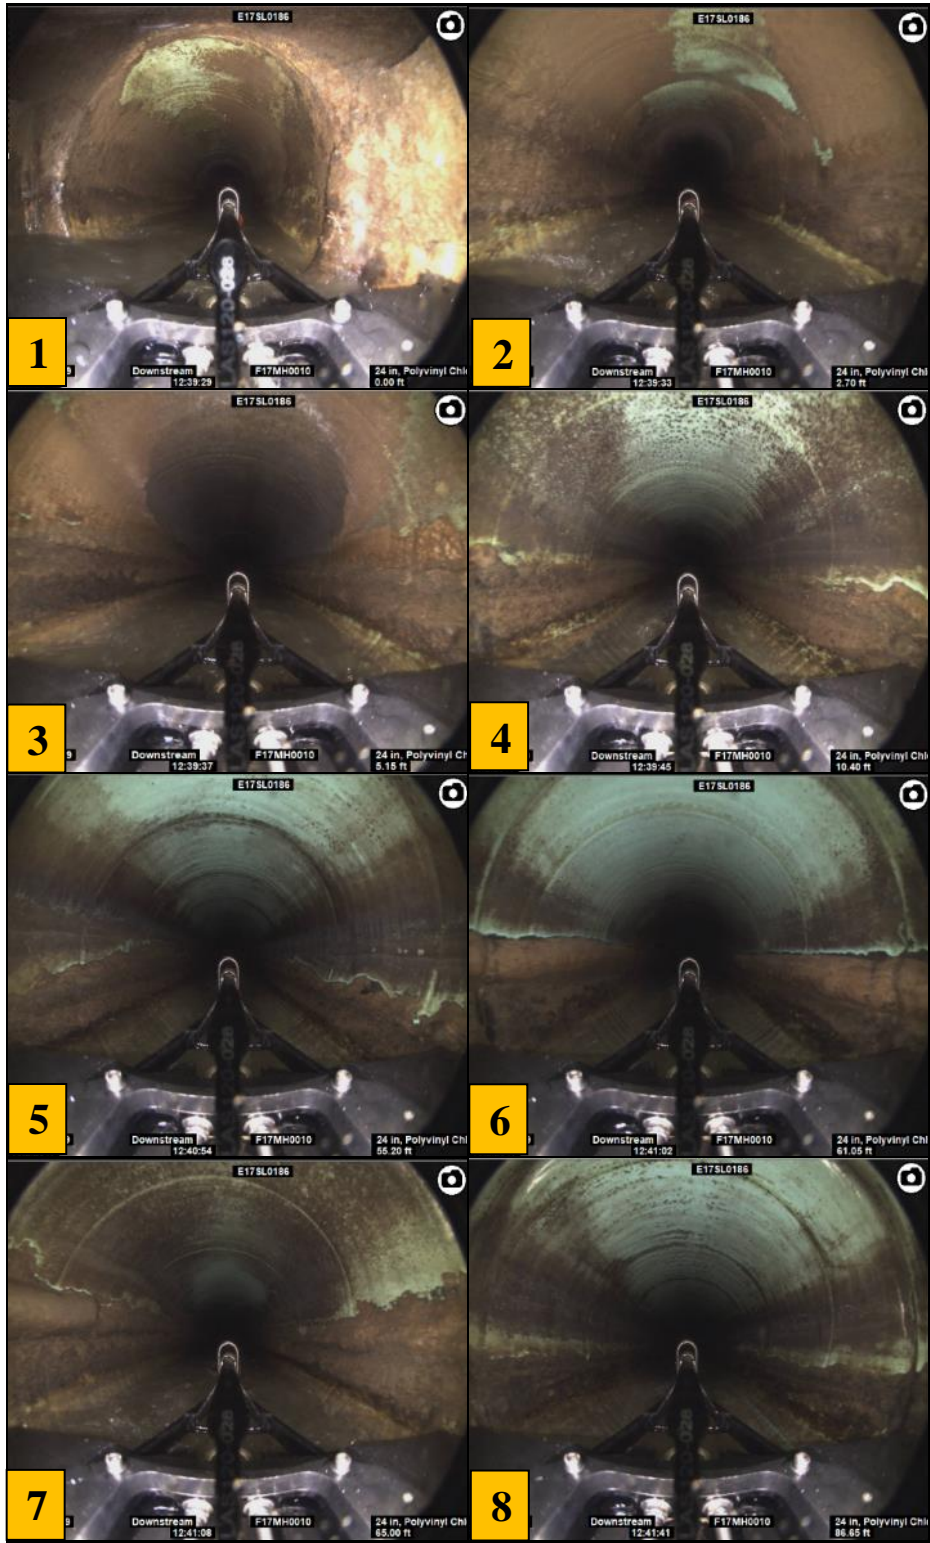
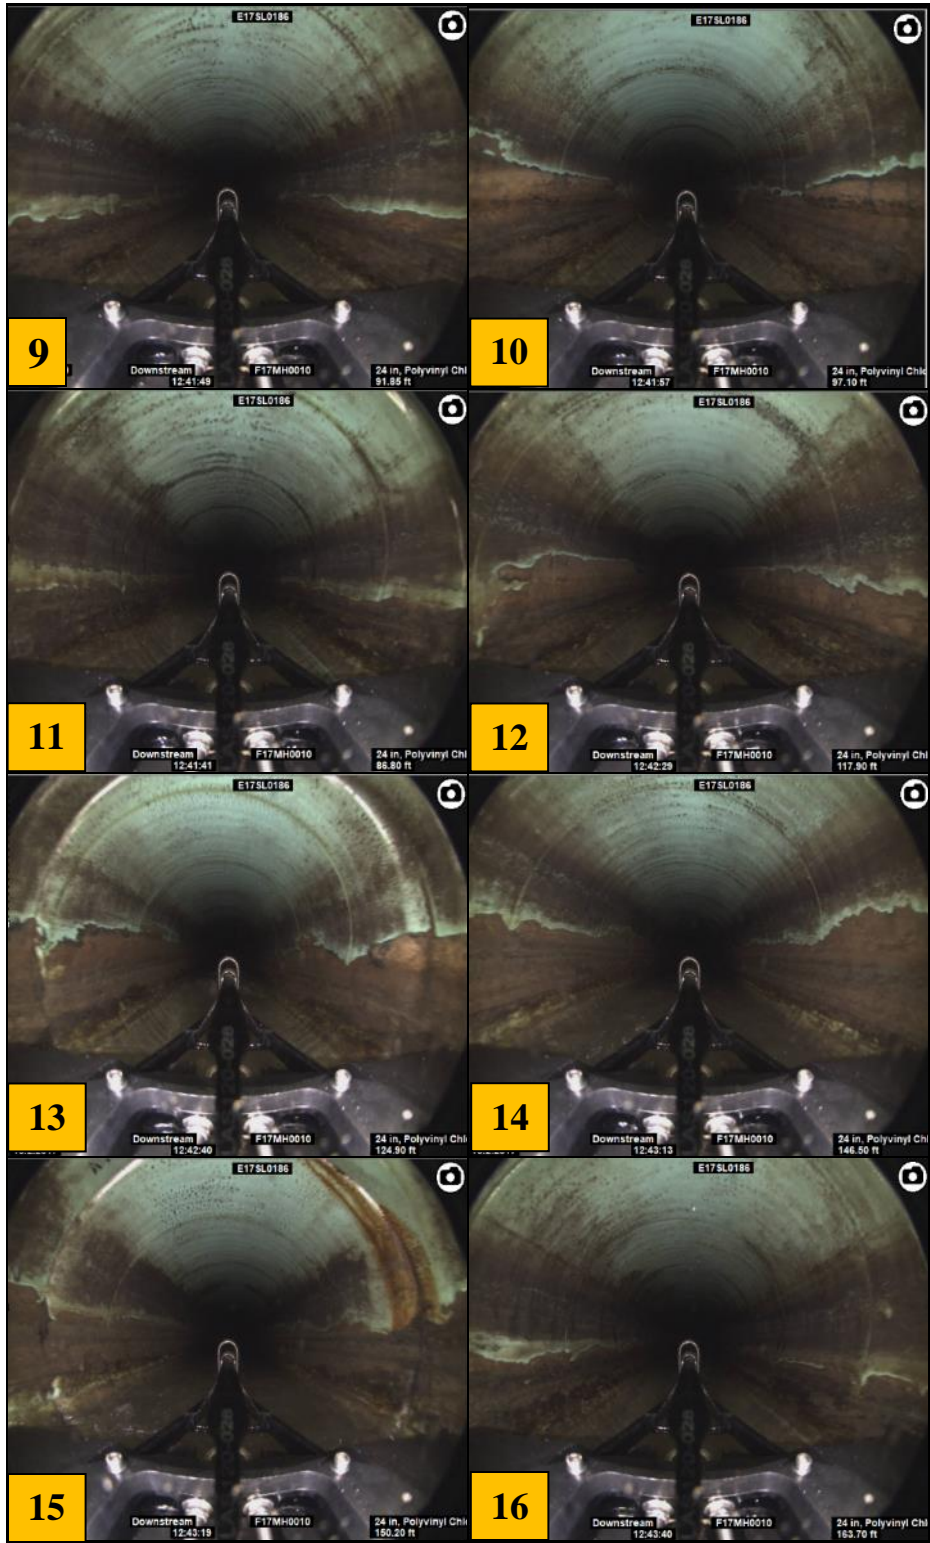
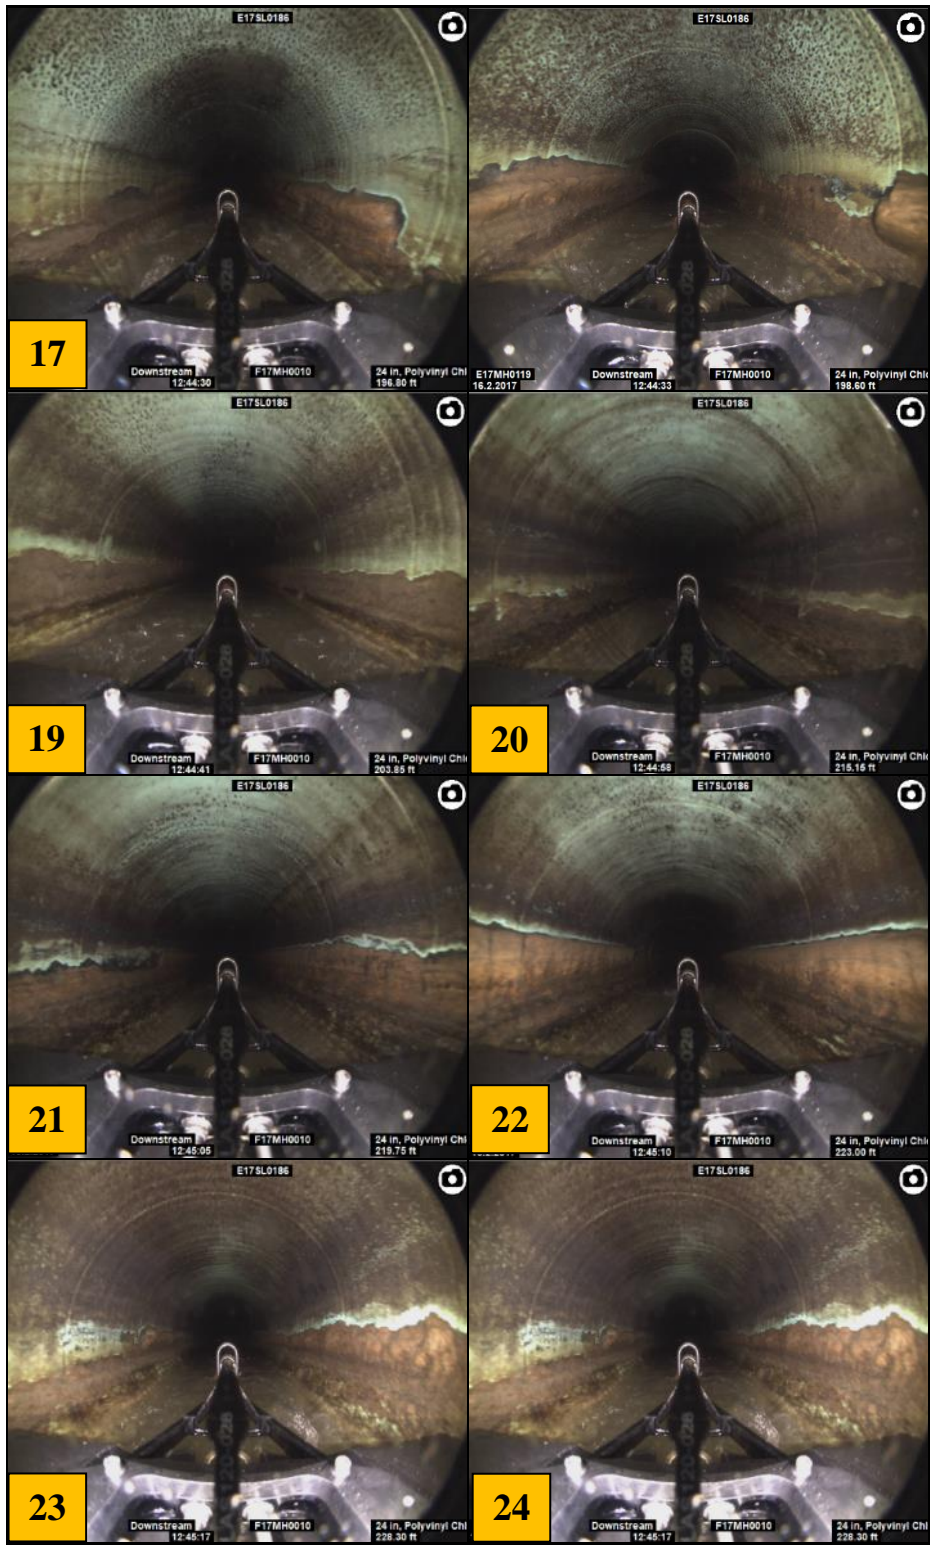
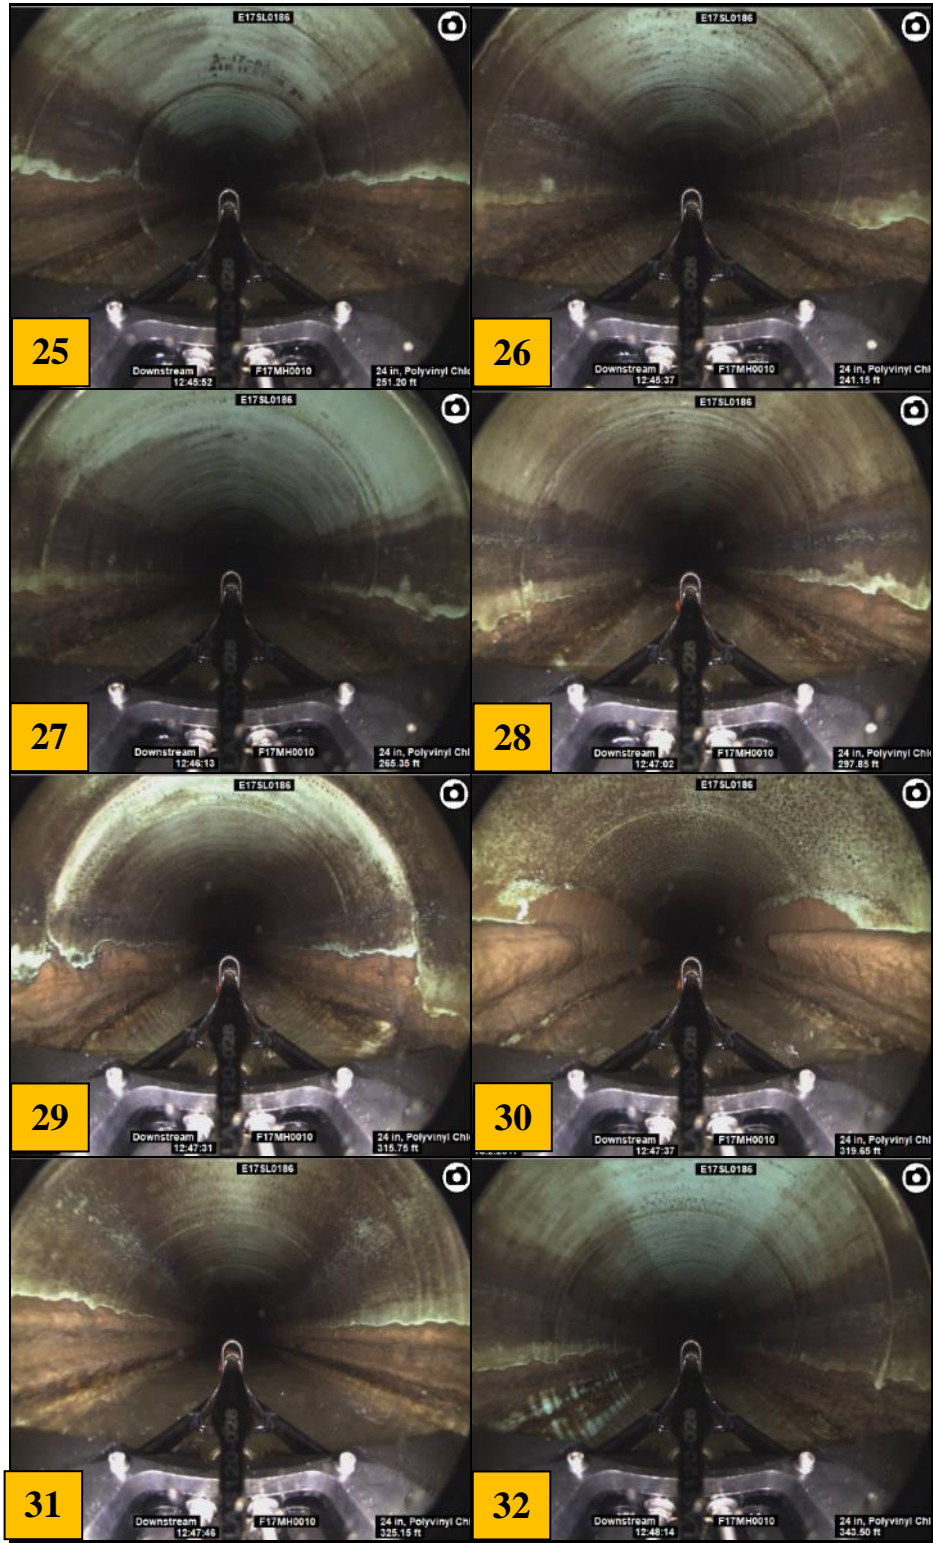
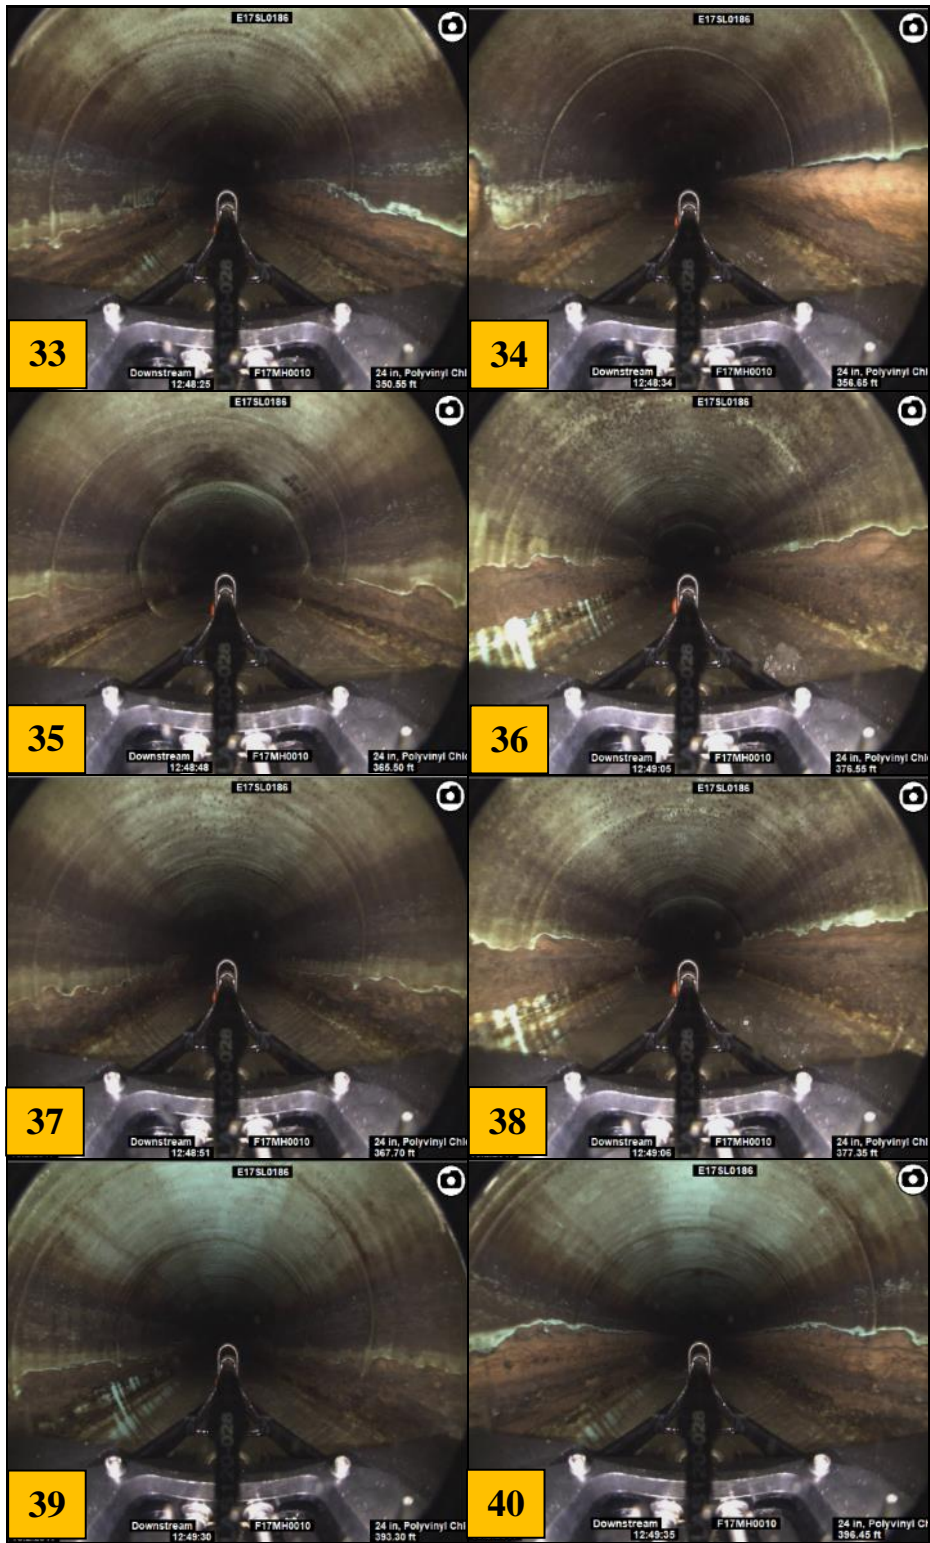
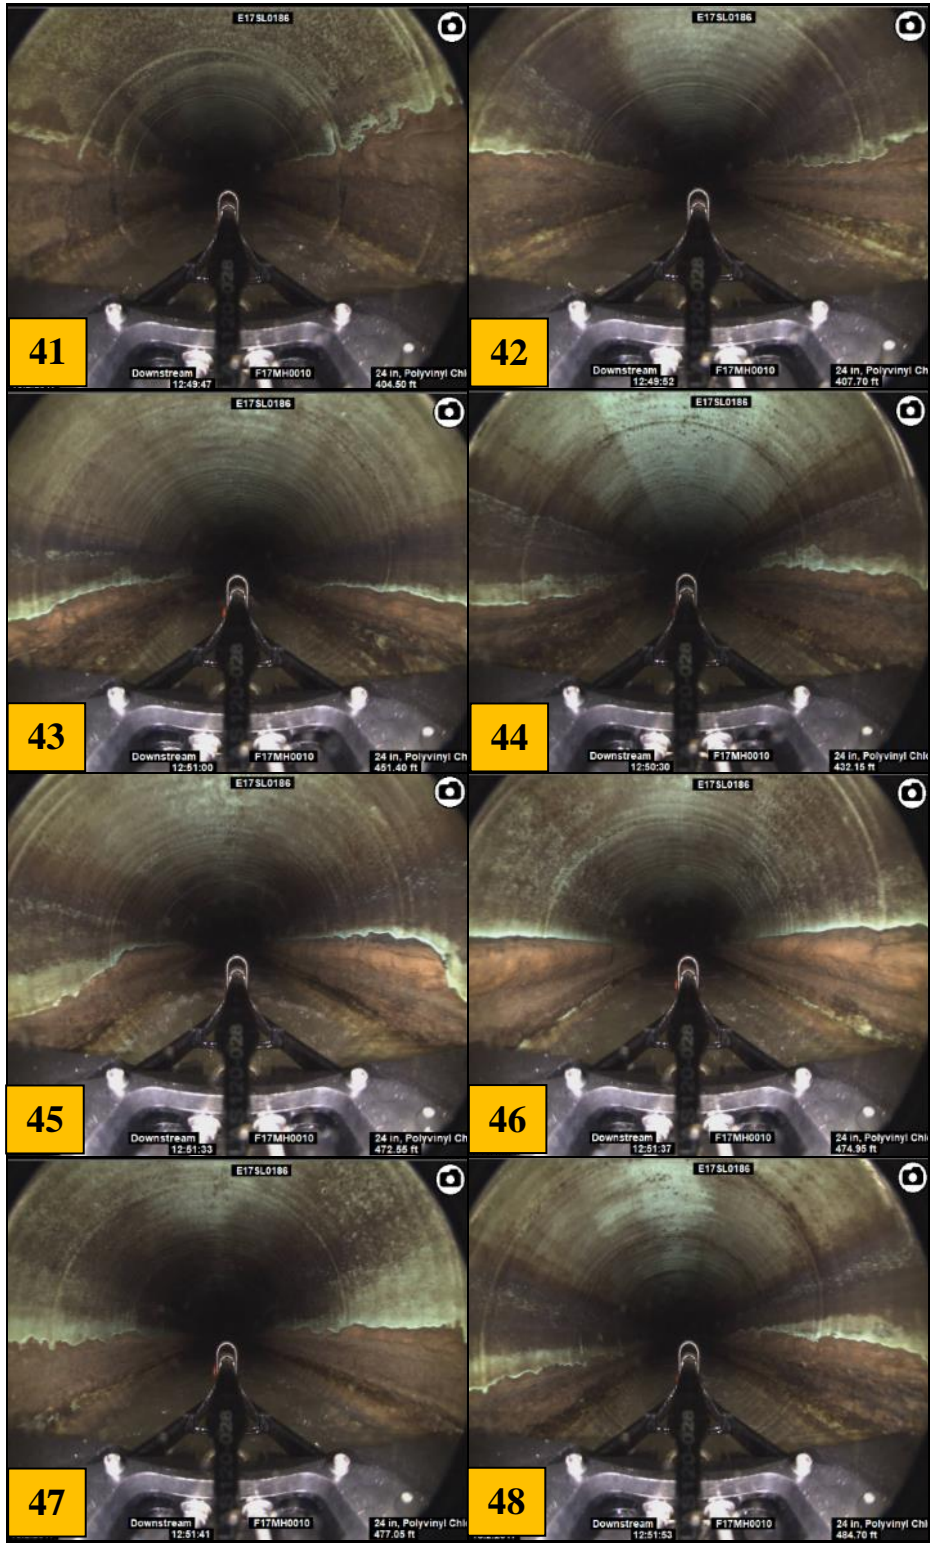
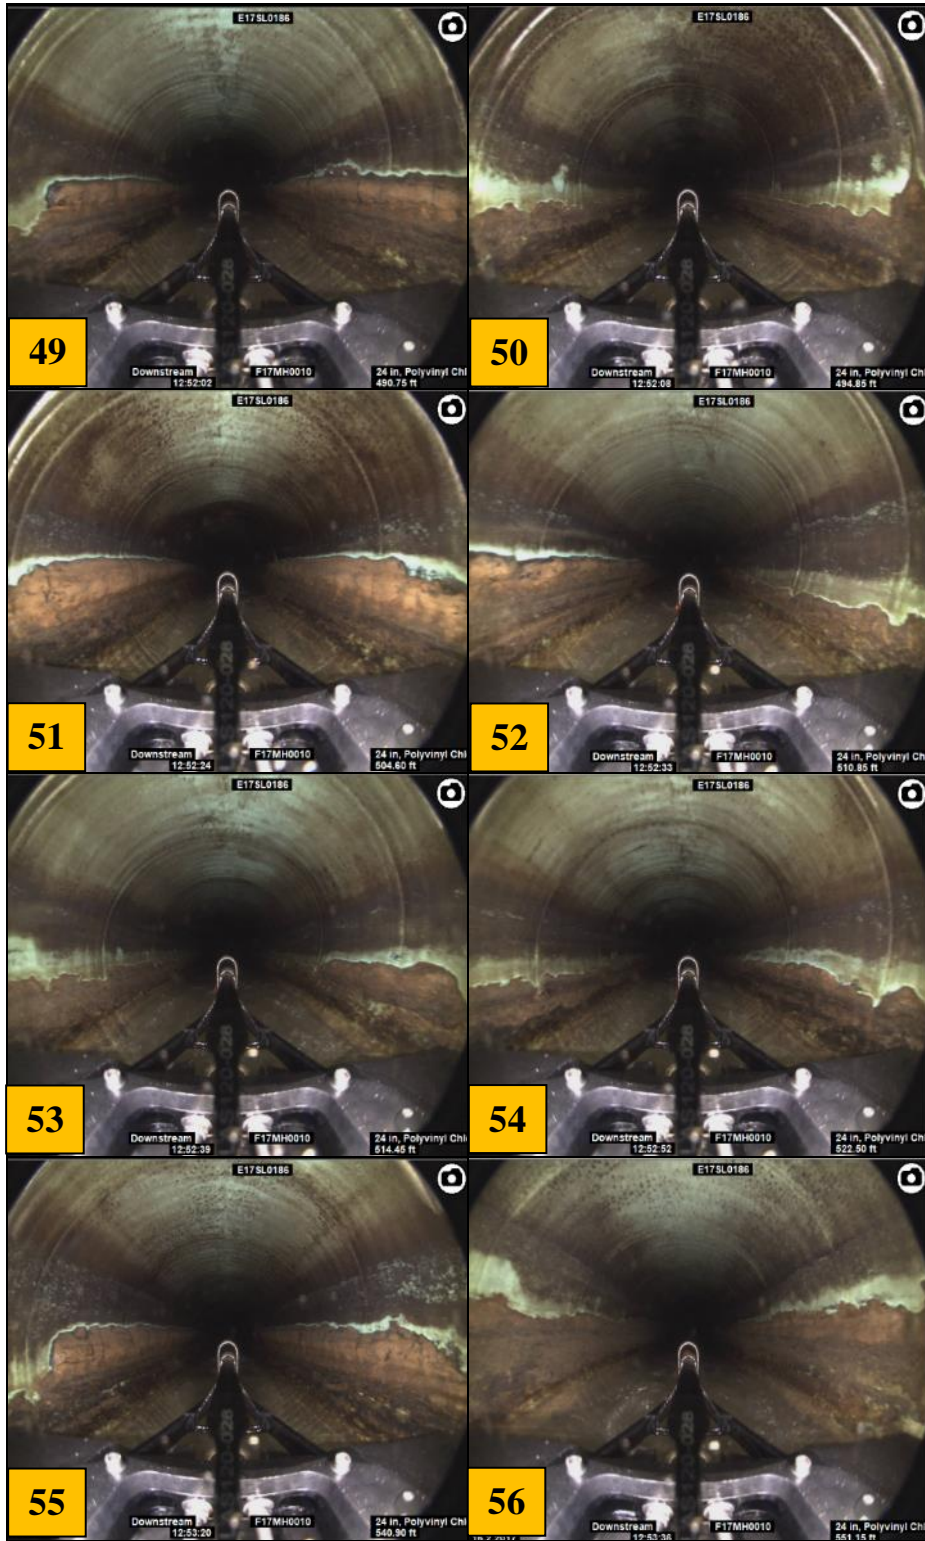
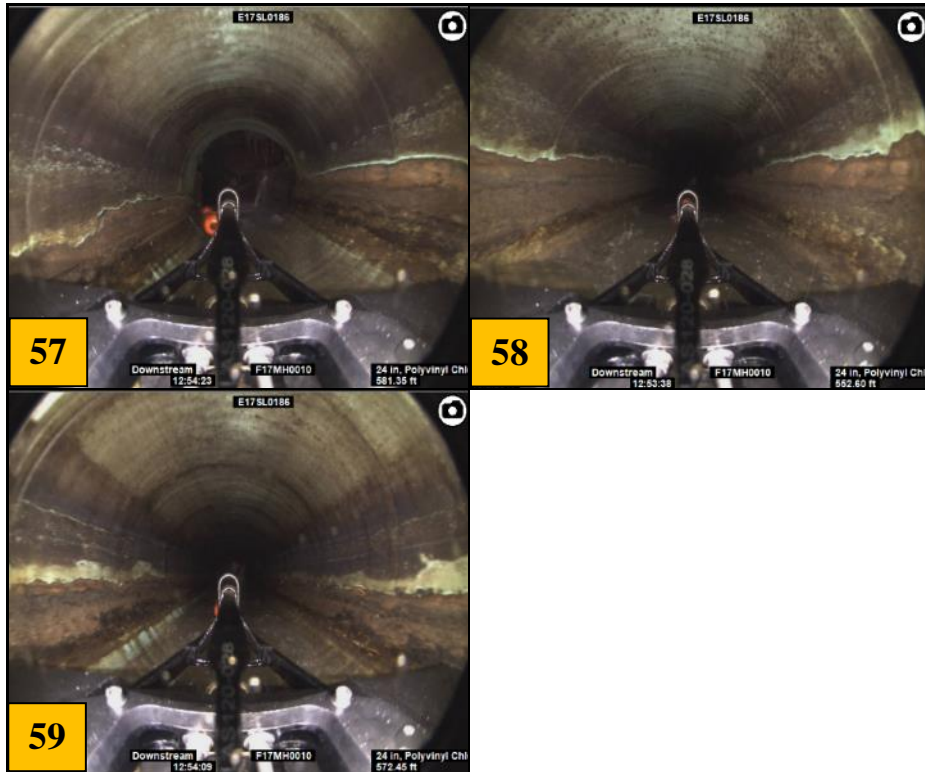
SN	Distance (feet)	Video Ref.	Code	Continuous Defect	Value		Joint	Circumferential Location		Img Reference	Remarks	
			Group/ Descriptor/ Modifier		Dimension			%	At/ From			To
					1st	2nd						
1	0		AMH									
2	0		MWL			10%						
3	0		DAE	S01		15%				1,2		
4	4.55		DAE	F01								
5	5.15		DAE	S02		5%				3		
6	10.4		MWL			5%				4		
7	55.2		DAE	F02								
8	55.2		DAE	S03		10%				5,6		
9	65		MWL			10%				7		
10	86.65		DAE	F03								
11	86.65		DAE	S04		5%				8,9,10		
12	86.8		MWL			5%				11		
13	117.9		DAE	F04								
14	117.9		DAE	S05		10%				12		
15	124.9		DAE	F05								
16	124.9		DAE	S06		5%				13		
17	146.5		MWL			10%				14		
18	150.2		DAG			<5%	J			15		
19	163.7		MWL			5%				16		
20	196.8		DAE	F06								
21	196.8		DAE	S07		10%				17		
22	198.6		MWL			10%				18		
23	203.85		DAE	F07								
24	203.85		DAE	S08		5%				19		
25	215.15		MWL			5%				20		
26	219.55		DAE	F08								
27	219.75		DAE	S09		10%				21,22		
28	228.3		MWL			10%				23

31	241.15		MWL			5%				26	
32	265.35		DAE	F10							
33	265.35		DAE	S11		5%				27,28	
34	315.75		DAE	F11							
35	315.75		DAE	S12		10%				29	
36	319.65		MWL			10%				30	
37	325.15		DAE	F12							
38	325.15		DAE	S13		5%				31	
39	343.5		MWL			5%				32	
40	350.55		DAE	F13							
41	350.55		DAE	S14		10%				33	
42	356.65		MWL			10%				34	
43	365.5		DAE	F14							
44	365.5		DAE	S15		5%				35,36	
45	367.7		MWL			5%				37	
46	377.35		MWL			10%				38	
47	393.3		MWL			5%				39	
48	396.45		DAE	F15							
49	396.45		DAE	S16		10%				40	
50	404.5		MWL			10%				41	
51	407.7		DAE	F16							
52	407.7		DAE	S17		5%				42,43	
53	432.15		MWL			5%				44	
54	472.55		DAE	F17							
55	472.55		DAE	S18		10%				45	
56	474.95		MWL			10%				46	
57	477.05		DAE	F18							
58	477.05		DAE	S19		5%				47	
59	484.7		MWL			5%				48	
60	490.75		DAE	F19							
61	490.75		DAE	S20		10%				49	
62	494.85		DAE	F20							
63	494.85		DAE	S21		5%				50	
64	504.6		DAE	F21

65	504.6		DAE	S22		10%				51	
66	510.85		MWL			10%				52	
67	514.45		DAE	F22							
68	514.45		DAE	S23		5%				53	
69	522.5		MWL			5%				54	
70	540.9		DAE	F23							
71	540.9		DAE	S24		10%				55	
72	551.15		DAE	F24							
73	551.15		DAE	S25		5%				56,57	
74	552.6		MWL			10%				58	
75	572.45		MWL			5%				59	
76	583.1		DAE	F25							
77	583.1		MSA
