ALGORITHM DEVELOPMENT FOR SEWER PIPE SYSTEM CONDITION
ASSESSMENT USING MULTI-SENSOR (MSI) TECHNOLOGY

ALGORITHM DEVELOPMENT FOR SEWER PIPE SYSTEM CONDITION ASSESSMENT USING MULTI-SENSOR (MSI) TECHNOLOGY

This study investigates the performance of all the current large-diameter pipeline system of The City of Arlington (COA) sewer lines of 48 miles (24-inch inner diameter and above for rigid and flexible pipes). Proper inspection and rehabilitation plan for the city sewer pipeline system are better choice for the municipality and tax payers in terms of cost than dealing with pipe damage and collapsing problems when they happen.

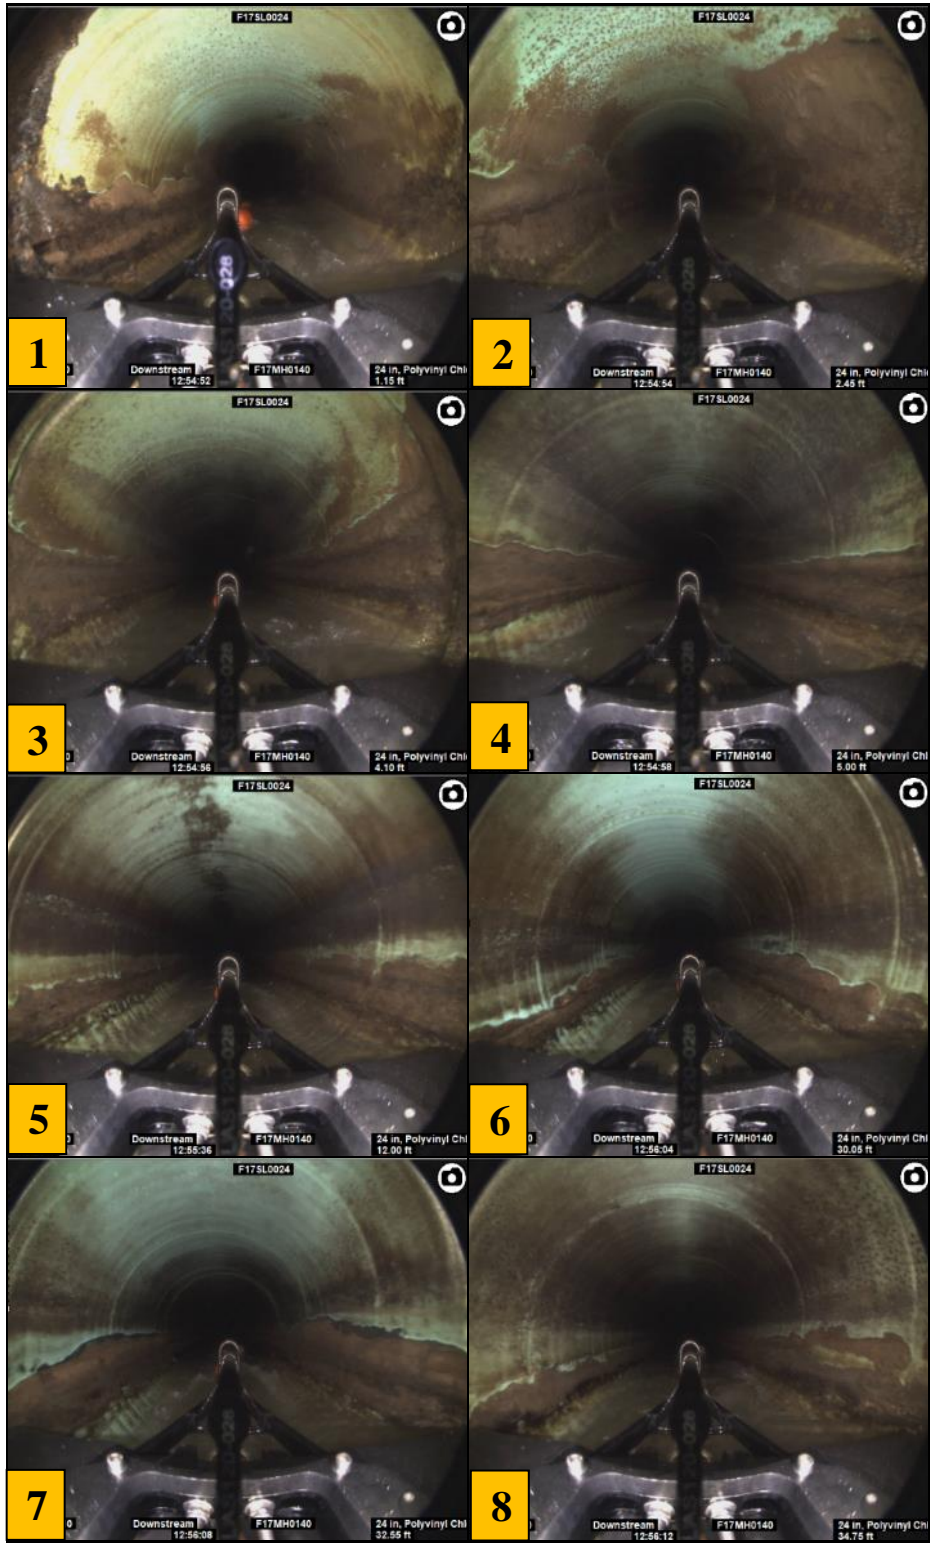
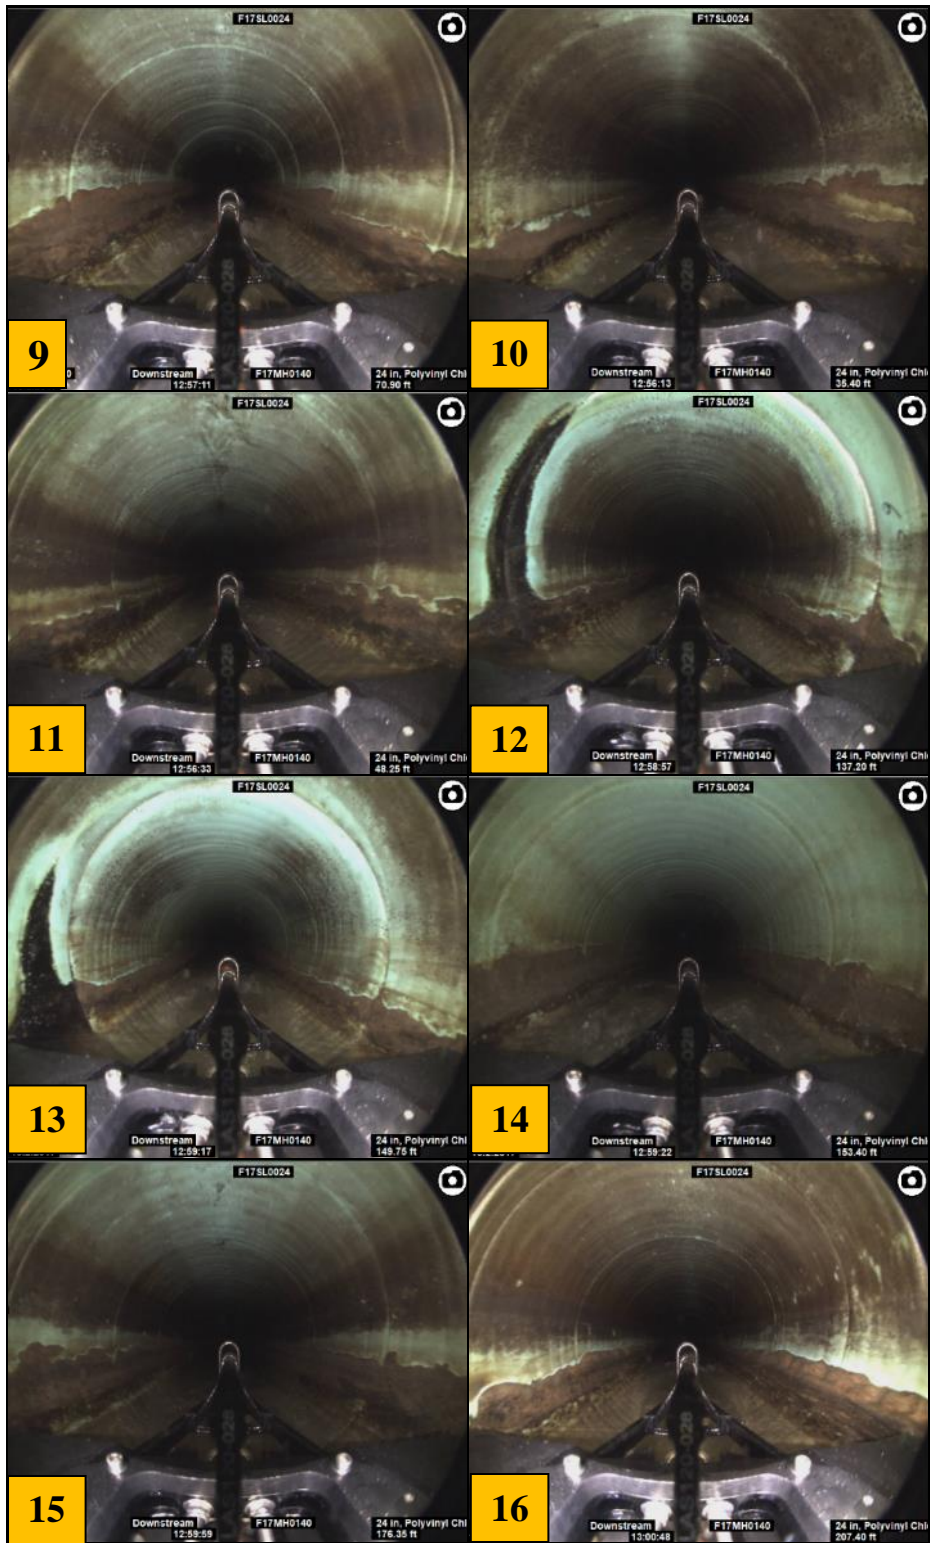
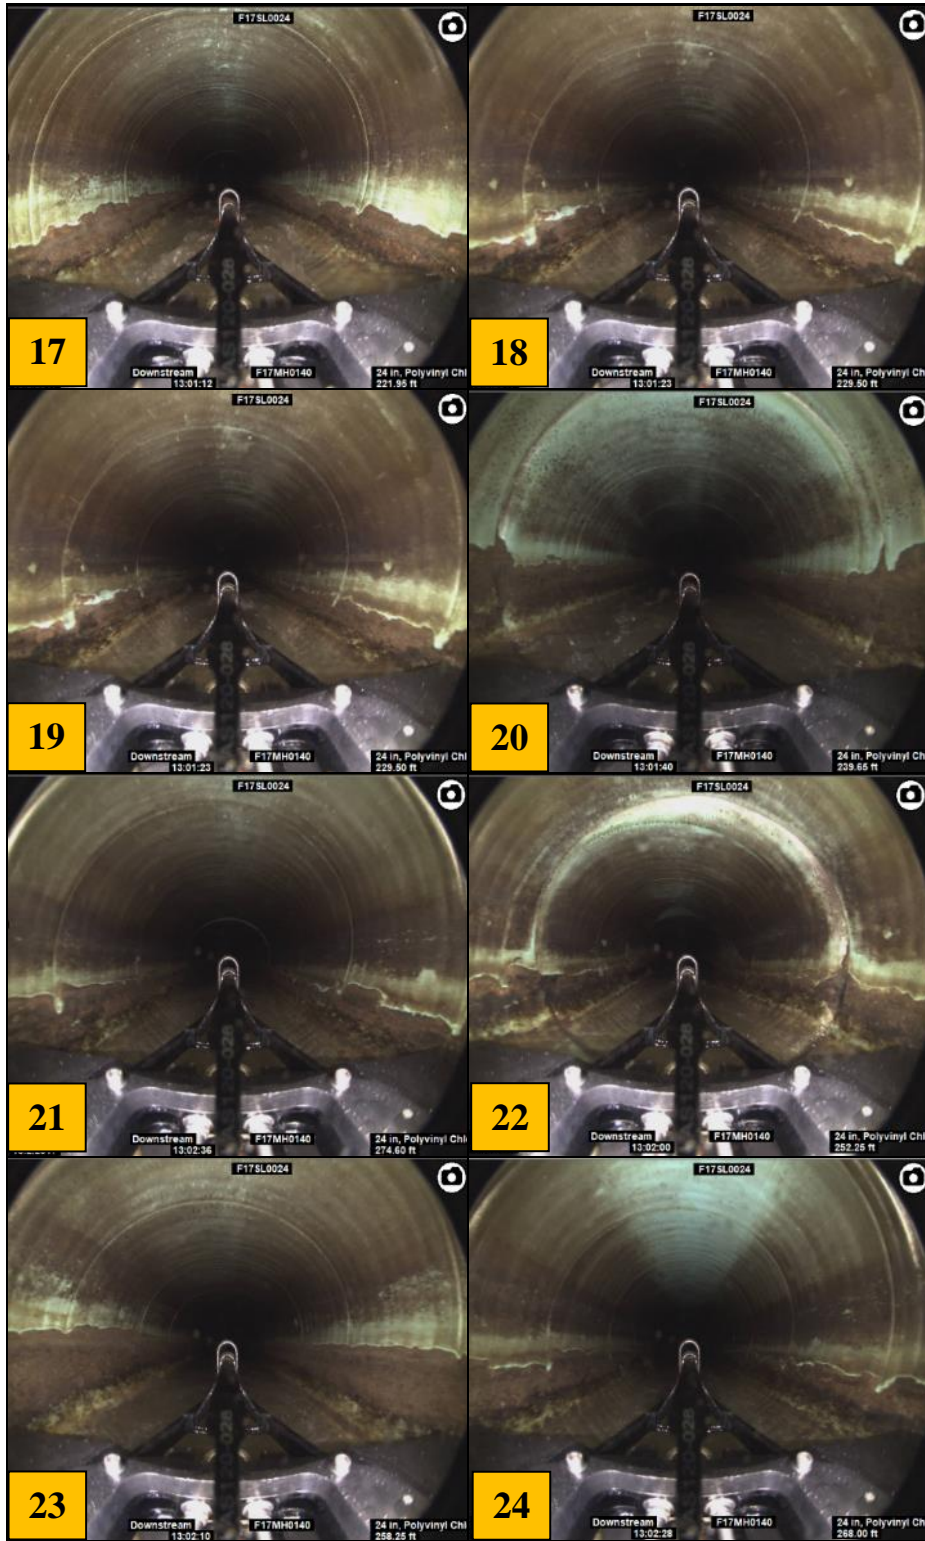
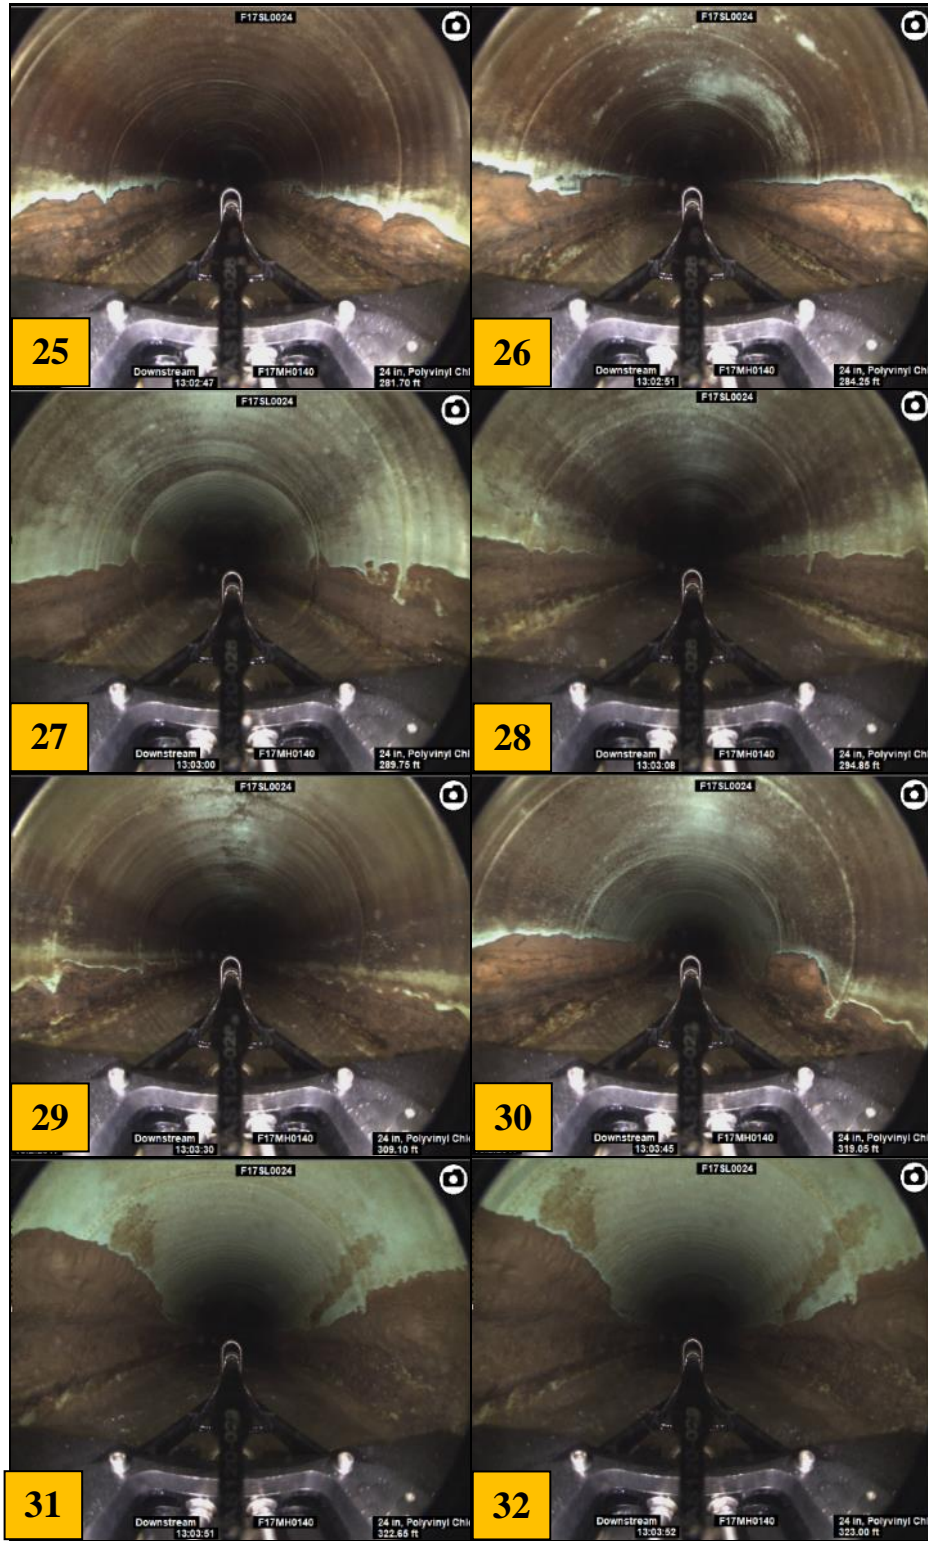
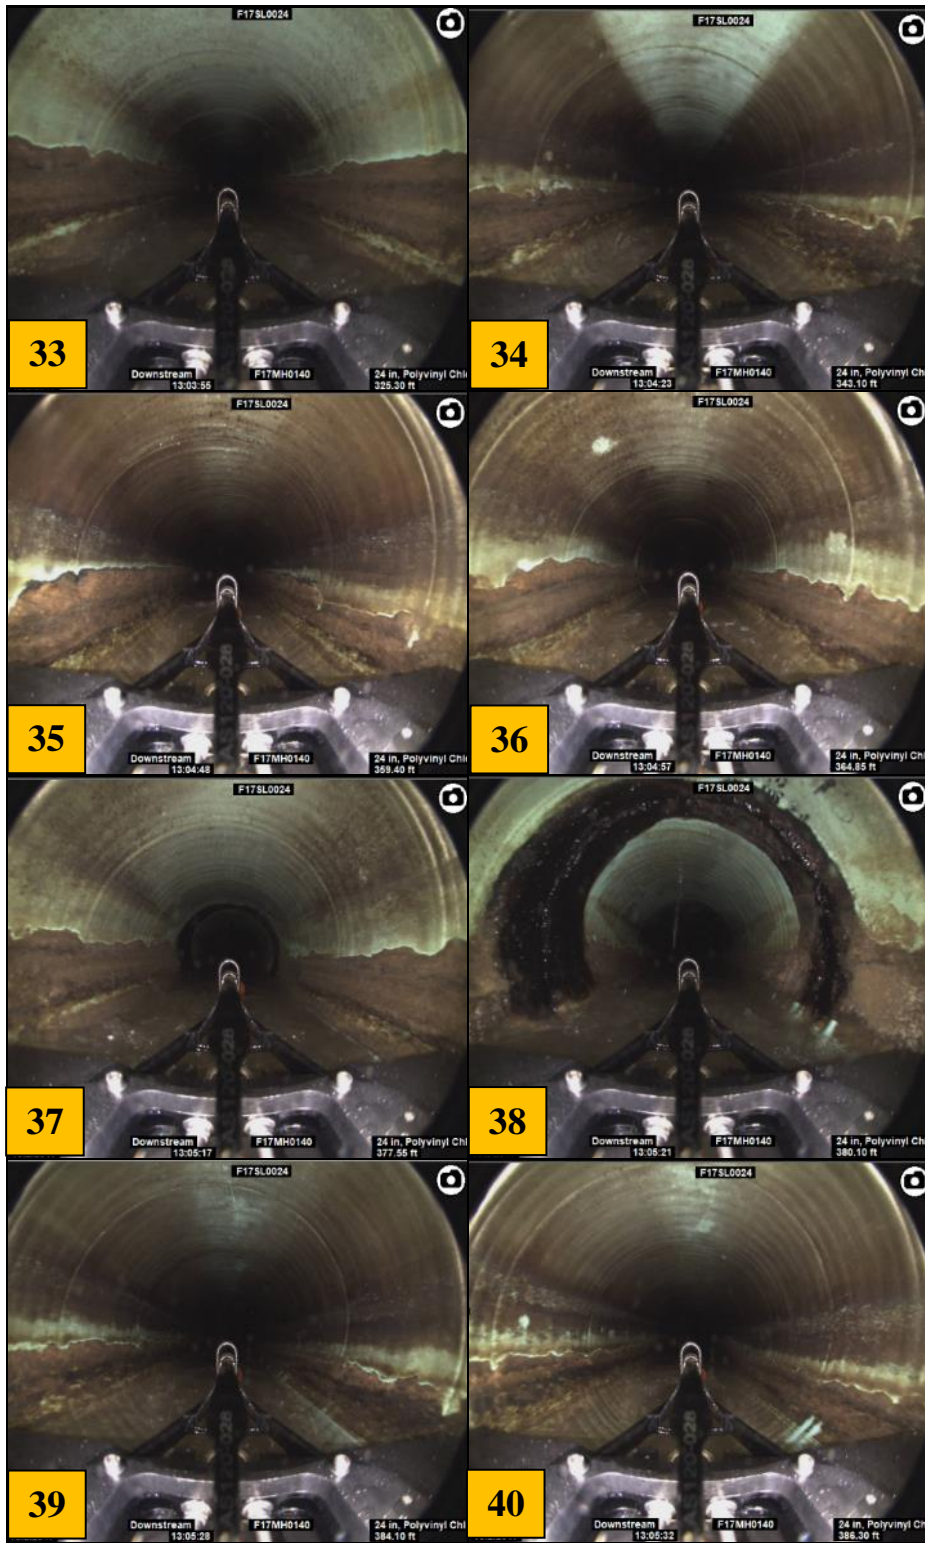
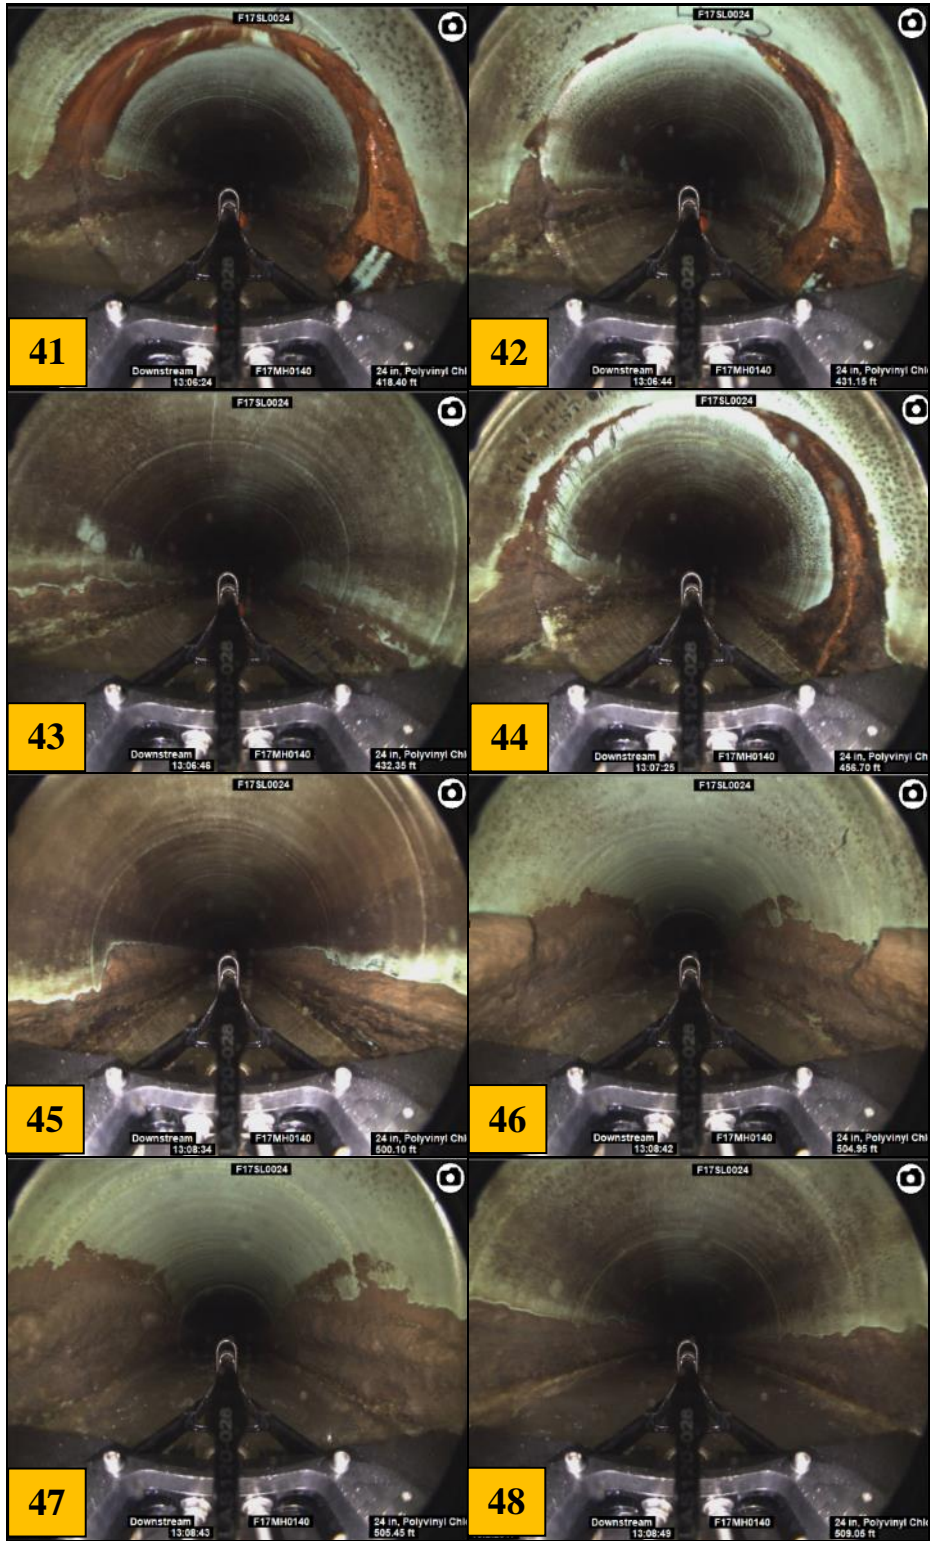
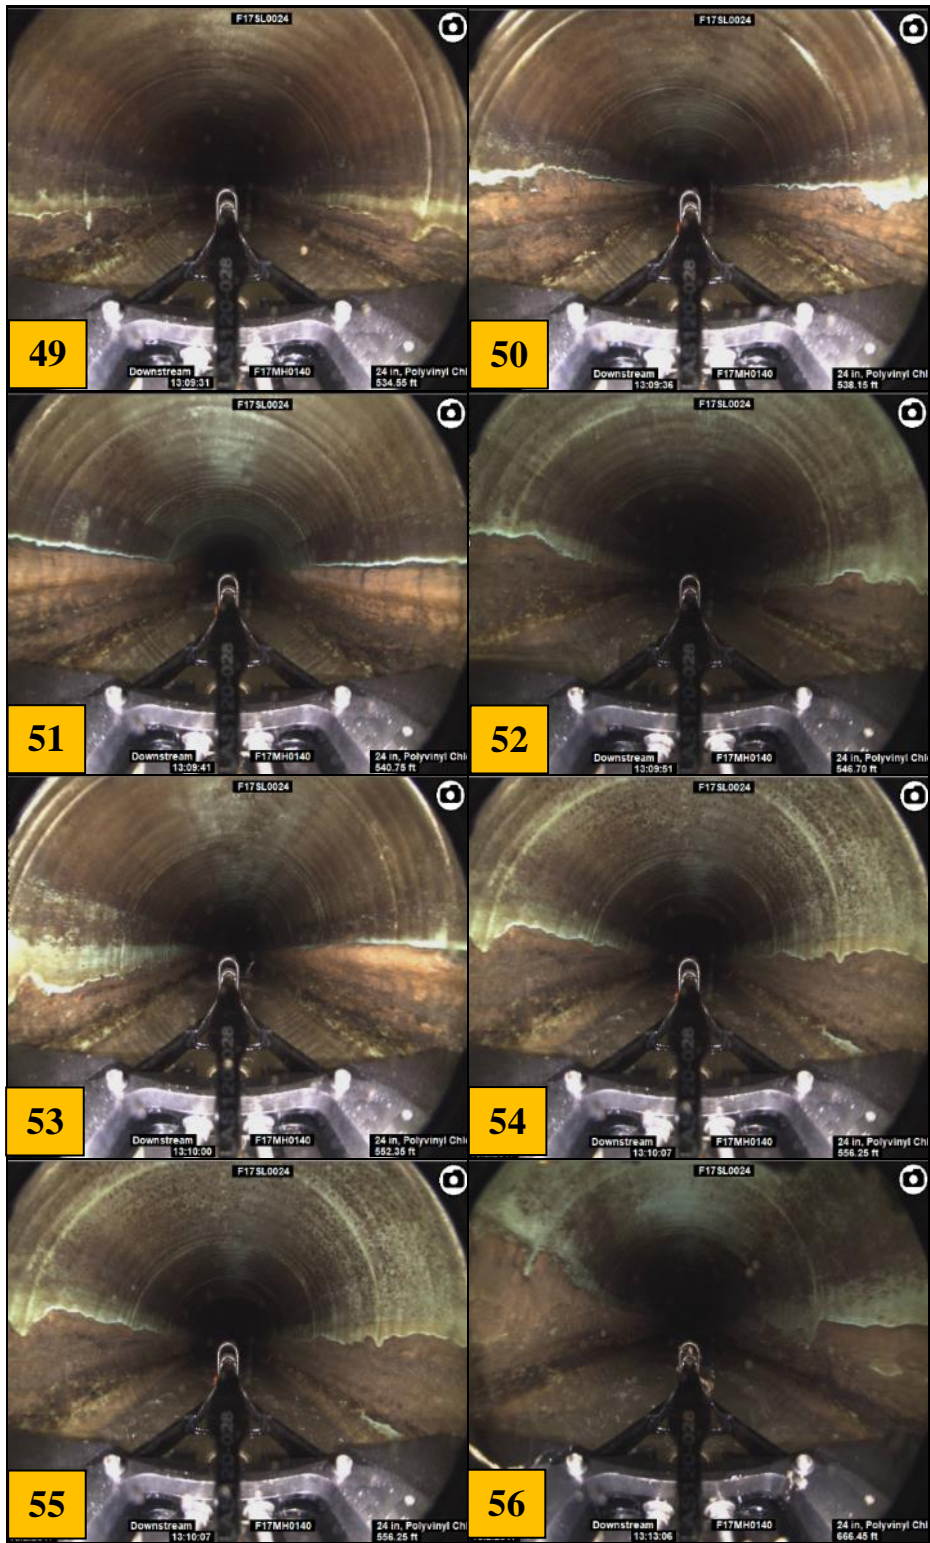
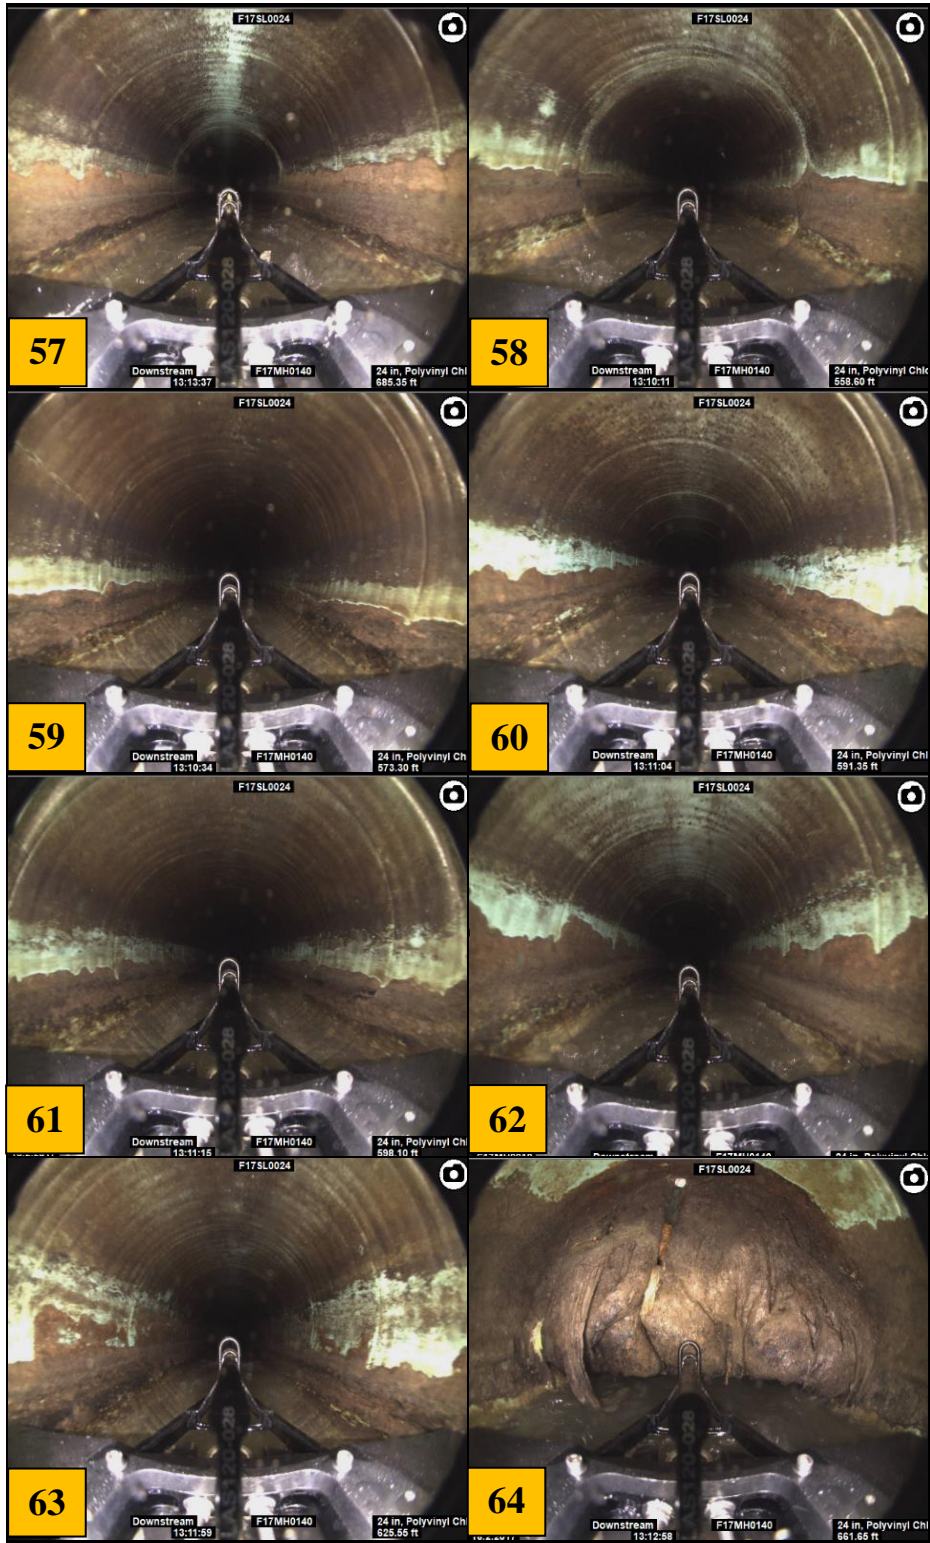
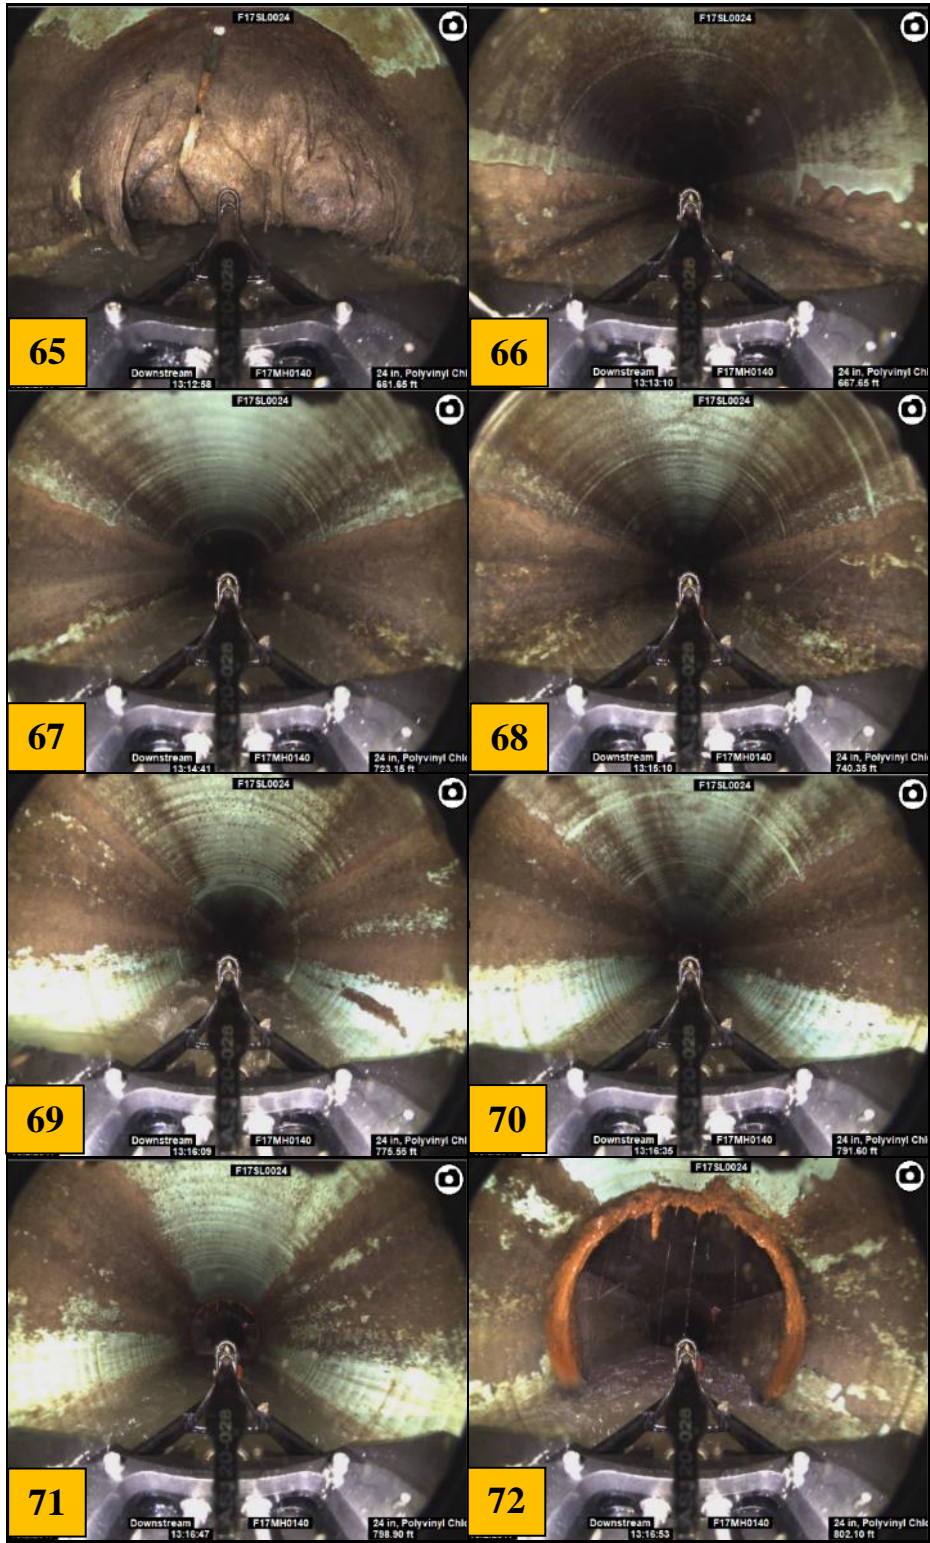
SN	Distance (feet)	Video Ref.	Code Group/ Descriptor/ Modifier	Continuous Defect	Value		Joint	Circumferential Location		Img Reference	Remarks	
					Dimension			%	At/ From			To
					1st	2nd						
1	0		AMH									
2	0		MWL				5%					
3	1.15		DAE				10%			1,2		
4	4.1		DAE	S01			<5%			3		
5	5		MWL				10%			4		
6	12		MWL				5%			5		
7	30.05		DAE	F01								
8	30.05		DAE	S02			5%			6,7		
9	34.75		DAE	F02								
10	34.75		DAE	S03			5%			8,9		
11	35.45		MWL				10%			10		
12	48.25		MWL				5%			11		
13	137.2		DAG				<5%	J		12		
14	149.75		DAG				<5%	J		13		
15	153.4		MWL				10%			14		
16	176.35		MWL				5%			15		
17	207.4		DAE	F03								
18	207.4		DAE	S04			5%			16		
19	221.95		MWL				10%			17		
20	229.5		MWL				5%			18		
21	235.9		MWL				10%			19		
22	239.65		DAE	F04								
23	239.65		DAE	S05			<5%			20,21		
24	252.25		MWL				5%			22		
25	258.25		MWL				10%			23

26	268		MWL			5%				24	
27	281.7		DAE	F05							
28	281.7		DAE	S06		5%				25,26	
29	289.75		DAE	F06							
30	289.75		DAE	S07		<5%				27	
31	294.85		MWL			10%				28	
32	309.1		MWL			5%				29	
33	319.05		DAE	F07							
34	319.05		DAE	S08		10%				30,31	
35	323		MWL			10%				32	
36	325.3		DAE	F08							
37	325.3		DAE	S09		5%				33	
38	343.1		MWL			5%				34	
39	359.4		DAE	F09							
40	359.4		DAE	S10		5%				35	
41	364.85		DAE	F10							
42	364.85		DAE	S11		5%				36	
43	377.55		MWL			10%				37	
44	380.15		DAG			10%	J			38	
45	384.1		DAE	F11							
46	384.1		DAE	S12		5%				39	
47	386.3		MWL			5%				40	
48	418.45		DAG			10%	J			41	
50	431.15		DAE	F12			J				
51	431.15		DAG			5%				42	
52	432.35		DAE	S13		5%				43	
53	456.7		RMJ				J			44	
54	500.1		DAE	F13							
55	500.1		DAE	S14		10%				45,46	
56	505.45		MWL			10%				47	
57	509.05		DAE	F14							
58	509.05		DAE	S15		5%				48	
59	534.55		MWL			5%				49	
60	538.15		DAE	F15

61	538.15		DAE	S16		10%				50,51	
62	546.7		DAE	F16							
63	546.7		DAE	S17		5%				52	
64	552.35		DAE	F17							
65	552.35		DAE			5%				53	
66	556.25		DAE	S18		5%				54,55,56,57	
67	558.6		MWL			10%				58	
68	573.3		MWL			5%				59	
69	591.35		MWL			10%				60	
70	598.1		MWL			5%				61	
71	617.9		MWL			10%				62	
72	625.55		MWL			5%				63	
73	658.6		MWL			10%				64	
74	661.65		RLJ							65	
75	667.65		MWL			5%				66	
76	723.15		MWL			10%				67	
77	740.35		MWL			5%				68	
78	775.55		MWL			10%				69	
79	791.6		MWL			5%				70	
80	798.9		MWL			10%				71	
81	802.15		DAE	F18							
82	802.15		RMJ							72	
83	802.15		MSA

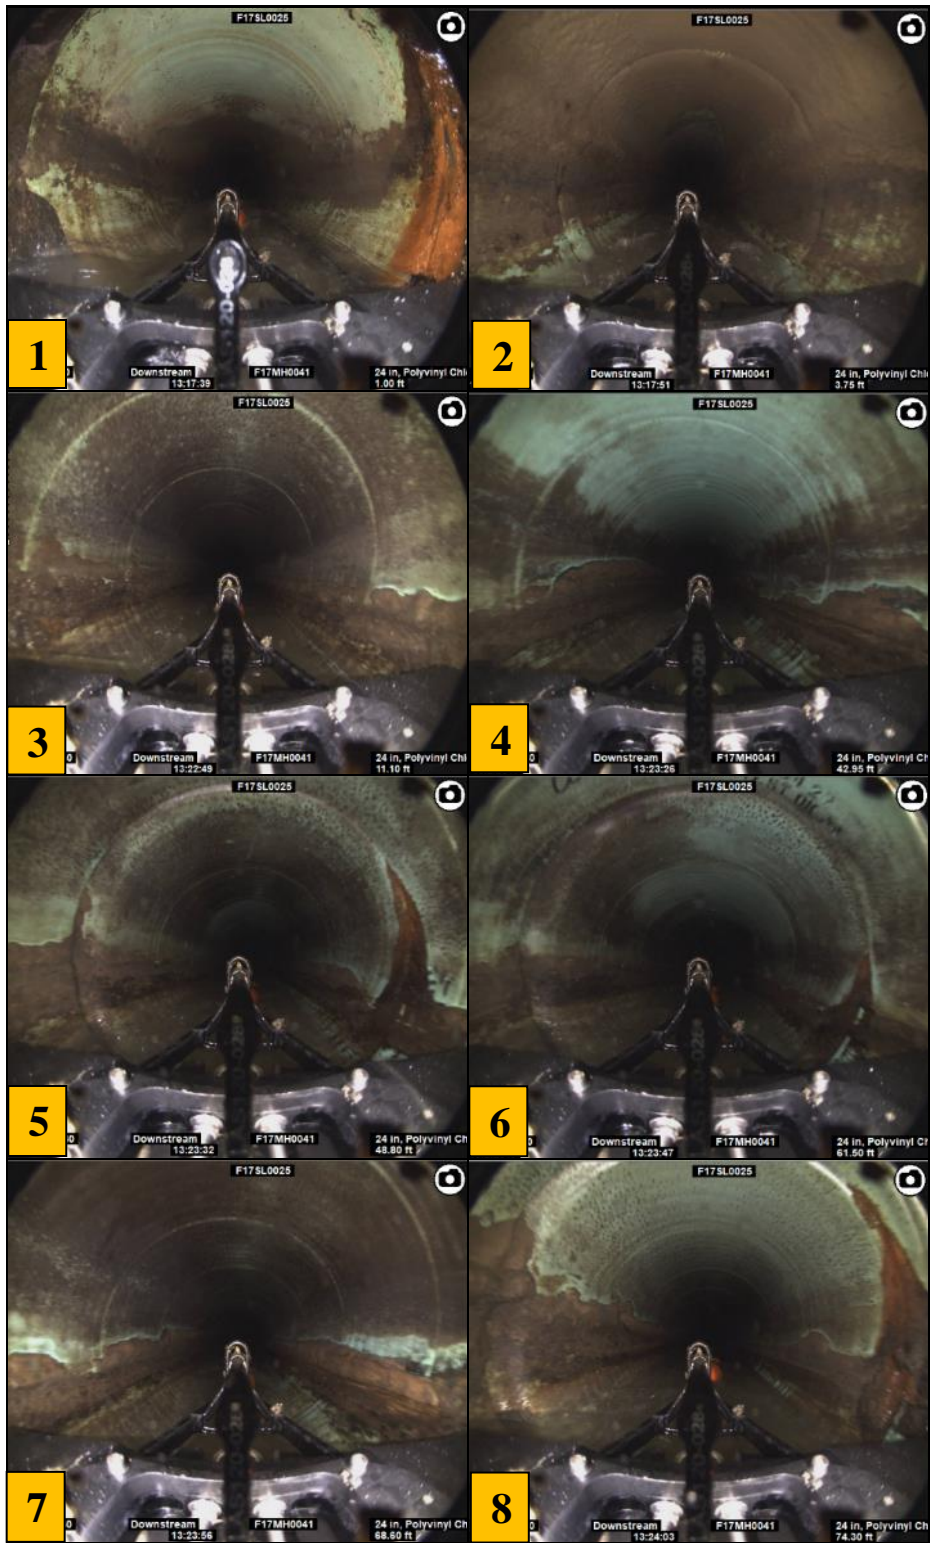
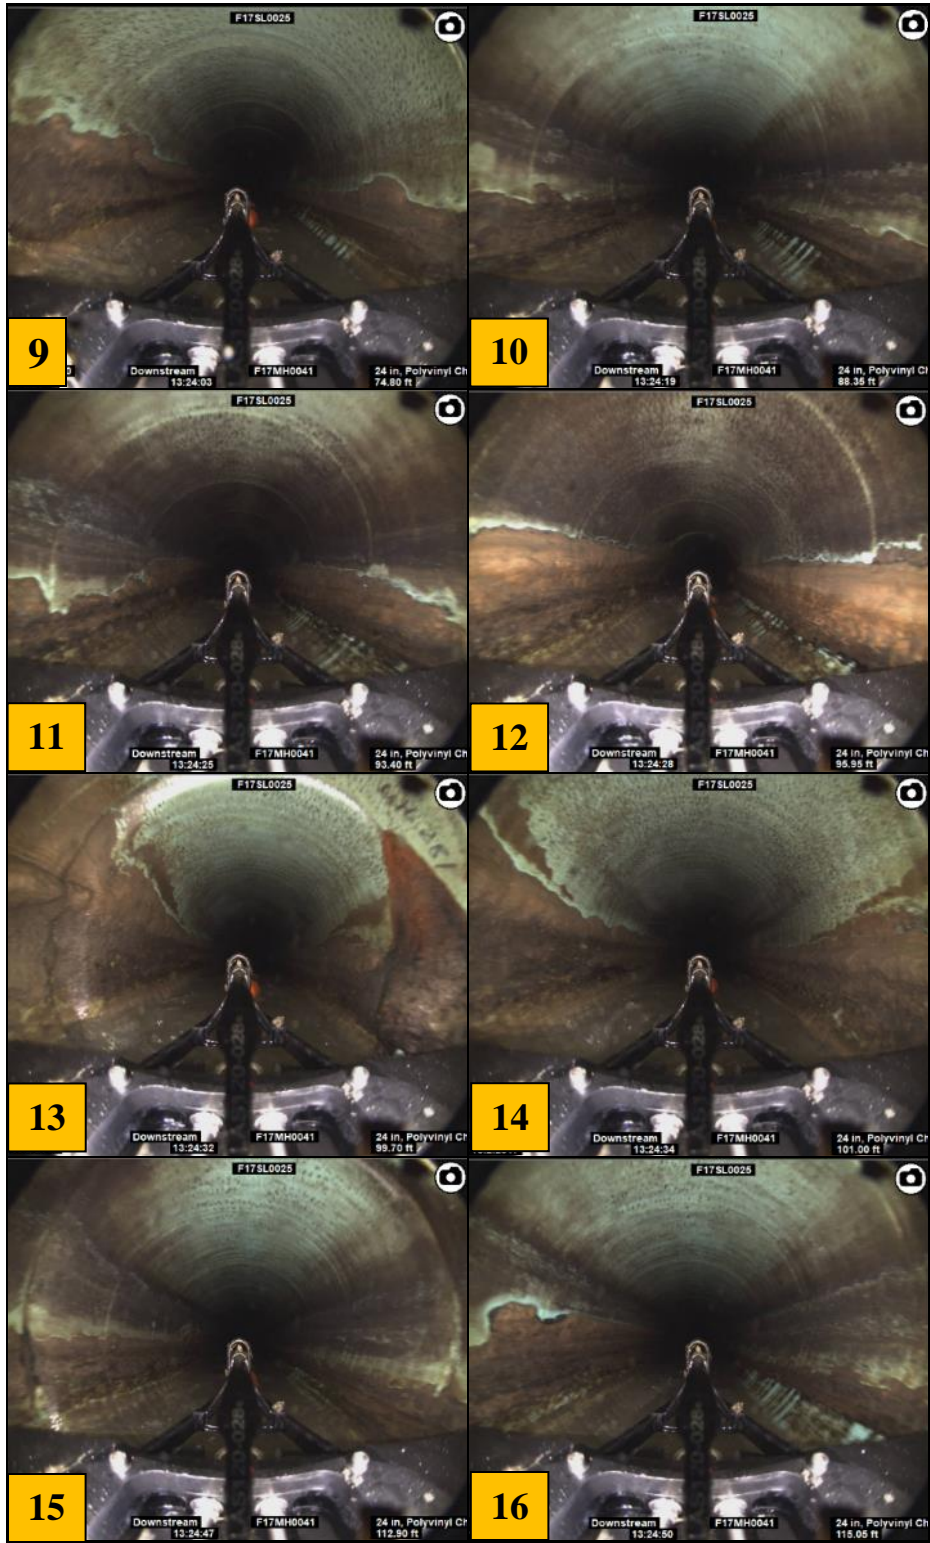
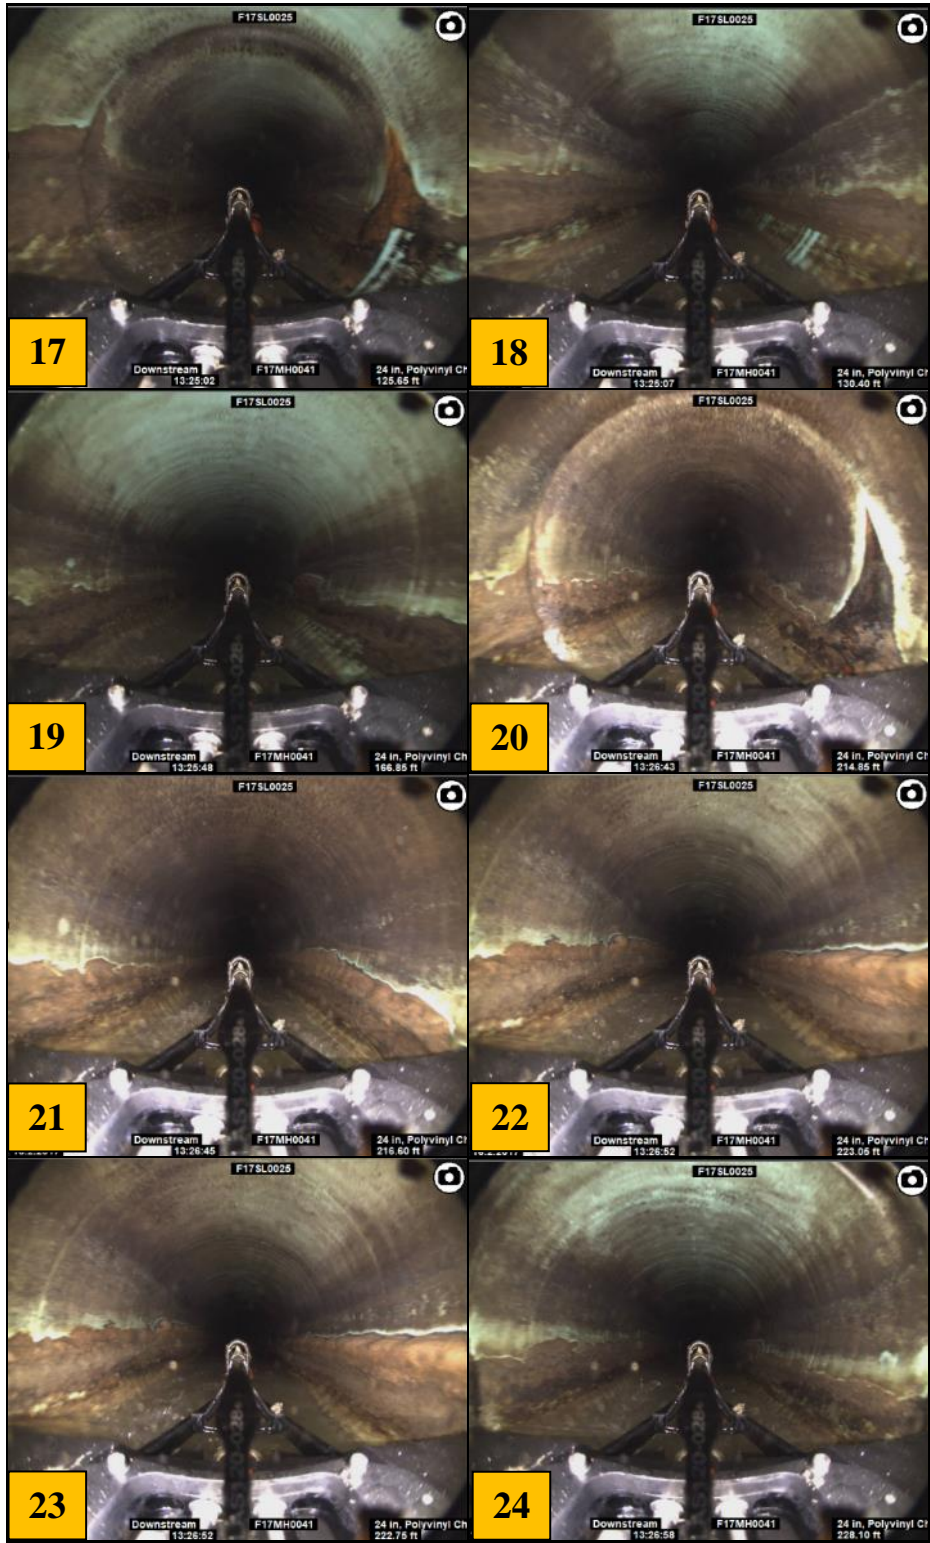
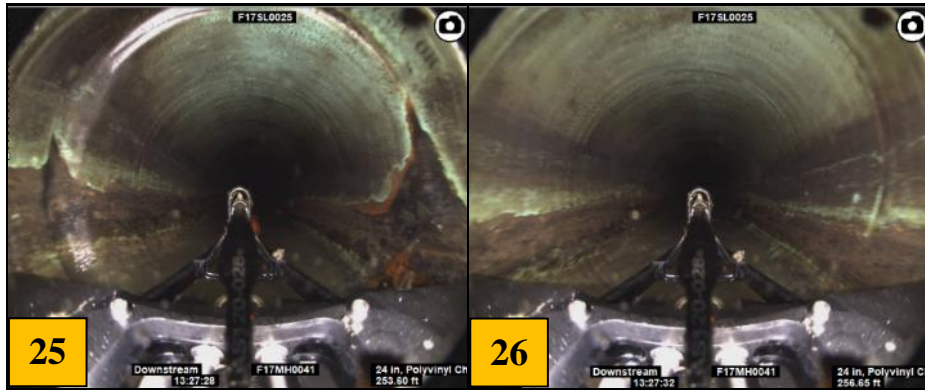
SN	Distance (feet)	Video Ref.	Code	Continuous Defect	Value		Joint	Circumferential Location		Img Reference	Remarks	
			Group/ Descriptor/ Modifier		Dimension			%	At/ From			To
					1st	2nd						
1	0		AMH									
2	1		MWL			5%						
3	1		DAG			<5%				1		
4	1		DAE	S01		10%				1,2		
5	11.1		DAE	F01								
6	11.1		DAE	S02		5%				3,4		
7	48.8		RMJ				J			5		
8	61.5		RMJ				J			6		
9	68.6		DAE	F02								
10	68.6		DAE	S03		5%				7		
11	74.3		DAE	F03								
12	74.3		RMJ							8		
13	74.3		DAE	S04		5%				8		
14	74.8		MWL			10%				9		
15	88.35		MWL			5%				10

16	93.4		DAE	F04								
17	93.4		DAE	S05		5%					11,12	
18	99.7		RMJ								13	
19	101		MWL			10%					14	
20	112.9		DAE	F05								
21	112.9		DAE	S06		5%					15	
22	115.05		MWL			5%					16	
23	125.95		DAE	F06								
24	125.65		RMJ								17	
25	125.95		DAE	S07		5%					17	
26	130.4		MWL			10%					18	
27	166.85		MWL			5%					19	
28	214.85		RMJ								20	
29	216.6		DAE	F07								
30	216.6		DAE	S08		5%					21,22	
31	222.75		MWL			10%					23	
32	228.1		DAE	F08								
33	228.1		DAE	S09		5%					24	
34	253.6		RMJ								25	
35	256.65		MWL			5%					26	
36	271.55		DAE	F09								
37	271.55		MSA
