ALGORITHM DEVELOPMENT FOR SEWER PIPE SYSTEM CONDITION
ASSESSMENT USING MULTI-SENSOR (MSI) TECHNOLOGY

ALGORITHM DEVELOPMENT FOR SEWER PIPE SYSTEM CONDITION ASSESSMENT USING MULTI-SENSOR (MSI) TECHNOLOGY

This study investigates the performance of all the current large-diameter pipeline system of The City of Arlington (COA) sewer lines of 48 miles (24-inch inner diameter and above for rigid and flexible pipes). Proper inspection and rehabilitation plan for the city sewer pipeline system are better choice for the municipality and tax payers in terms of cost than dealing with pipe damage and collapsing problems when they happen.

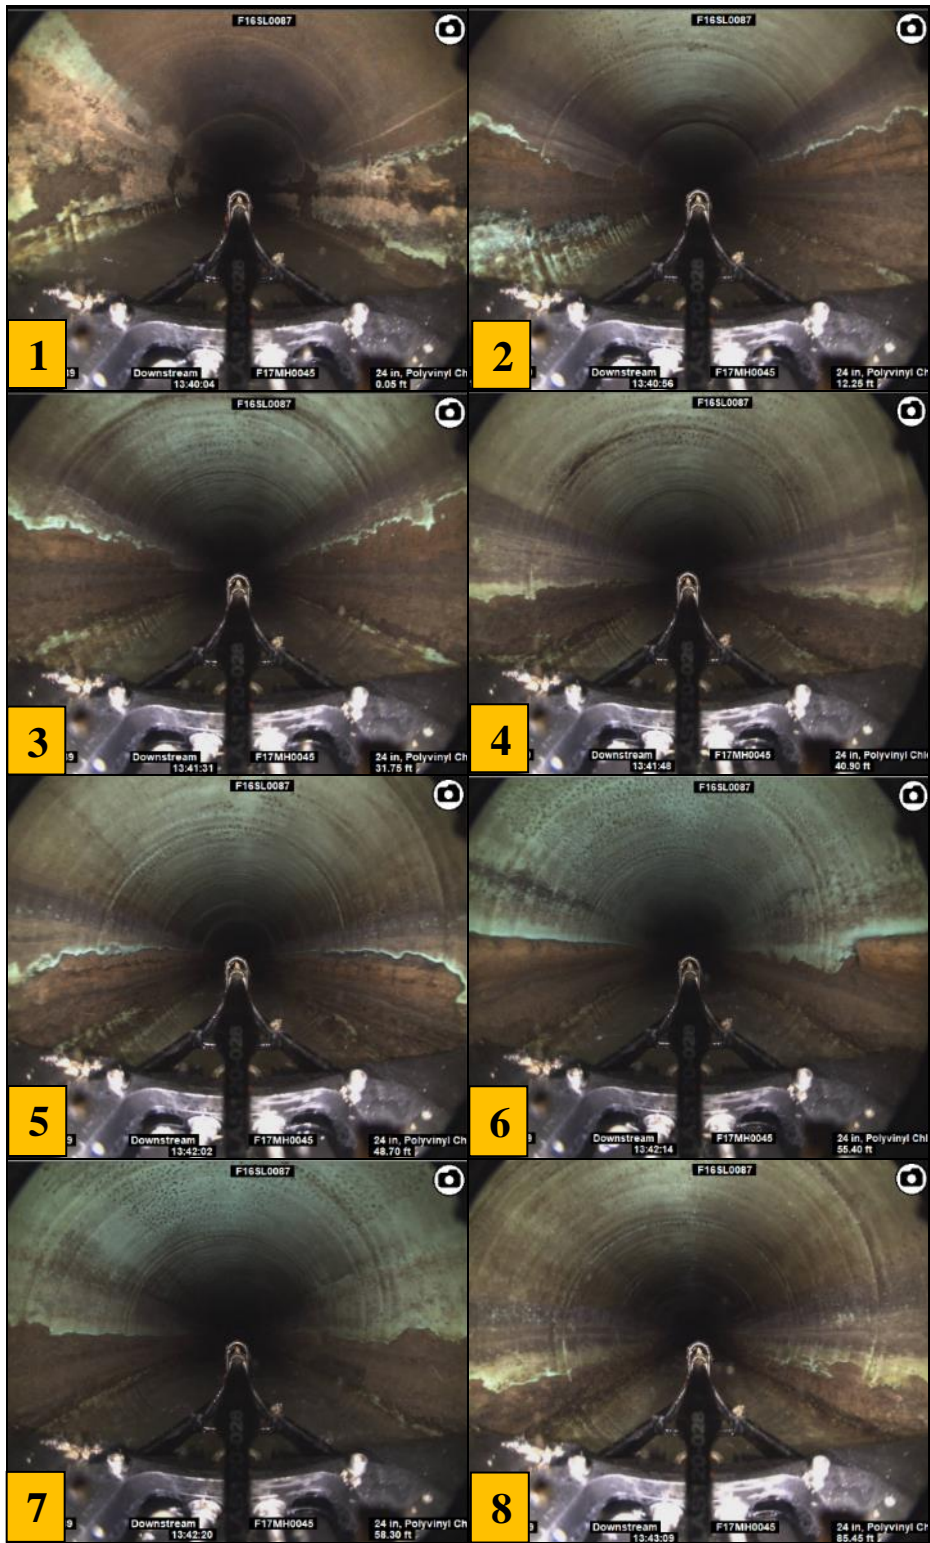
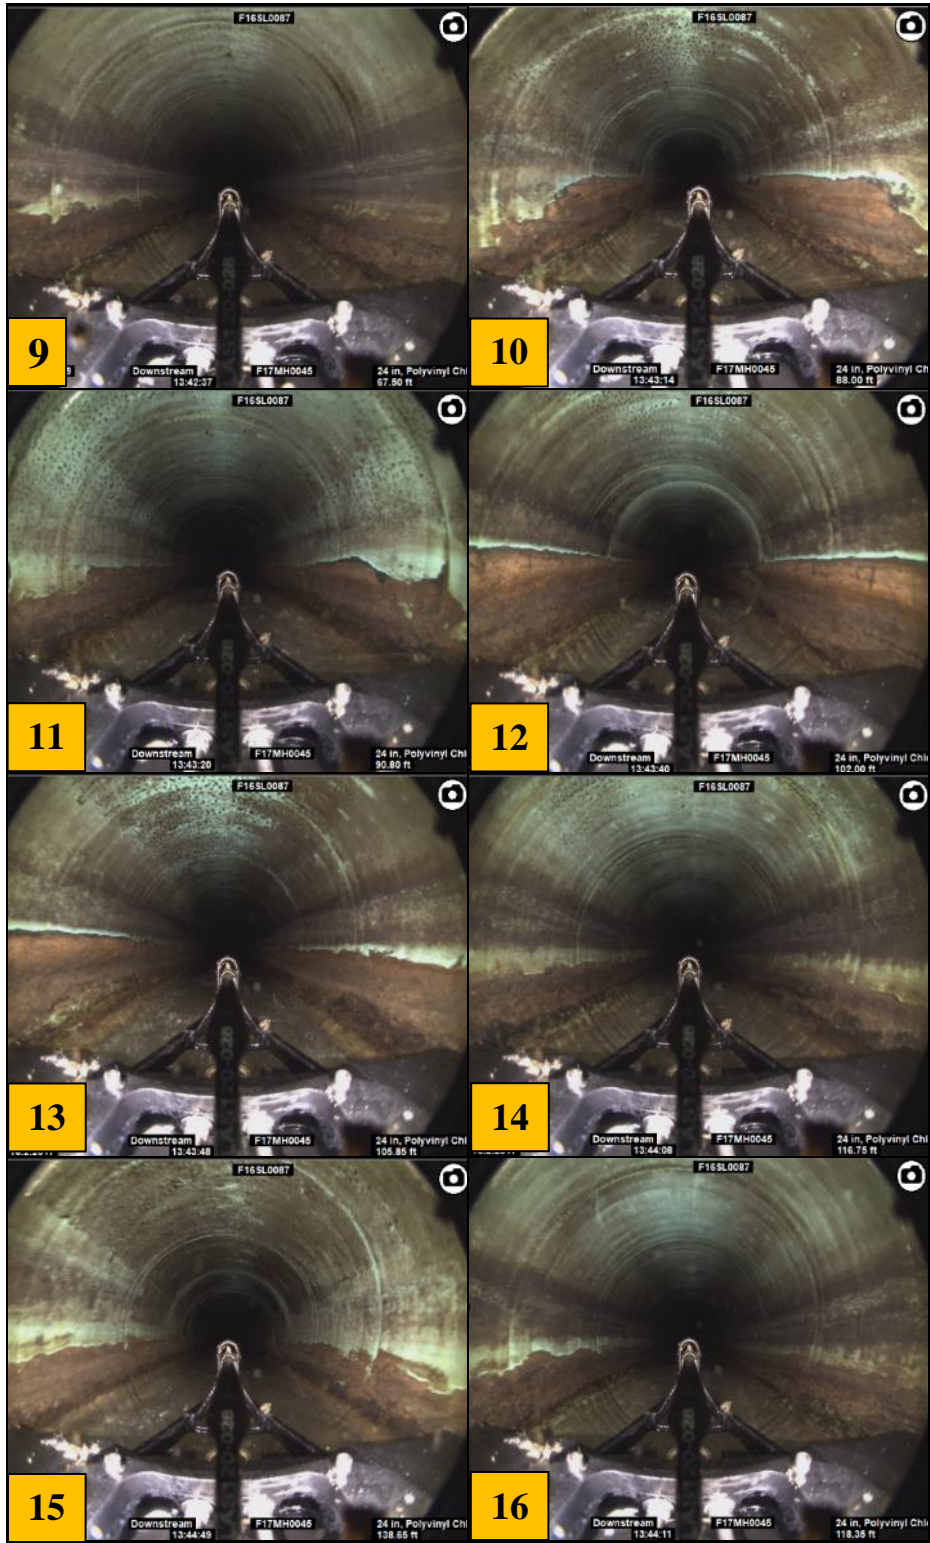
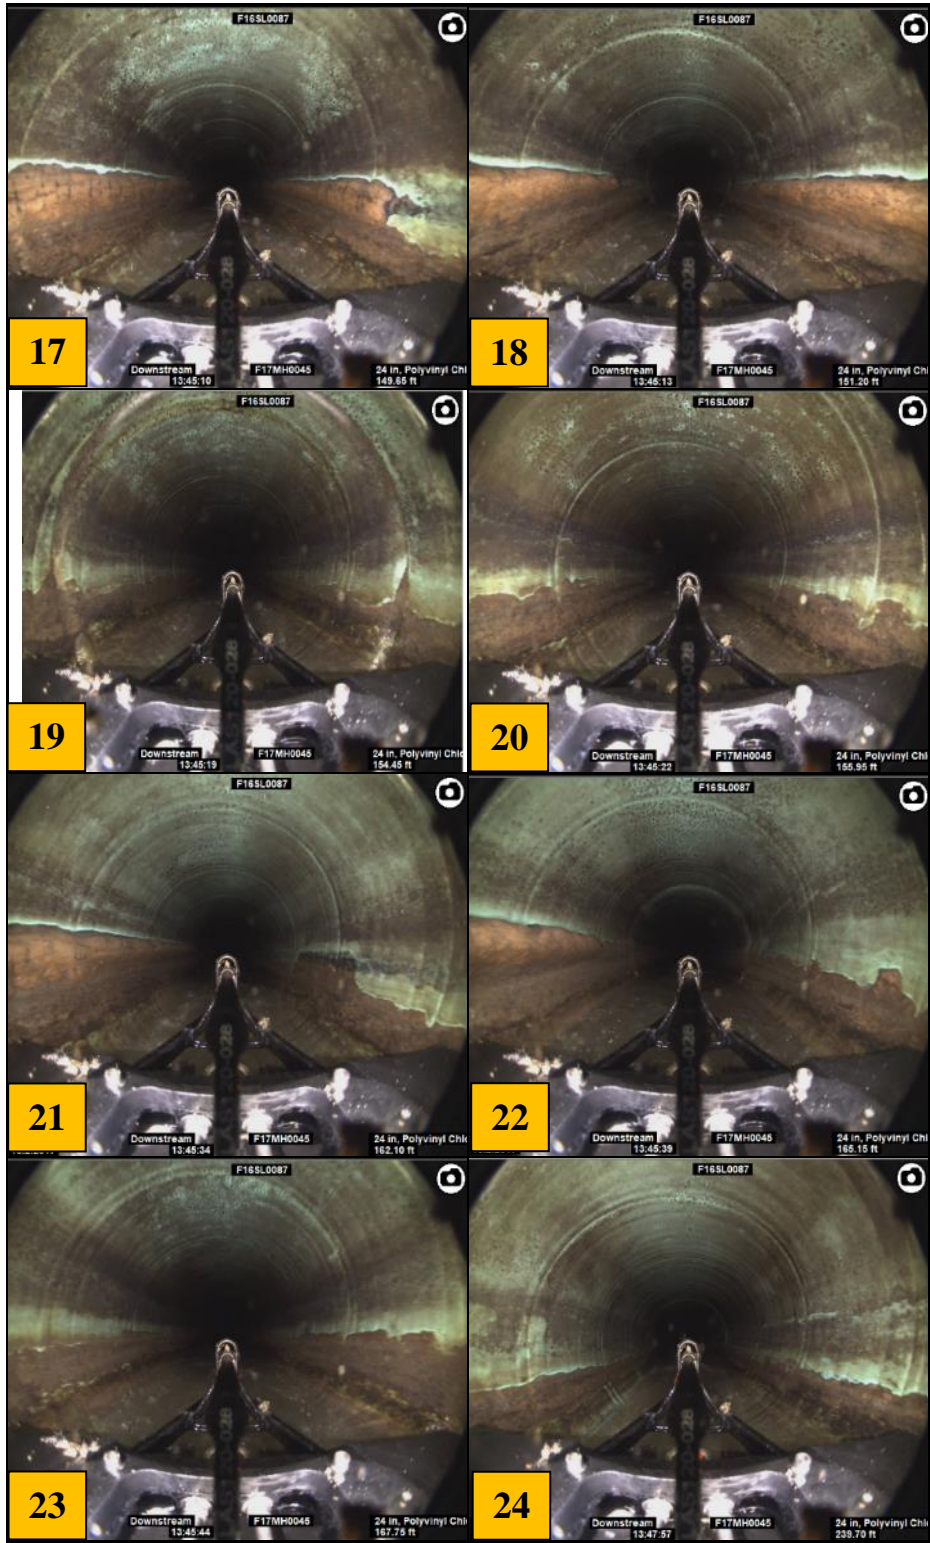
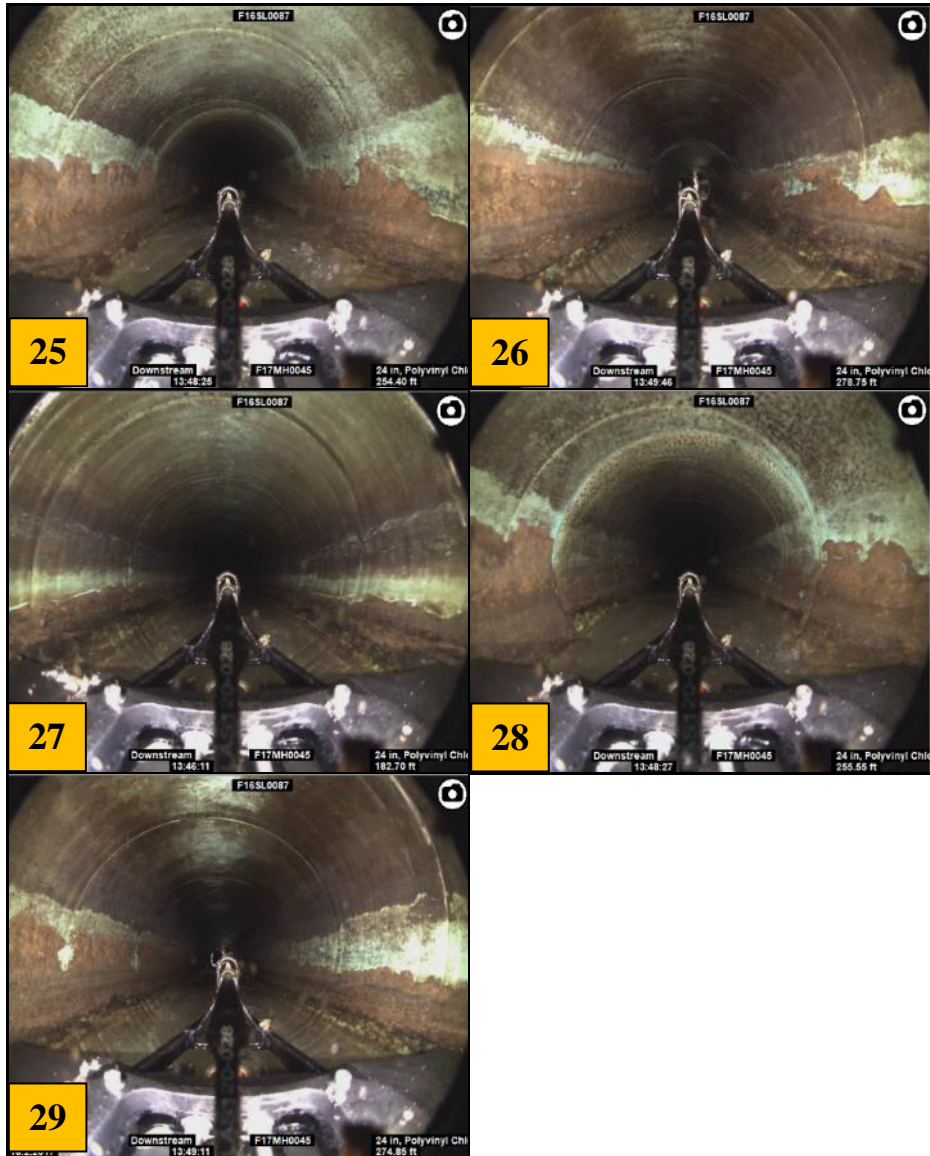
SN	Distance (feet)	Video Ref.	Code	Continuous Defect	Value		Joint	Circumferential Location		Img Reference	Remarks	
			Group/ Descriptor/ Modifier		Dimension			%	At/ From			To
					1st	2nd						
1	0		AMH									
2	0		MWL			10%						
3	0		DAE	S01		5%				1,2,3		
4	40.9		MWL			5%				4		
5	48.7		DAE	F01								
6	48.7		DAE	S02		10%				5		
7	55.4		MWL			10%				6		
8	58.3		DAE	F02								
9	58.3		DAE	S03		5%				7,8		
10	67.5		MWL			5%				9		
11	88		DAE	F03								
12	88		DAE			5%				10		
14	90.8		DAE	S04		5%				11,12		
15	105.85		MWL			10%				13		
16	116.75		DAE	F04

17	116.75		DAE	S05			5%				14,15	
18	118.35		MWL				5%				16	
19	149.65		DAE	F05								
20	149.65		DAE	S06			5%				17	
21	151.2		MWL				10%				18	
22	154.45		DAE	F06								
23	154.45		DAE	S07			5%				19	
24	155.95		MWL				5%				20	
25	162.1		DAE	F07								
26	162.1		DAE	S08			5%				21	
27	165.15		MWL				10%				22	
28	167.75		DAE	F08								
29	167.75		DAE	S09			5%				23,24,25,26	
30	182.7		MWL				5%				27	
31	255.55		MWL				10%				28	
32	274.85		MWL				5%				29	
33	287.8		DAE	F09								
34	287.8		MSA

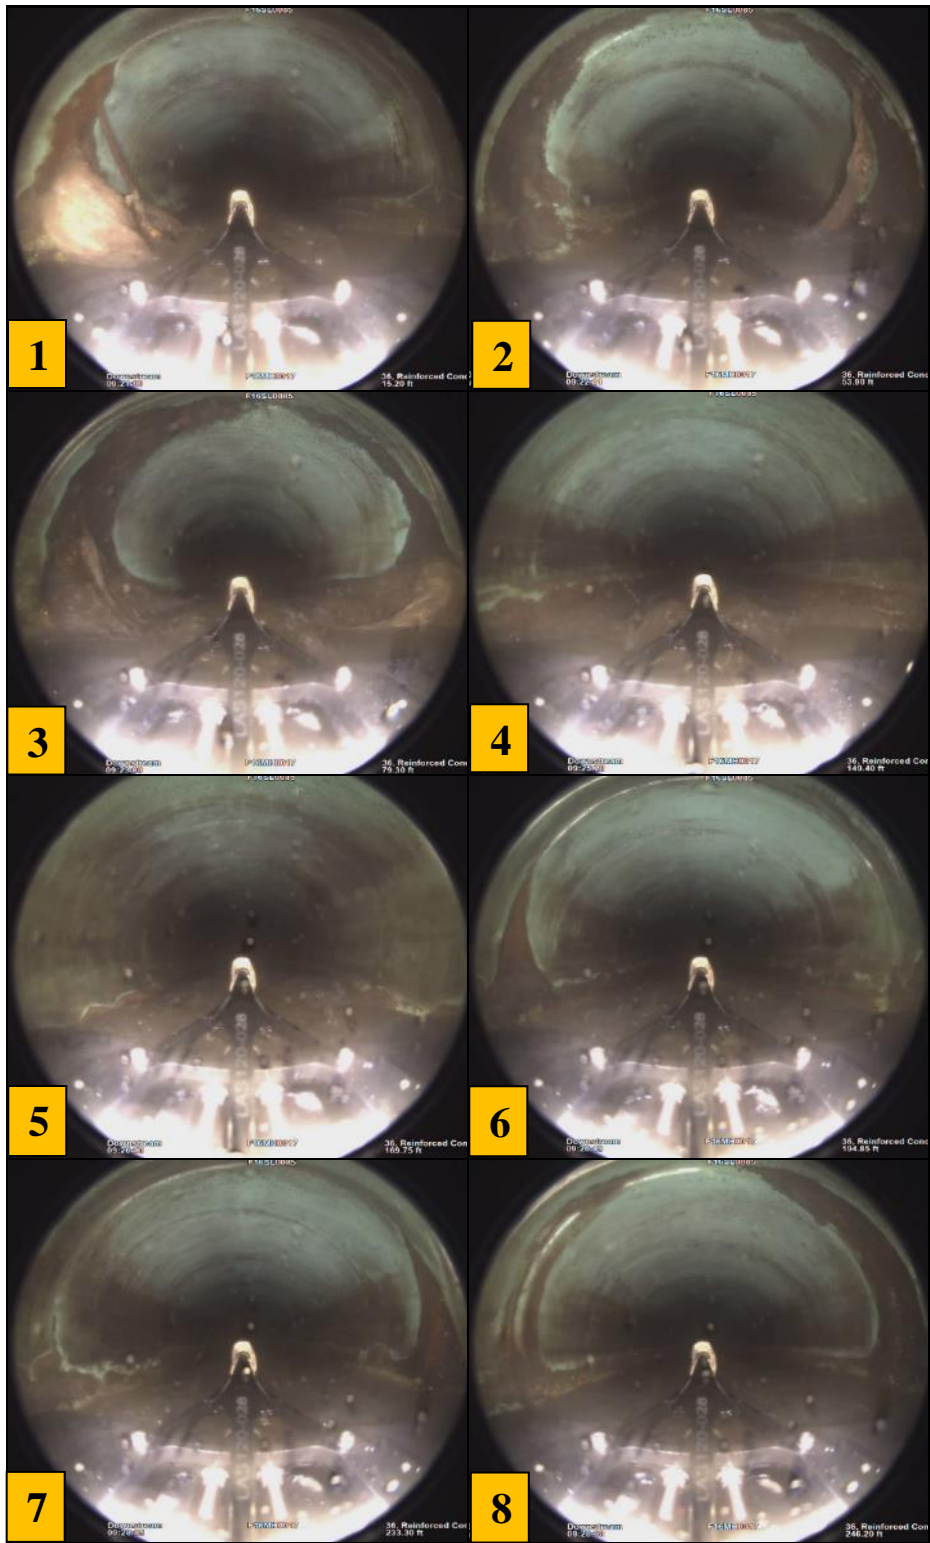
Figure A58-1 images from 1 through 8

SN	Distance (feet)	Video Ref.	Code	Continuous Defect	Value		Joint	Circumferential Location		Img Reference	Remarks
			Group/Descriptor/Modifier		Dimension			At/From	To		
					1st	2nd					
1	0		AMH								PIPE IS OVAL IN SHAPE AT SOME PLACES AND COVERED WITH DEPOSITS THROUGH-OUT THE LENGTH OF THE PIPE
2	8		MWL			10%					
3	15.2		RMJ							1	
4	53.9		RMJ							2	
5	79.3		RMJ							3	
6	79.3		DAE			20%				3	
7	149.4		MWL			5%				4	
8	169.75		MWL			10%				5	
9	194.85		RMJ							6	
10	233.3		RMJ							7	
11	246.2		RMJ							8	
12	284.3		RLJ							9	
13	310.15		RMJ							10	
14	323.05		RMJ							11	
15	348.8		RMJ							12	
16	361.45		RLJ							13	
17	412.6		RMJ							14	
18	438.3		RMJ							15	
19	464.3		RMJ							16	
20	477.15		RLJ							17

21	494.15		JSL								18	
22	498.65		JSM								19	
23	498.65		DAE			5%					19	
24	580.45		MWL			5%					20	
25	593.05		RMJ								21	
26	598.55		MWL			10%					22	
27	776.55		RLJ								23	
28	780.45		RLJ								24	
29	785		MWL			5%					25	
30	792.7		MWL			10%					26	
31	811.1		RMJ								27	
32	861.5		MSA

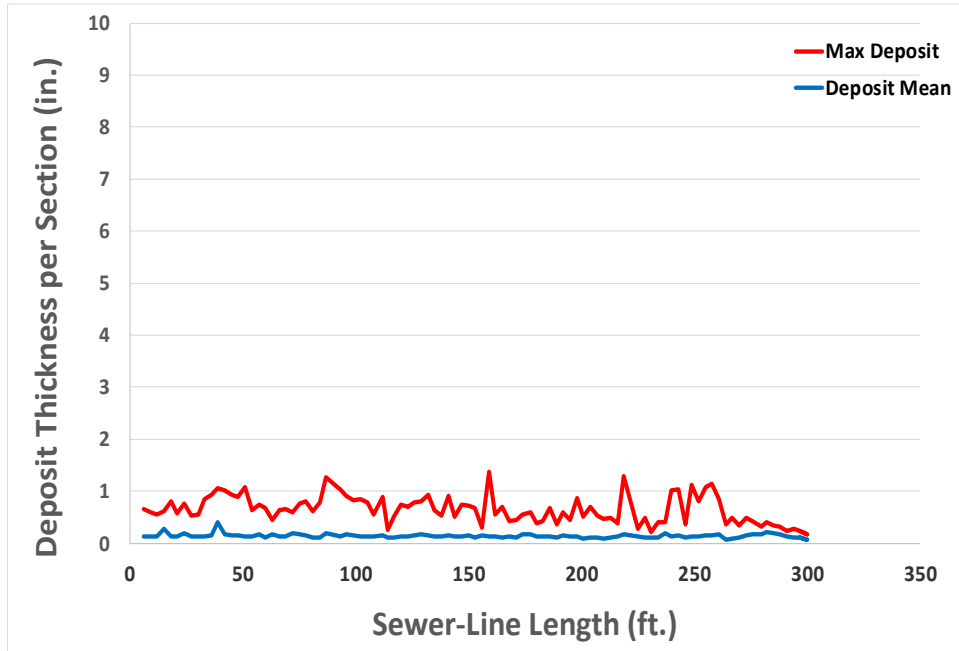
Figure A59-1 Deposit thickness per cross-section

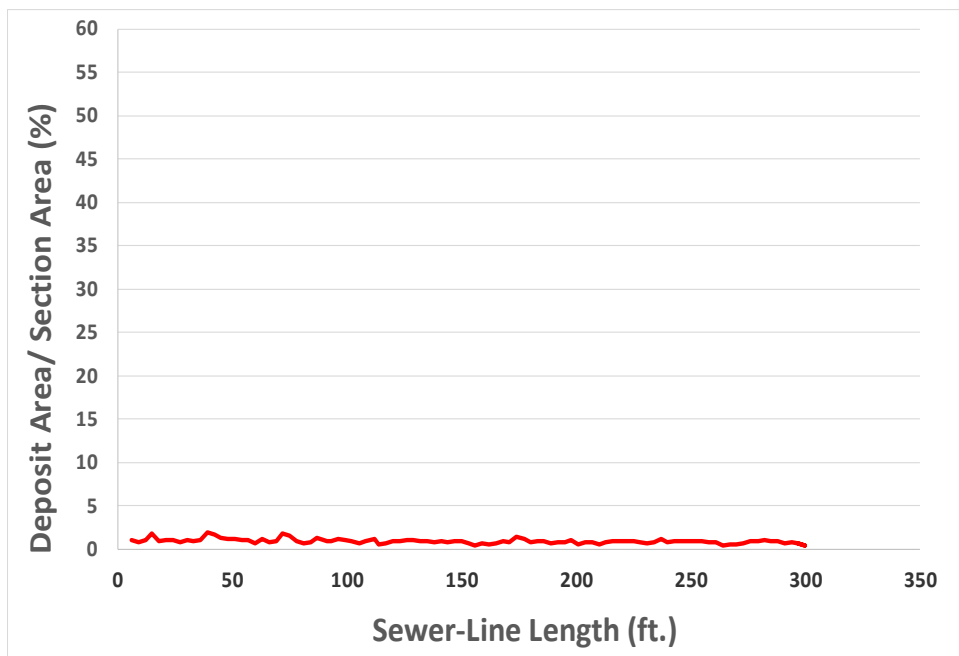
Figure A59-2 Deposit area percentage of the pipe cross section area

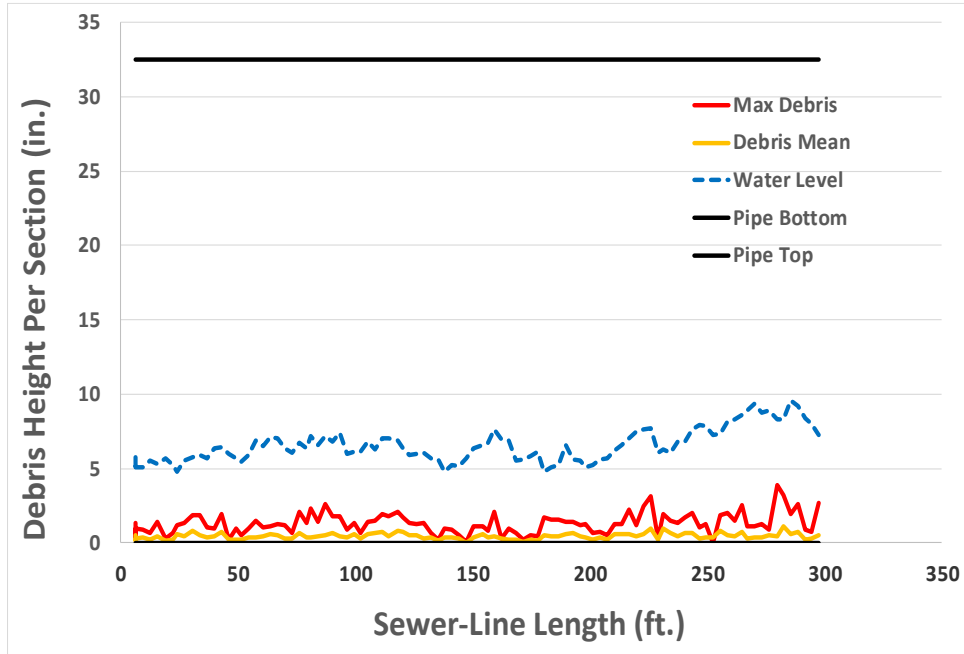
Figure A59-3 Debris height per cross-section

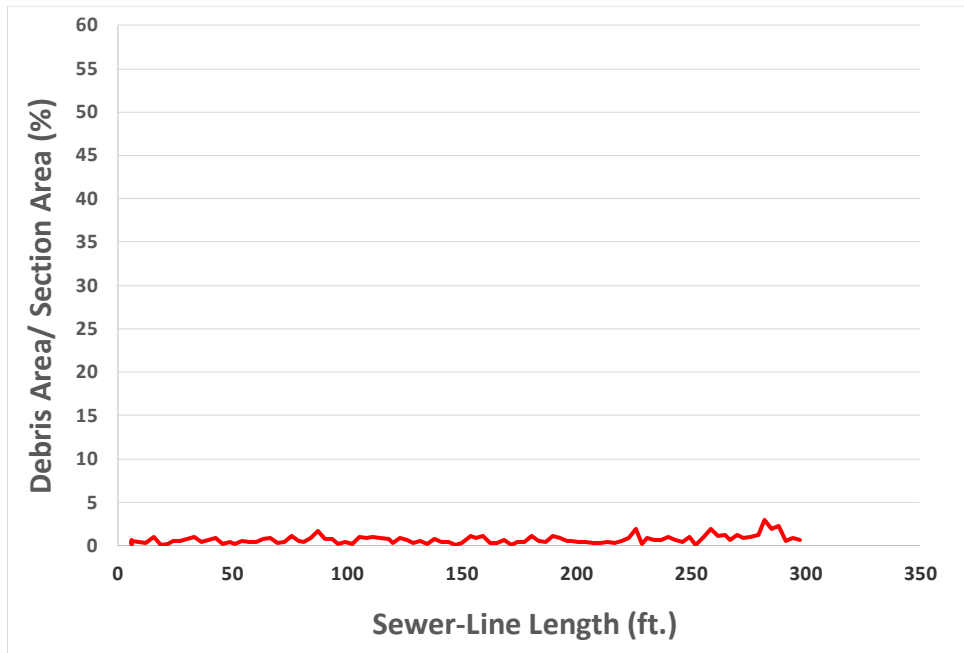
Figure A59-4 Debris area percentage of the pipe cross-sectional area

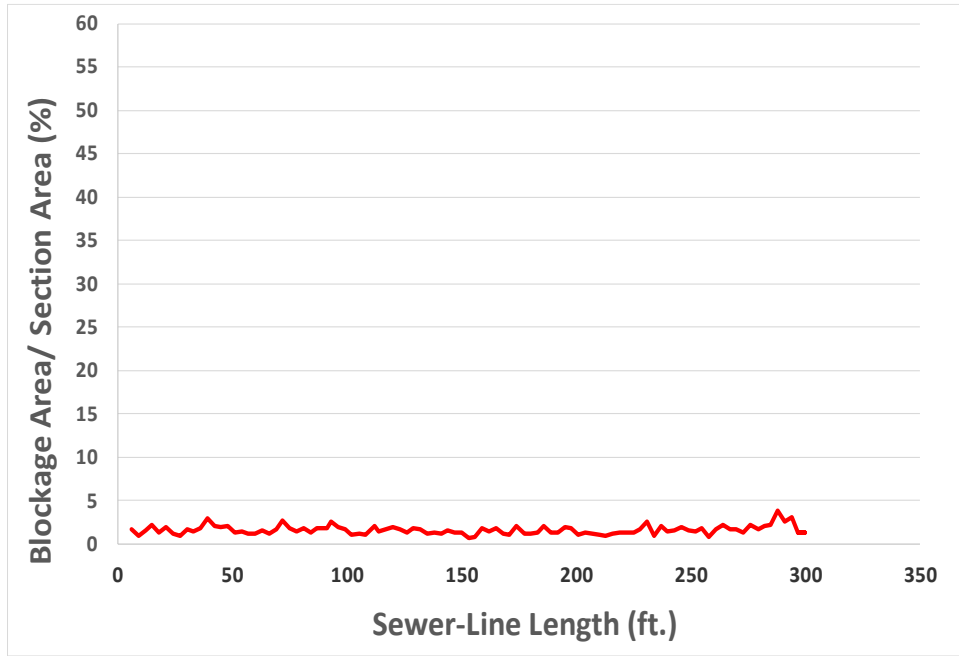
Figure A59-5 Blockage area (deposits and debris areas) percentage of pipe cross section area

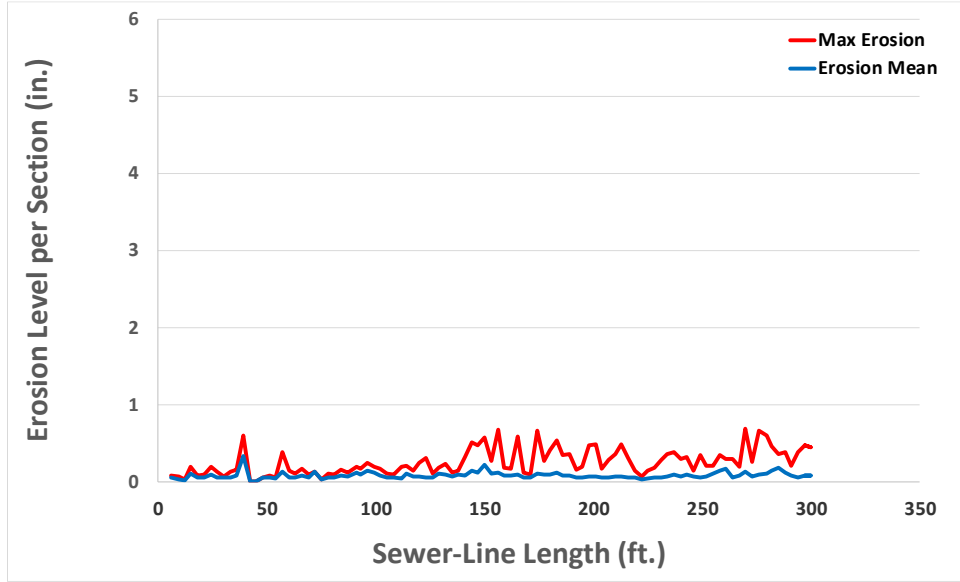
Figure A59-6 Erosion level per cross-section

Rank	Line ID	Observed Pipe Material	GIS Pipe Diameter (inches)	Observed Pipe Diameter (inches)	Approx. Max Erosion (Inches)	Approx. Mean Pipe Erosion (inches)
1	F15SL0146	RCP	33	32.5	0.6	0

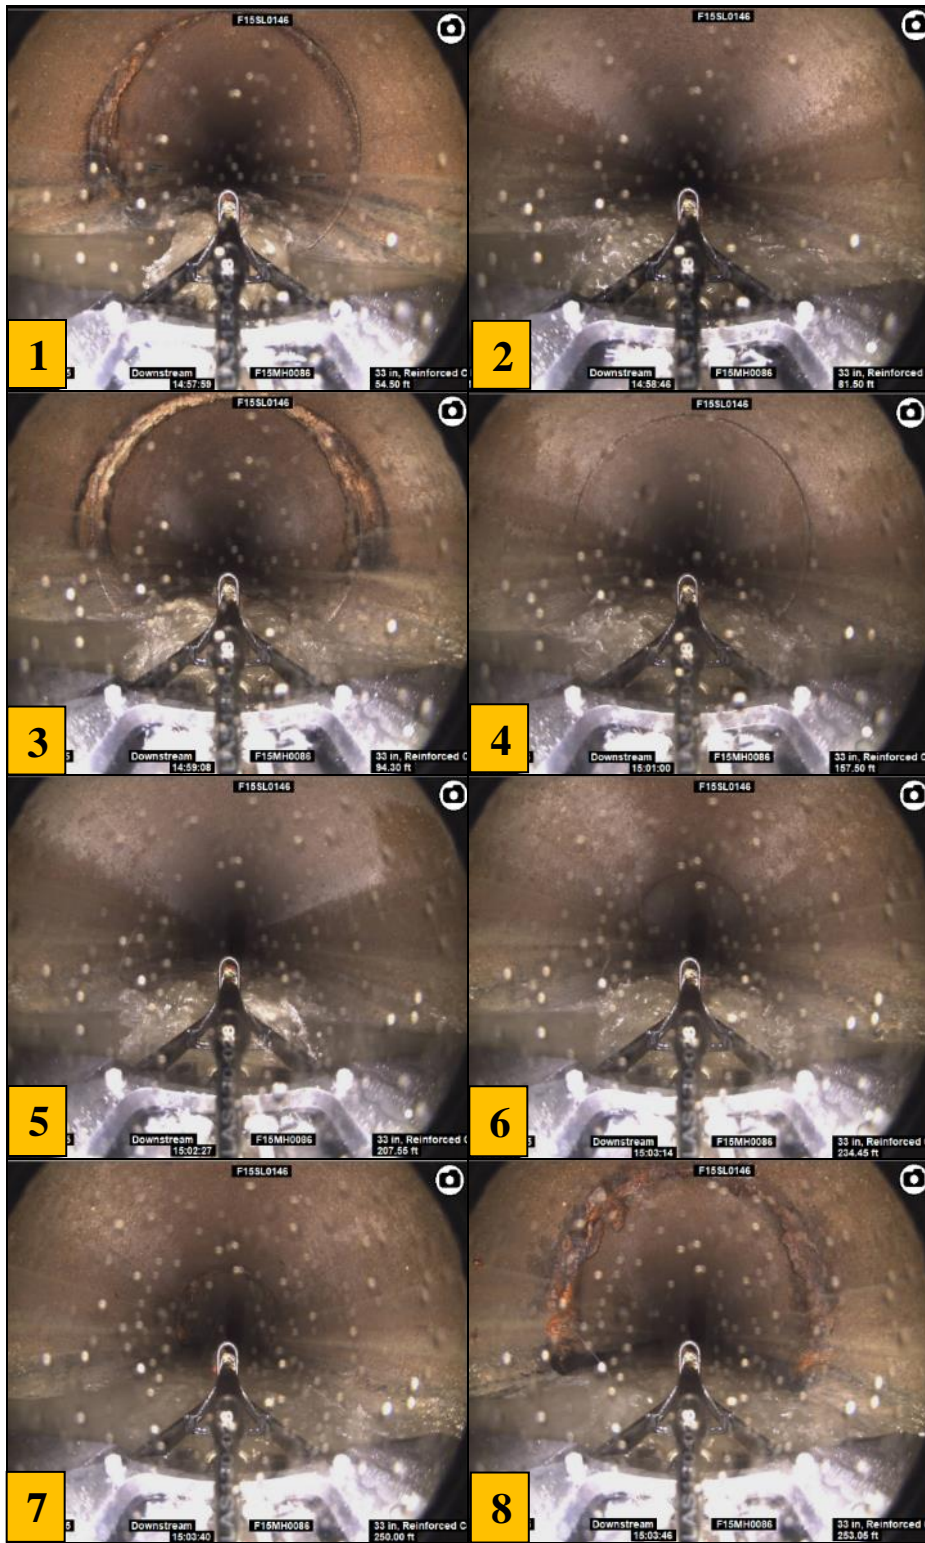
Figure A59-7 images from 1 through 8

SN	Distance (feet)	Video Ref.	Code	Continu ous Defect	Value			Joint	Circumferential Location		Img Reference	Remarks
			Group/ Descriptor/ Modifier		Dimension		%		At/ From	To		
					1st	2nd						
1	0		AMH									
2	6		MWL				5%					
3	54.5		DAG				5%	J			1	
4	81.5		MWL				10%				2	
5	94.3		DAG				20%	J			3	
6	157.5		MWL				5%				4	
7	207.55		MWL				10%				5	
9	234.45		MWL				5%				6	
10	250		MWL				10%				7	
11	253.05		DAG				20%	J			8	
12	300.8		MSA

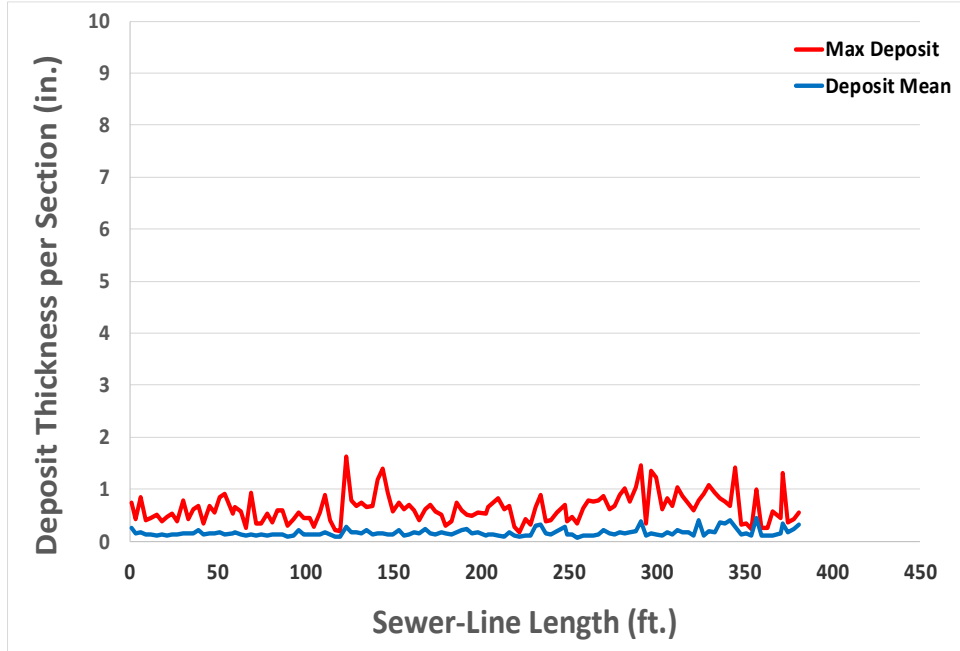
Figure A60-1 Deposit thickness per cross-section

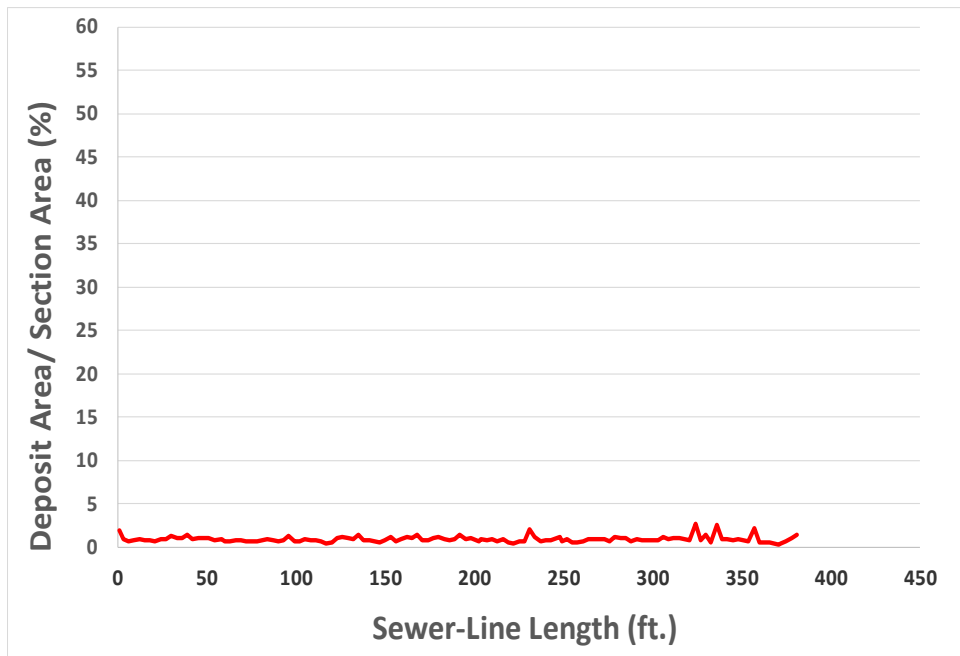
Figure A60-2 Deposit area percentage of the pipe cross section area

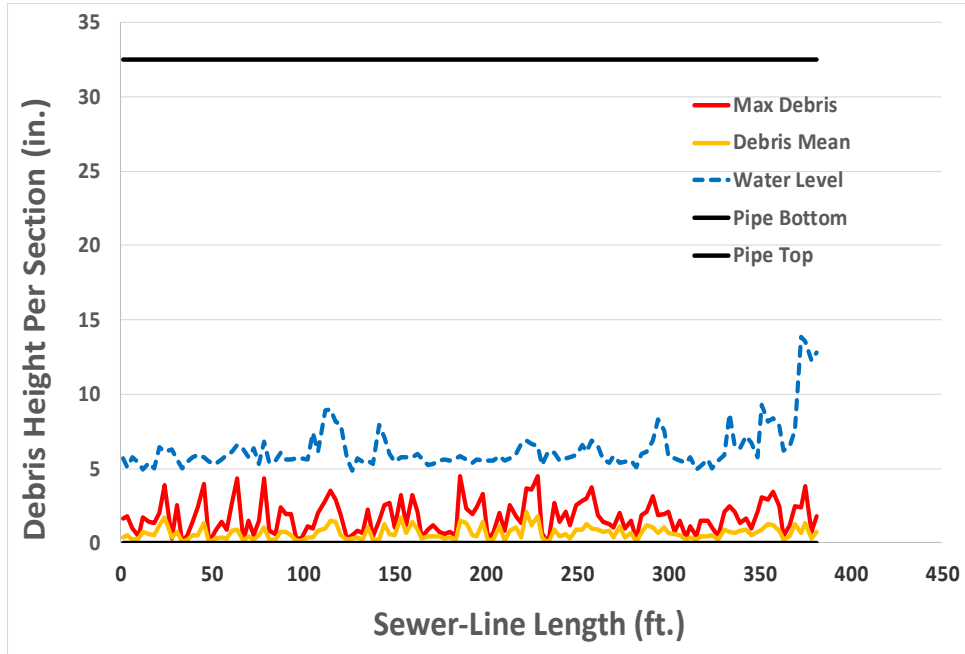
Figure A60-1 Debris height per cross-section

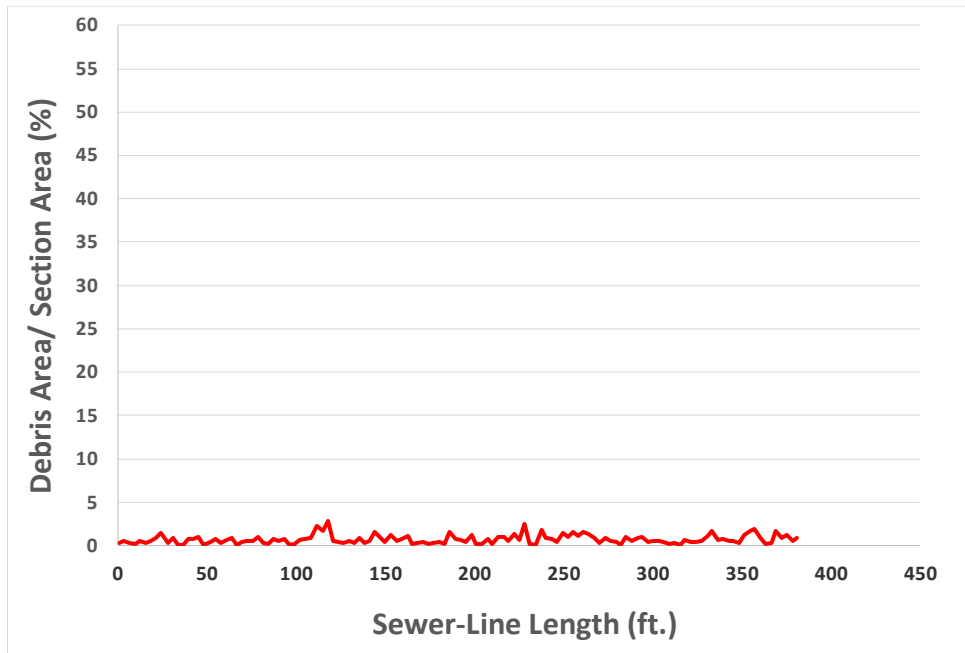
Figure A60-2 Debris area percentage of the pipe cross-sectional area

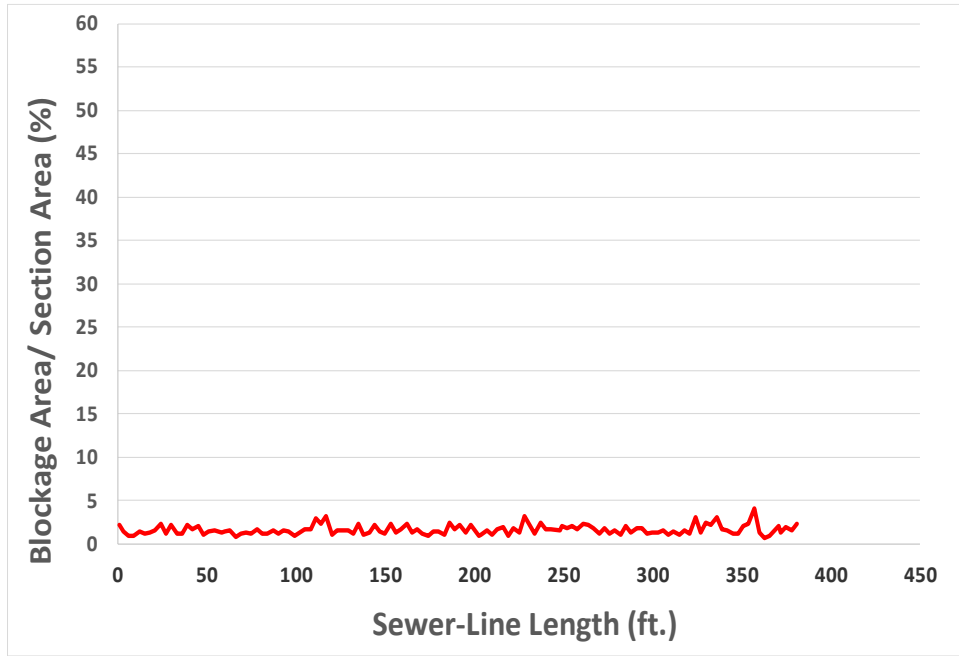
Figure A60-5 Blockage area (deposits and debris areas) percentage of pipe cross section area

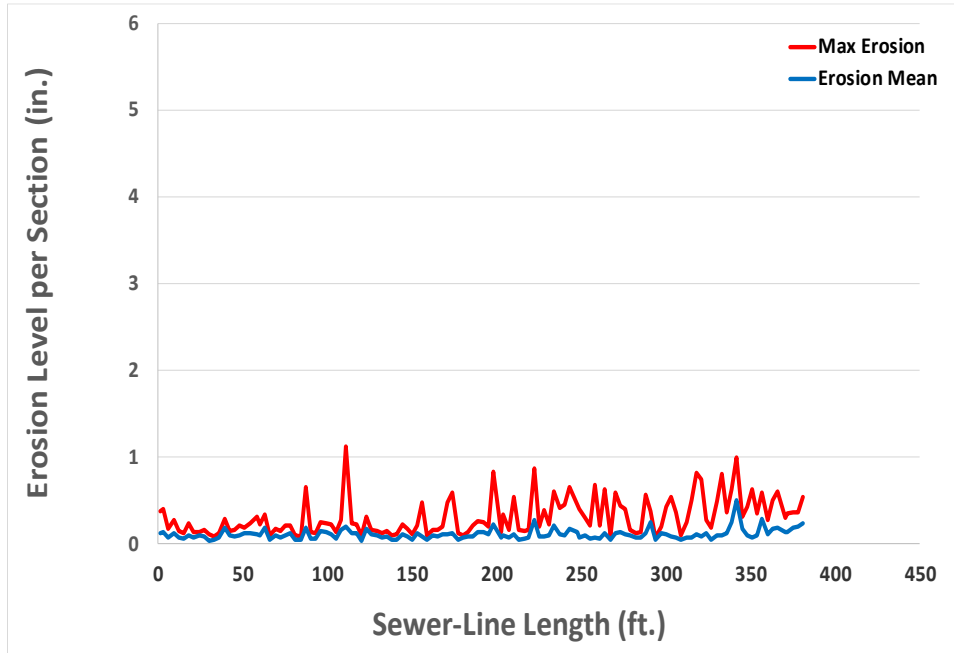
Figure A60-6 Erosion level per cross-section

Rank	Line ID	Observed Pipe Material	GIS Pipe Diameter (inches)	Observed Pipe Diameter (inches)	Approx. Max Erosion (Inches)	Approx. Mean Pipe Erosion (inches)
1	F15SL0161	RCP	33	32.5	1.1	0.1

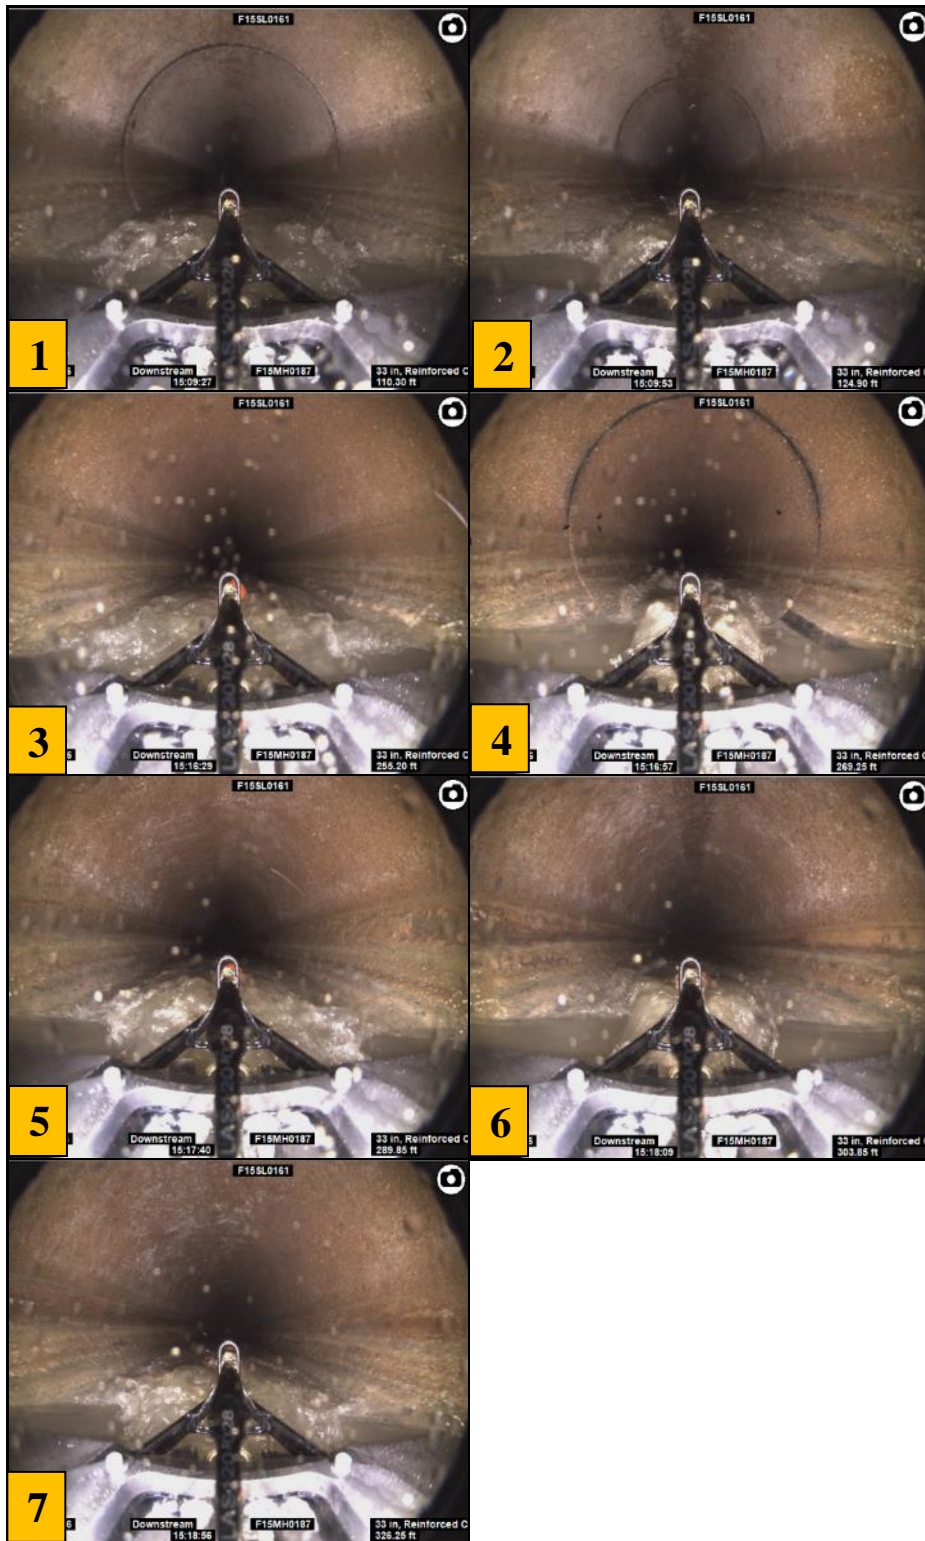
Figure A60-7 images from 1 through 7

SN	Distance (feet)	Video Ref.	Code	Continuous Defect	Value			Joint	Circumferential Location		Img Reference	Remarks
			Group/ Descriptor/ Modifier		Dimension		%		At/ From	To		
					1st	2nd						
1	0		AMH									
2	1		MWL			5%						
3	110.3		MWL			10%				1		
4	124.9		MWL			5%				2		
5	255.2		MWL			10%				3		
6	269.25		MWL			5%				4		
7	289.85		MWL			10%				5		
8	303.85		MWL			5%				6		
9	326.25		MWL			10%				7		
10	384.8		MSA

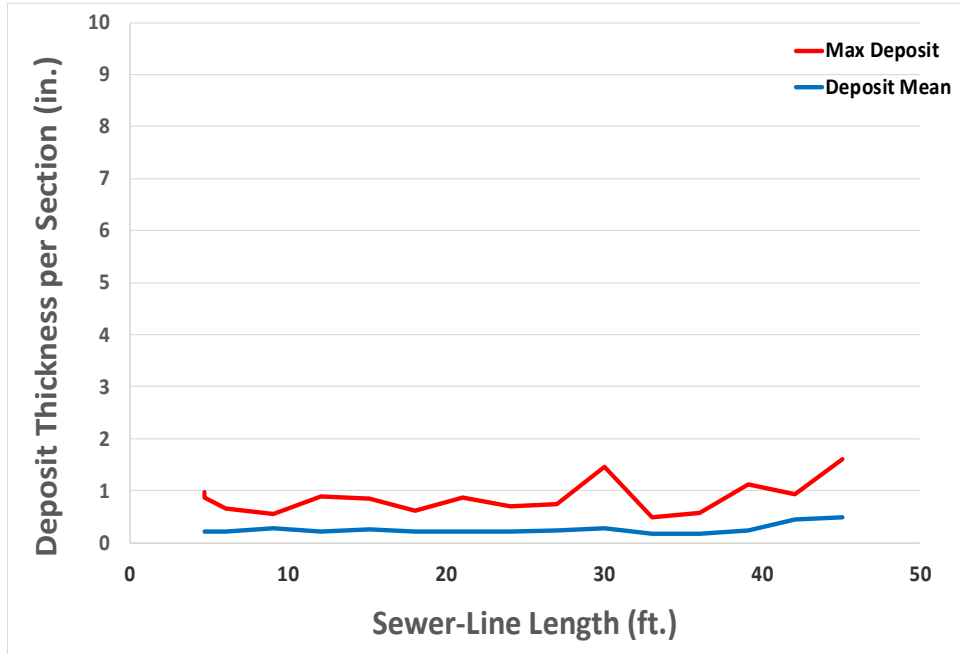
Figure A61-1 Deposit thickness per cross-section

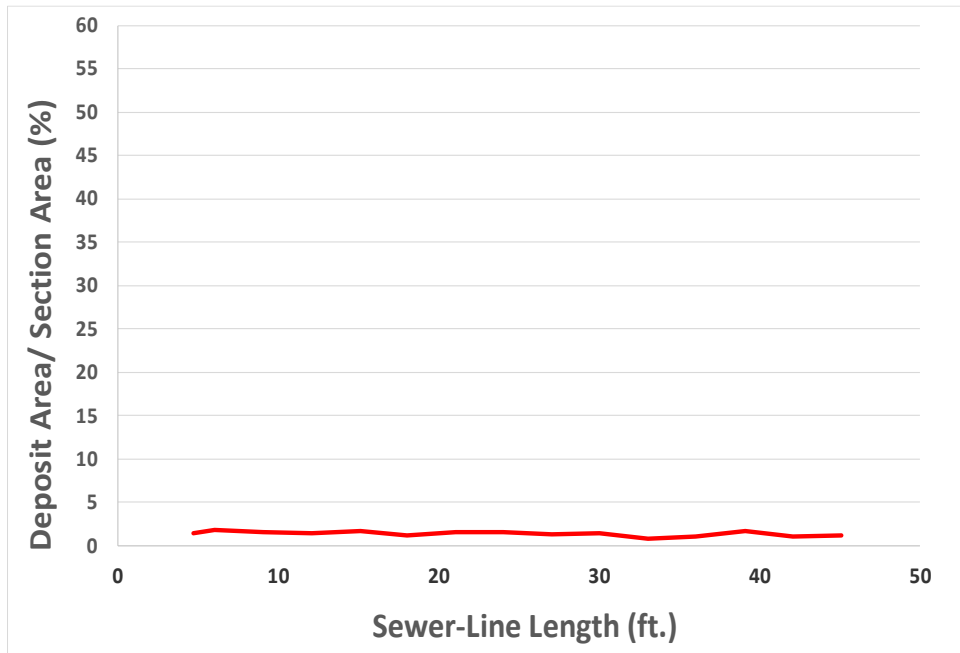
Figure A61-2 Deposit area percentage of the pipe cross section area

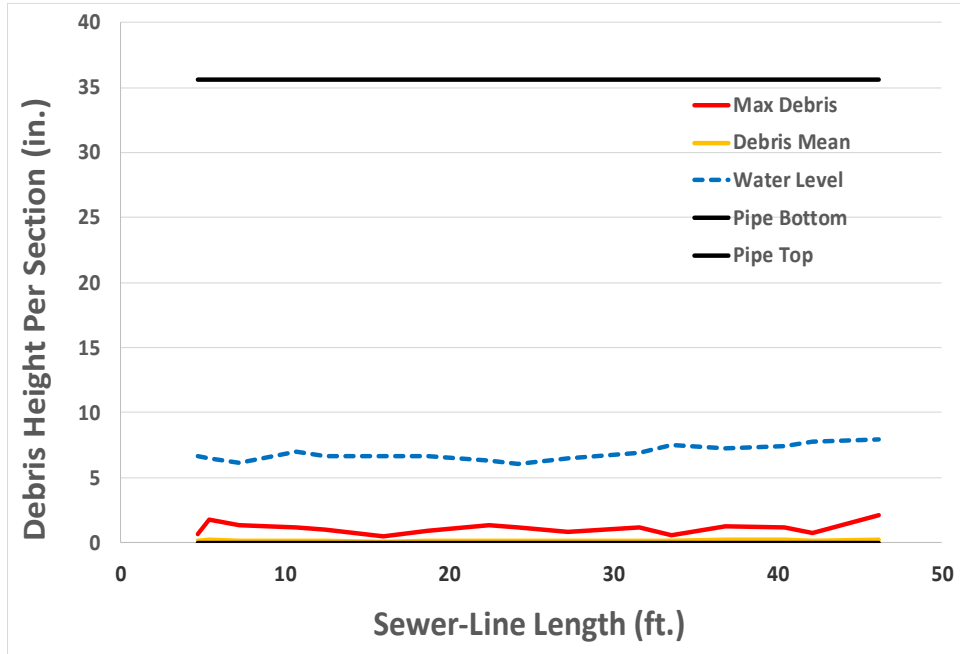
Figure A61-3 Debris height per cross-section

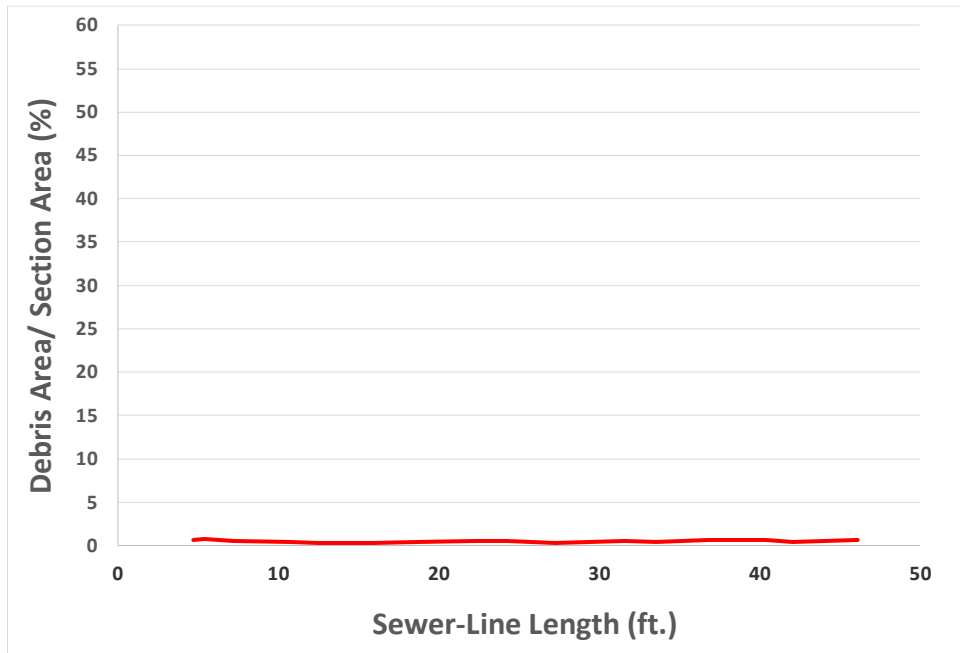
Figure A61-4 Debris area percentage of the pipe cross-sectional area

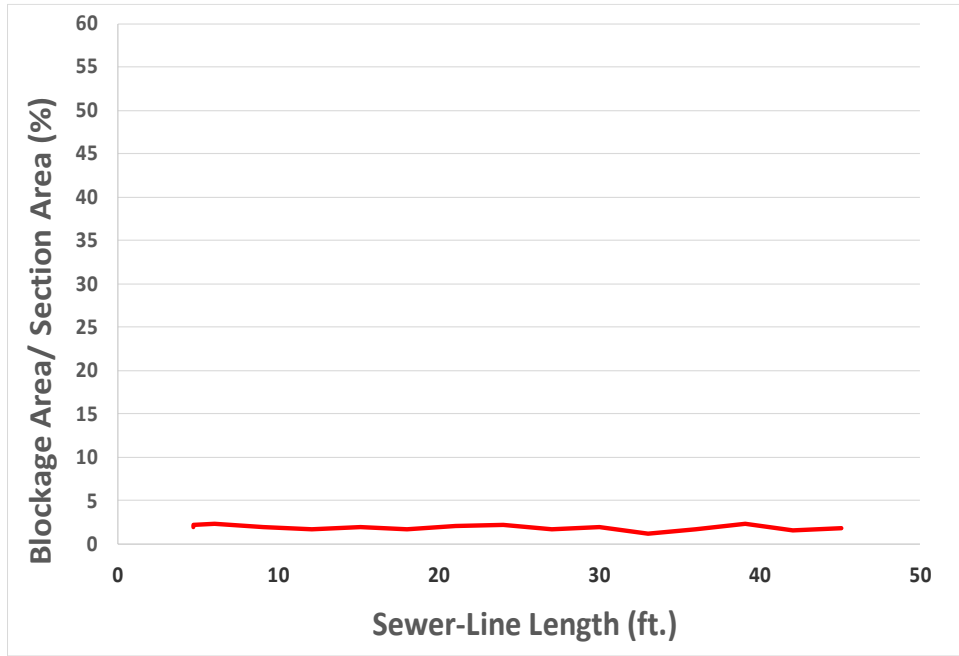
Figure A61-5 Blockage area (deposits and debris areas) percentage of pipe cross section area

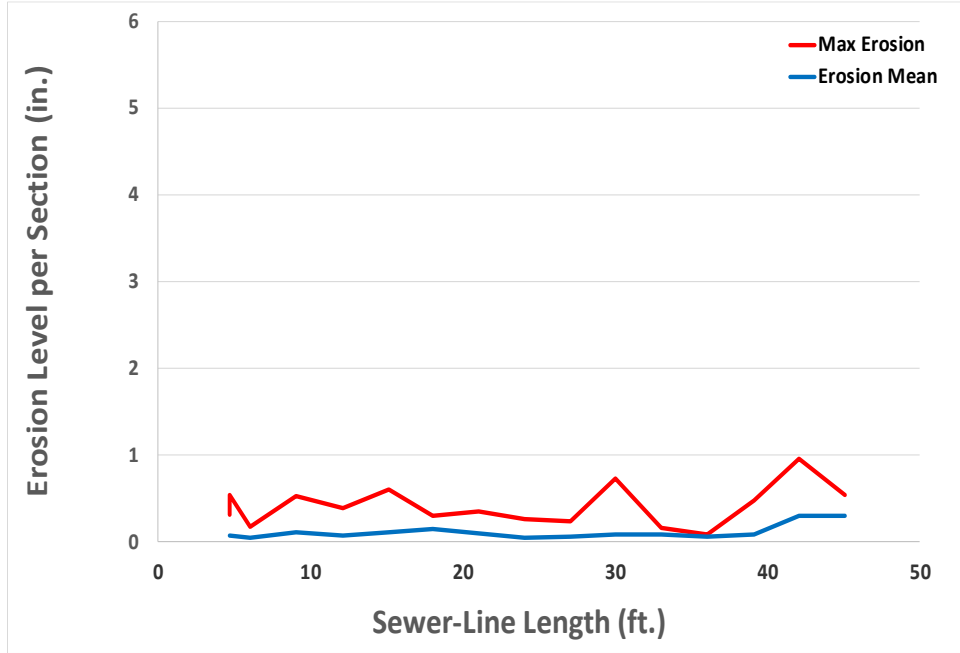
Figure A61-6 Erosion level per cross-section

Rank	Line ID	Observed Pipe Material	GIS Pipe Diameter (inches)	Observed Pipe Diameter (inches)	Approx. Max Erosion (Inches)	Approx. Mean Pipe Erosion (inches)
1	F15SL0346	RCP	36	35.6	0.9	0.1

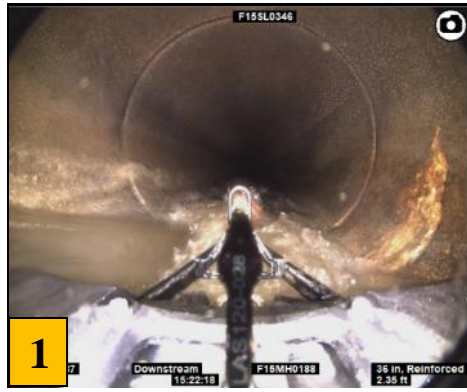
Figure A62-7 image1

SN	Distance (feet)	Video Ref.	Code	Continuous Defect	Value			Joint	Circumferential Location		Img Reference	Remarks
			Group/ Descriptor/ Modifier		Dimension		%		At/ From	To		
					1st	2nd						
1	0		AMH								NO MUCH DEFECTS	
2	0.5		MWL			10%						
3	2.35		DAG			<5%				1		
4	48.5		MSA
