ALGORITHM DEVELOPMENT FOR SEWER PIPE SYSTEM CONDITION
ASSESSMENT USING MULTI-SENSOR (MSI) TECHNOLOGY

ALGORITHM DEVELOPMENT FOR SEWER PIPE SYSTEM CONDITION ASSESSMENT USING MULTI-SENSOR (MSI) TECHNOLOGY

This study investigates the performance of all the current large-diameter pipeline system of The City of Arlington (COA) sewer lines of 48 miles (24-inch inner diameter and above for rigid and flexible pipes). Proper inspection and rehabilitation plan for the city sewer pipeline system are better choice for the municipality and tax payers in terms of cost than dealing with pipe damage and collapsing problems when they happen.

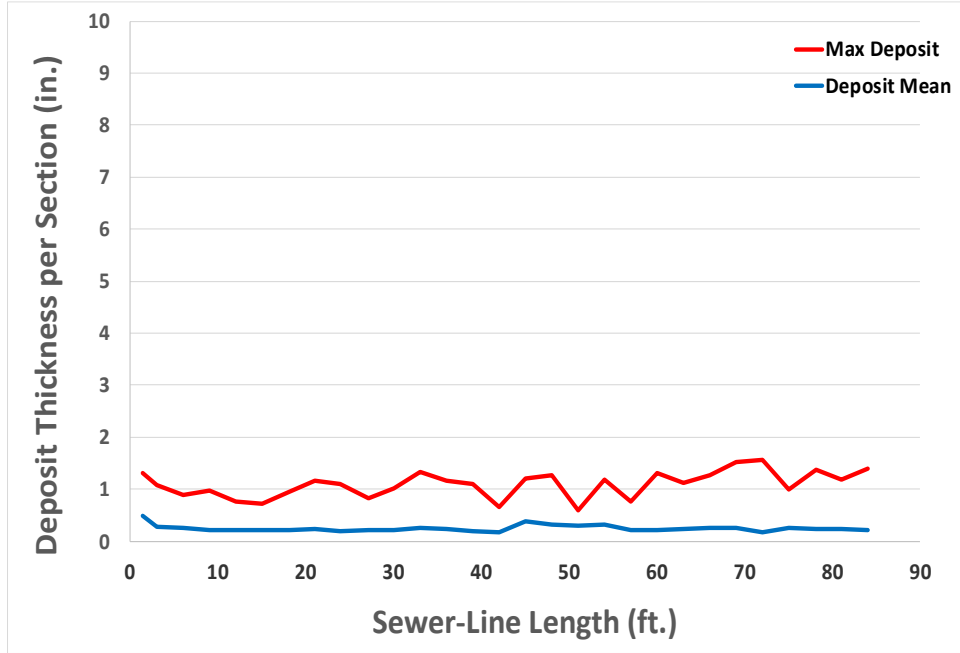
Figure A62-1 Deposit thickness per cross-section

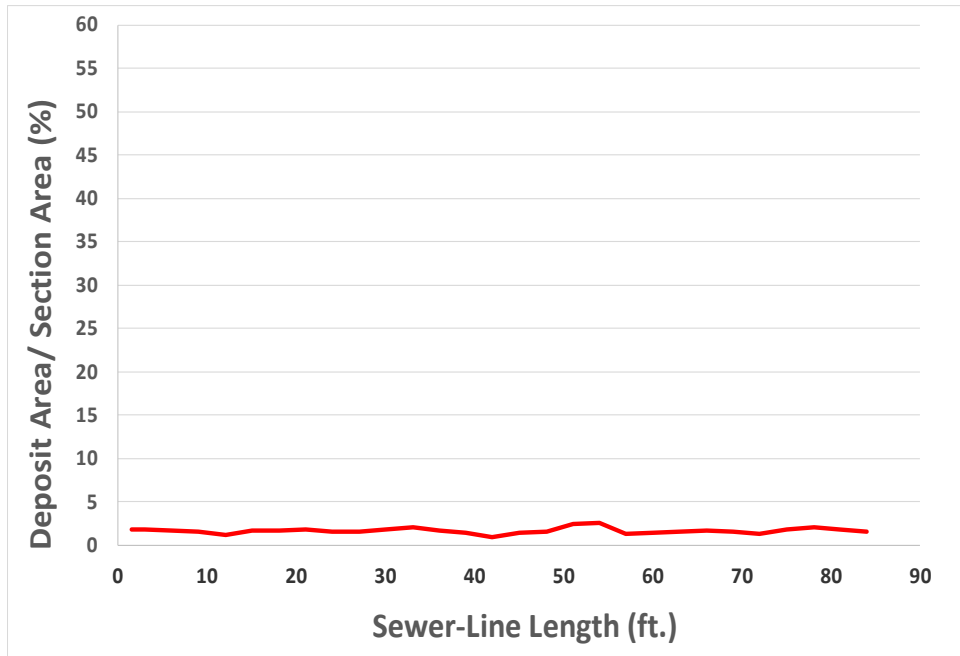
Figure A62-2 Deposit area percentage of the pipe cross section area

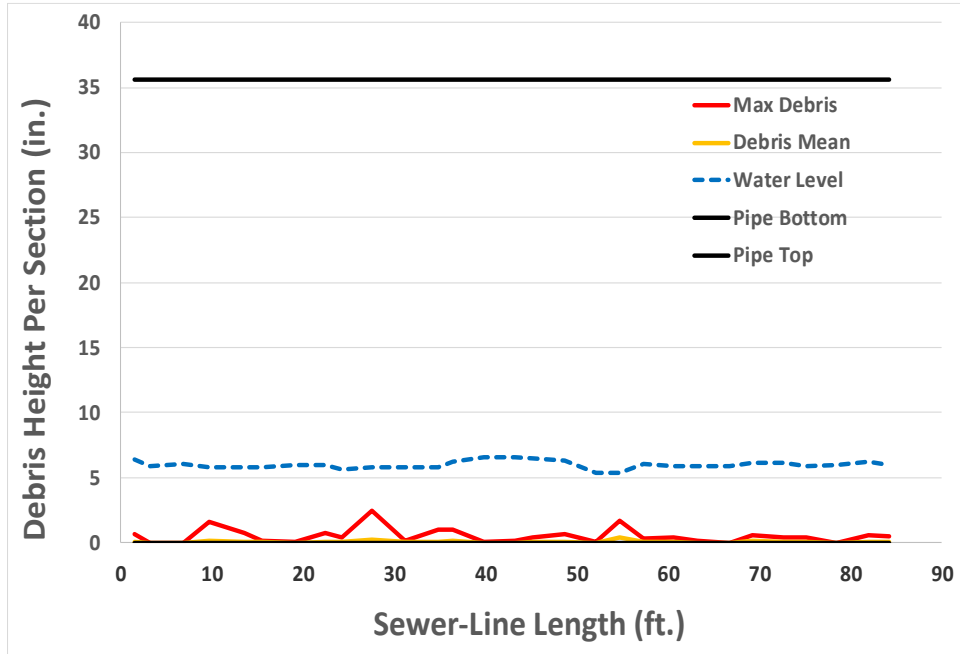
Figure A62-3 Debris height per cross-section

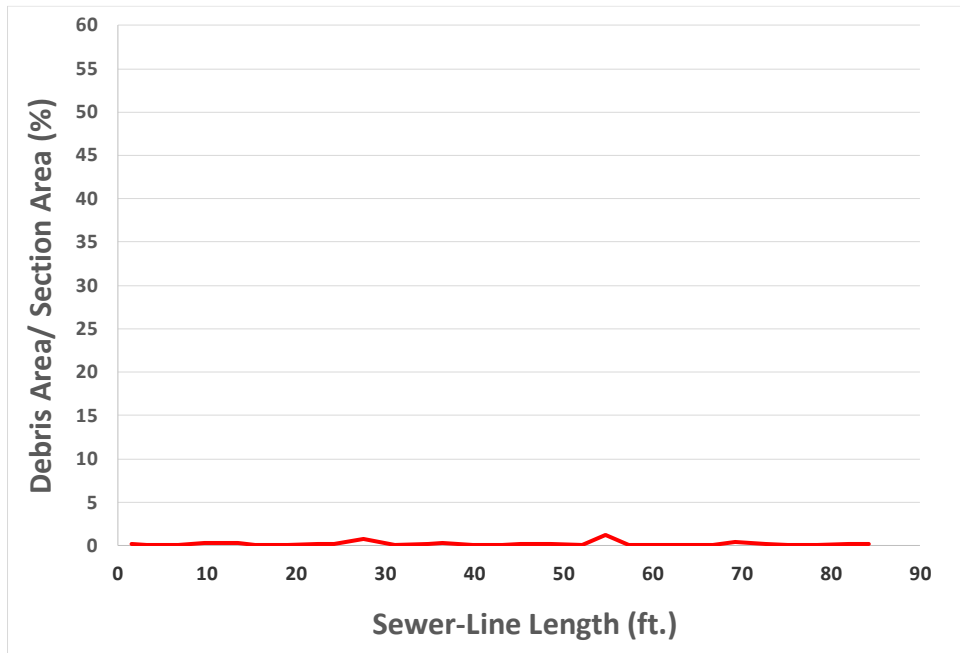
Figure A62-4 Debris area percentage of the pipe cross-sectional area

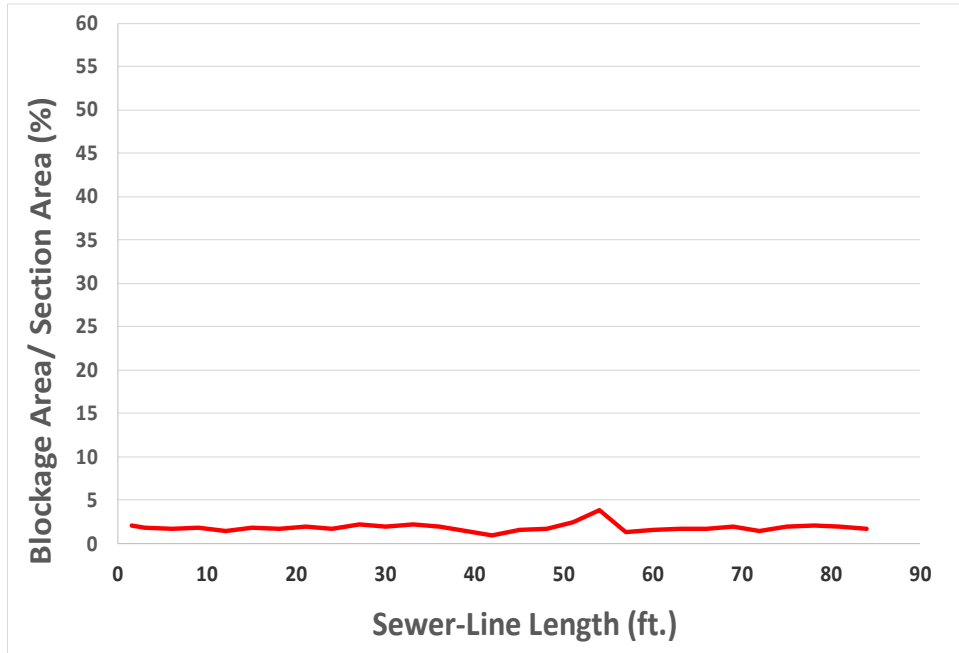
Figure A62-5 Blockage area (deposits and debris areas) percentage of pipe cross section area

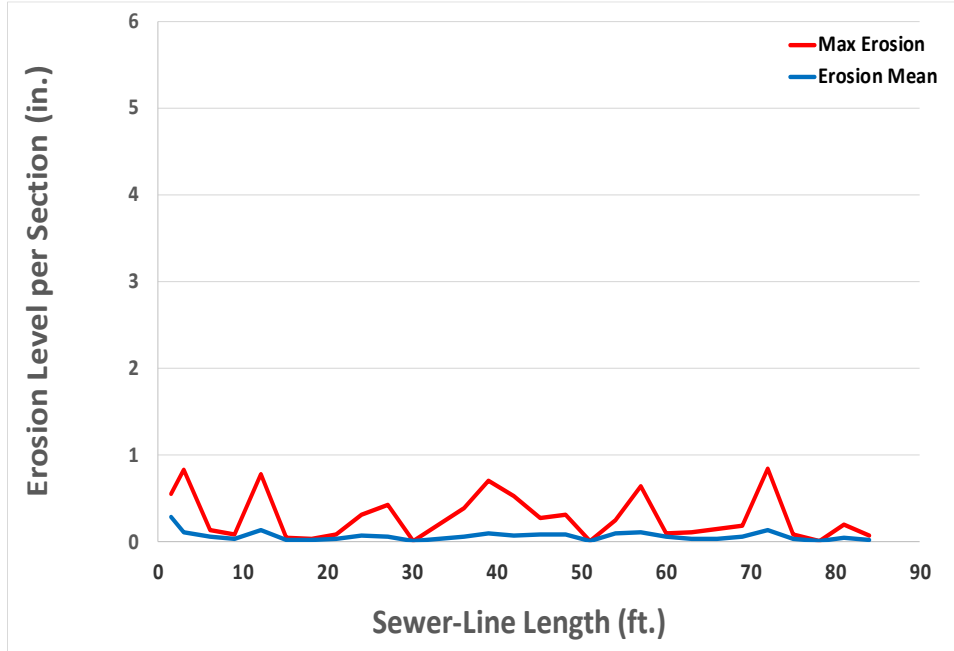
Figure A62-6 Erosion level per cross-section

Rank	Line ID	Observed Pipe Material	GIS Pipe Diameter (inches)	Observed Pipe Diameter (inches)	Approx. Max Erosion (Inches)	Approx. Mean Pipe Erosion (inches)
1	F15SL0146	RCP	33	32.5	0.6	0

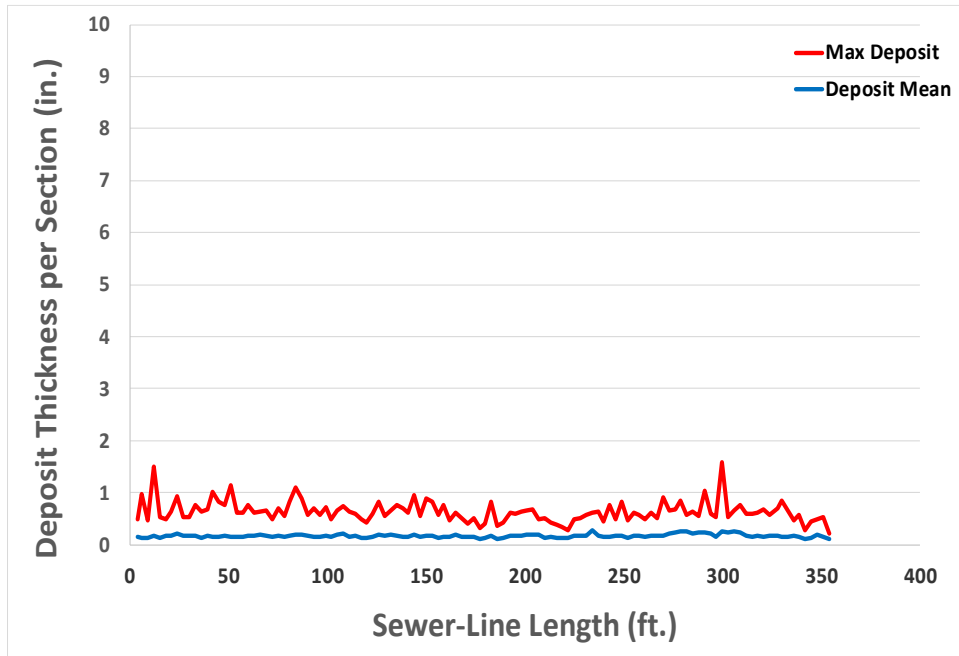
Figure A63-1 Deposit thickness per cross-section

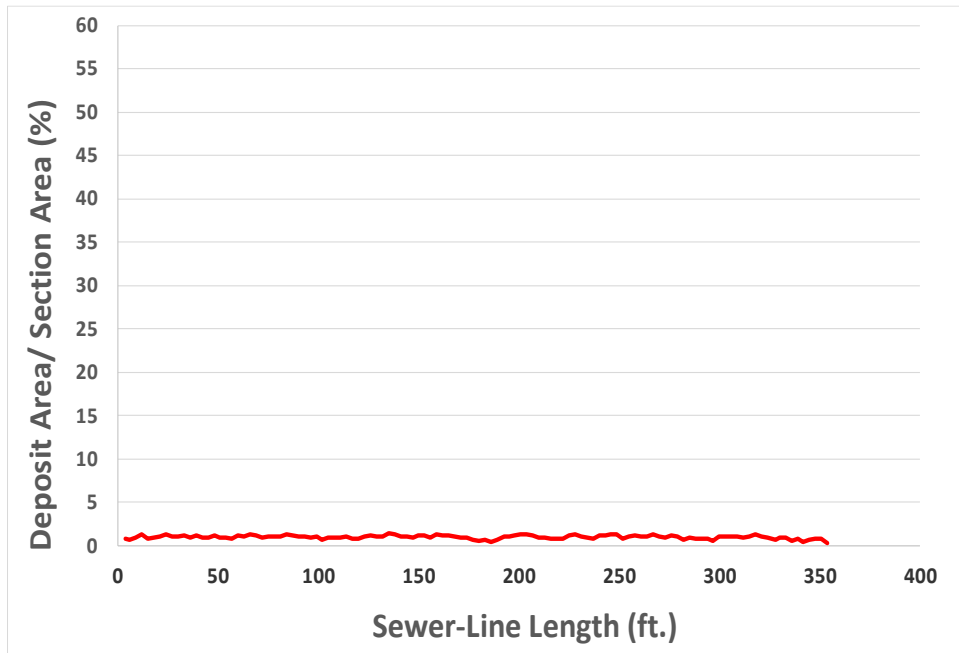
Figure A63-2 Deposit area percentage of the pipe cross section area

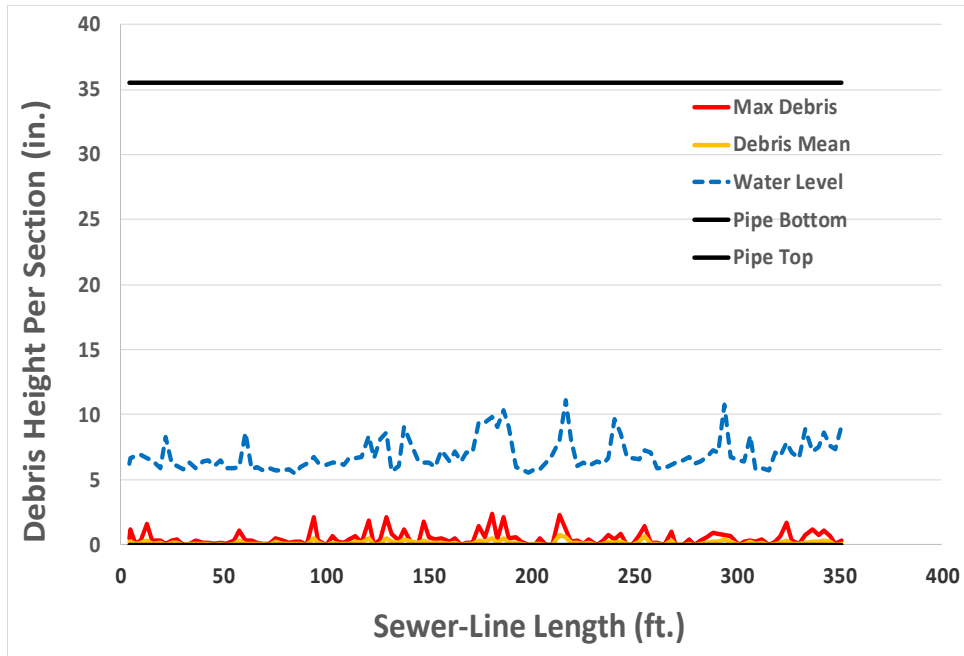
Figure A63-3 Debris height per cross-section

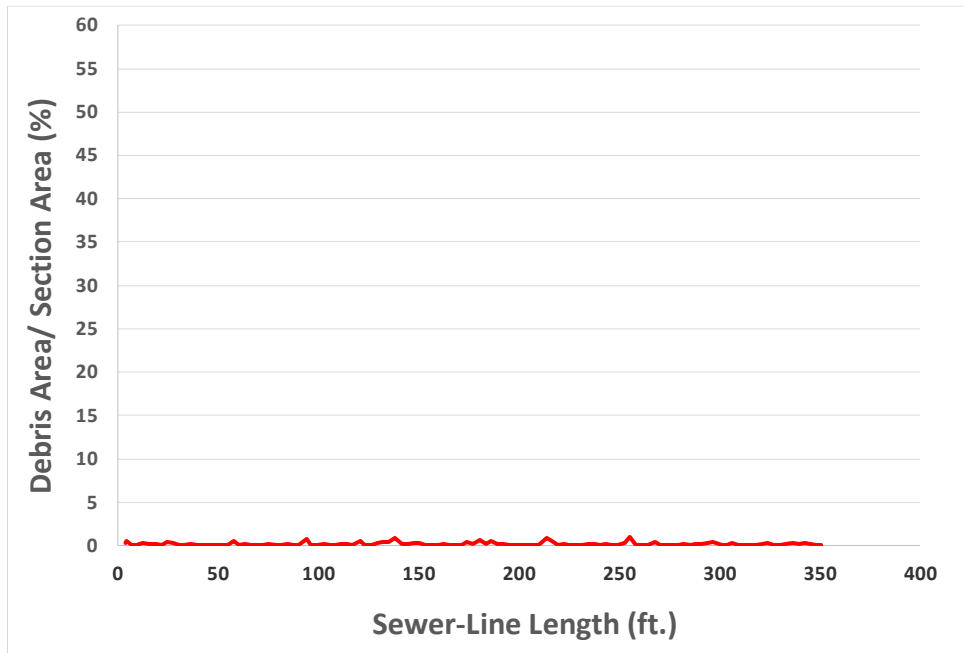
Figure A63-4 Debris area percentage of the pipe cross-sectional area

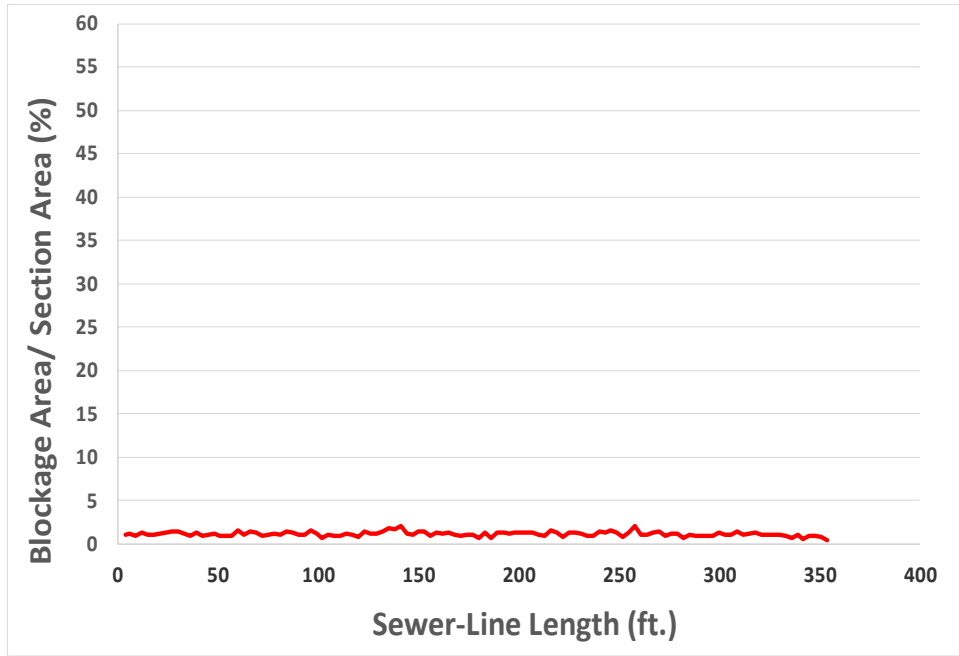
Figure A63-5 Blockage area (deposits and debris areas) percentage of pipe cross section area

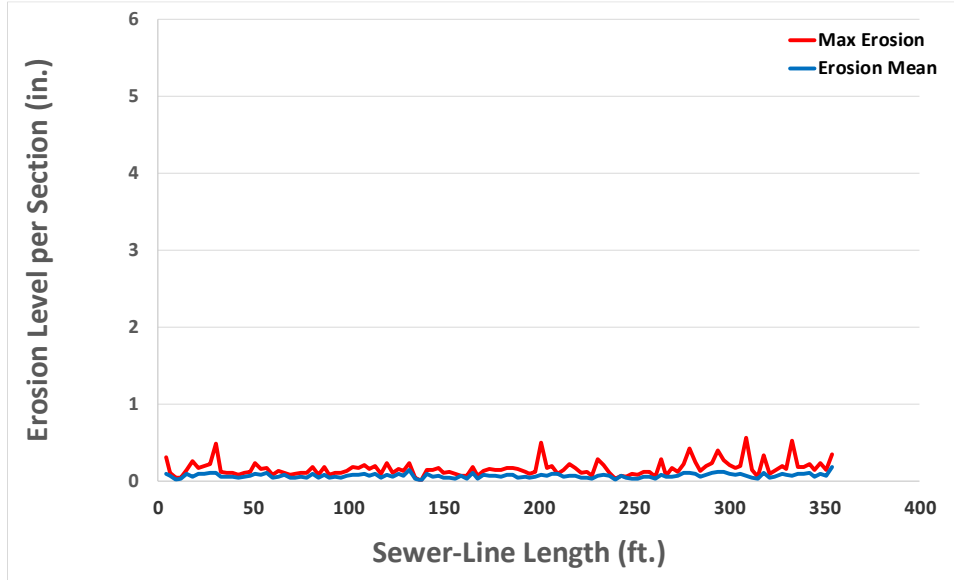
Figure A63-6 Erosion level per cross-section

Rank	Line ID	Observed Pipe Material	GIS Pipe Diameter (inches)	Observed Pipe Diameter (inches)	Approx. Max Erosion (Inches)	Approx. Mean Pipe Erosion (inches)
1	F15SL0146	RCP	33	32.5	0.6	0

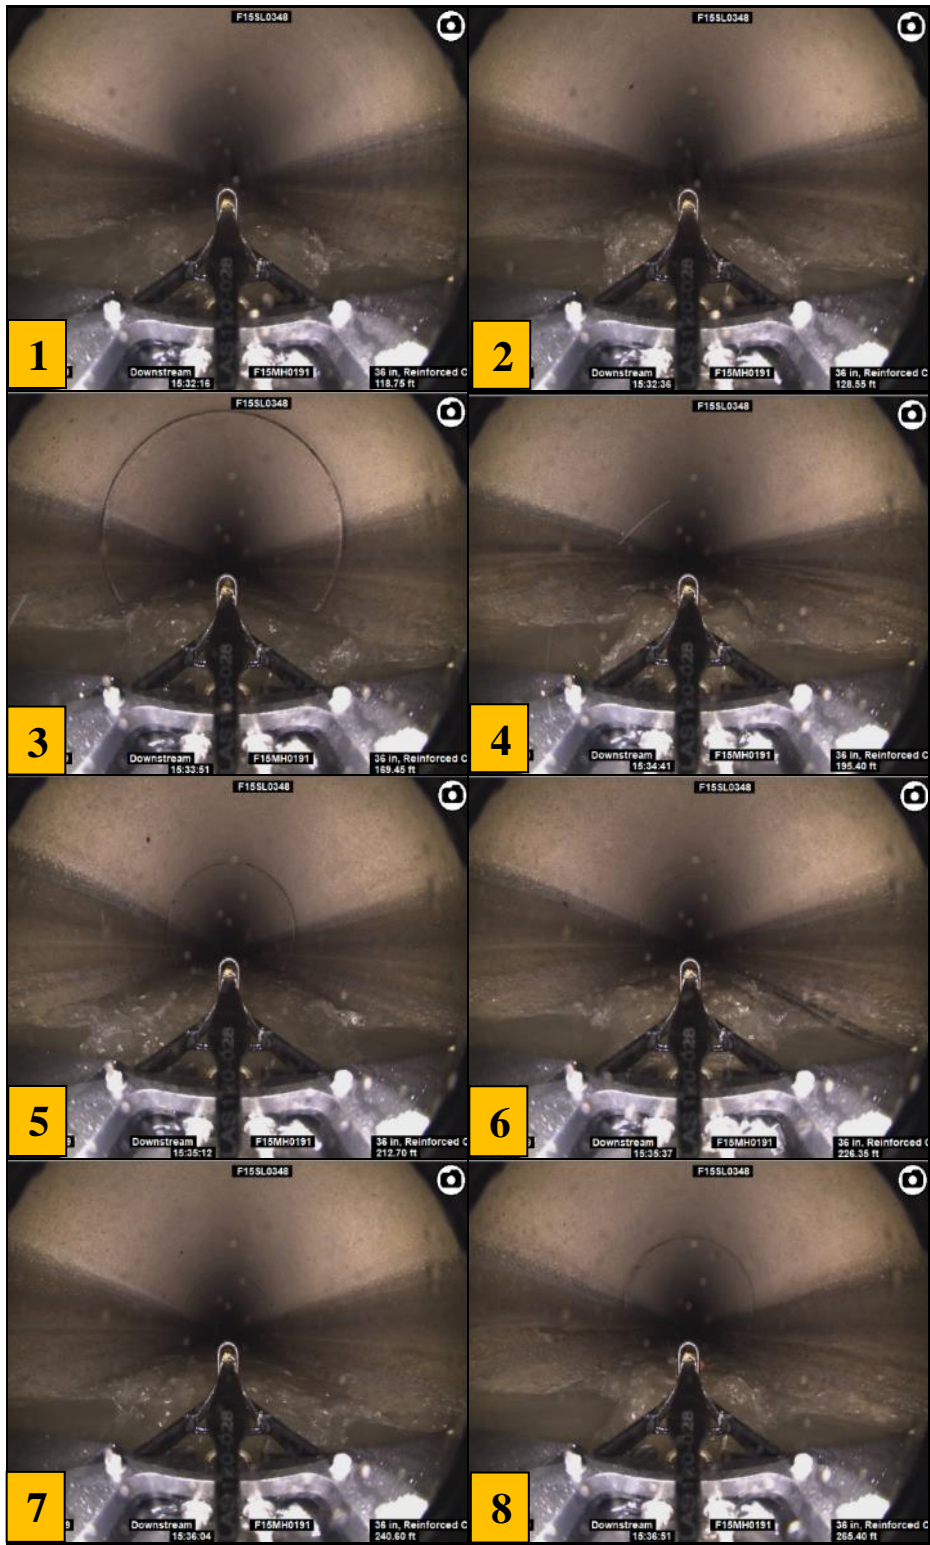
Figure A63-1 images from 1 through 8

SN	Distance (feet)	Video Ref.	Code Group/ Descriptor/ Modifier	Continuous Defect	Value			Joint	Circumferential Location		Img Reference	Remarks
					Dimension		%		At/ From	To		
					1st	2nd						
1	0		AMH									
2	2.5		MWL				5%					
3	118.75		MWL				10%				1	
4	128.55		MWL				5%				2	
5	169.45		MWL				10%				3	
6	195.4		MWL				5%				4	
7	212.7		MWL				10%				5	
8	226.35		MWL				5%				6	
9	240.6		MWL				10%				7	
10	265.4		MWL				5%				8	
11	287.85		MWL				10%				9	
12	311.75		MWL				5%				10	
13	321.25		MWL				10%				11	
14	356.3		MSA
