LONG TERM PERFORMANCE MONITORING OF SHALLOW SLOPE STABILIZATION
UTILIZING RECYCLED PLASTIC PINS

MASTER OF SCIENCE IN CIVIL ENGINEERING

THE UNIVERSITY OF TEXAS AT ARLINGTON

May 2019

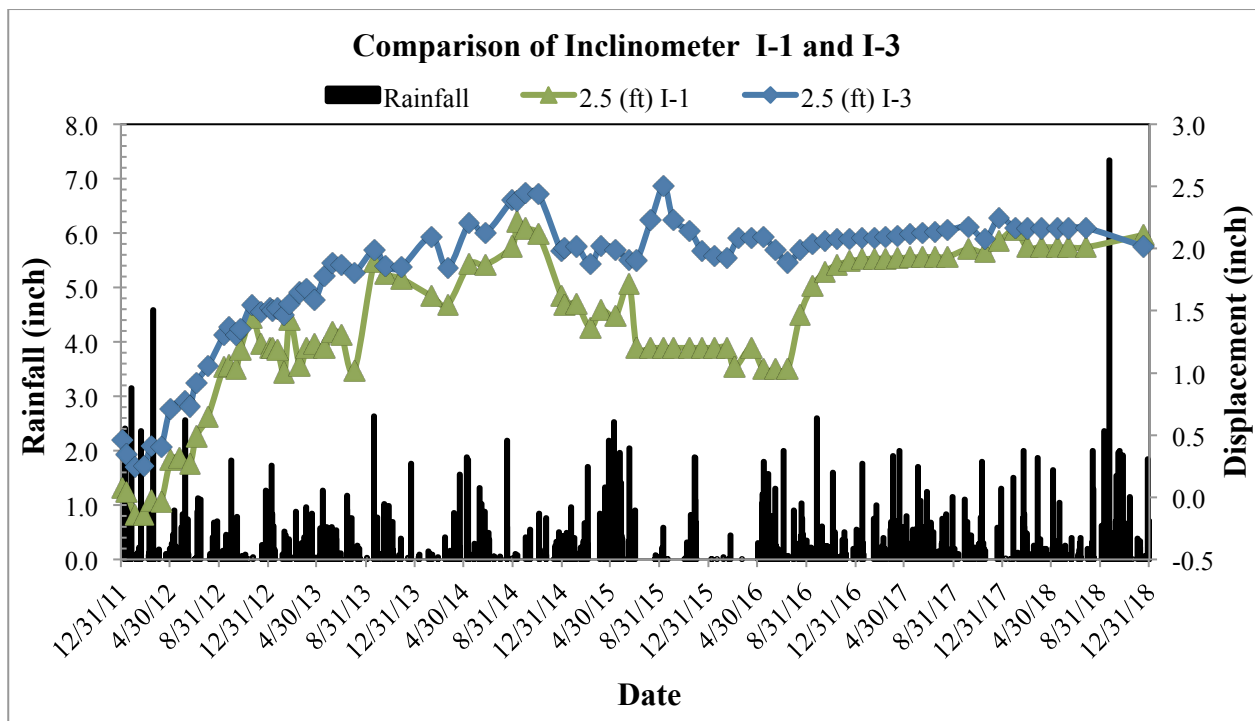
The top 2.5 ft. readings were taken from Inclinometer I-1 and I-3 in order to compare the results with rainfall, shown in Figure 4-8. Based on the results, it can be observed that Inclinometer I-1 typically performed better. Throughout the measurements for the two inclinometers, it can be observed that Inclinometer I-1 generally displayed a displacement value of approximately 0.25 to 0.5 in. less in comparison to Inclinometer I-3. It should be noted that Inclinometer I-1 was installed in Reinforced Section 1 with a RPP spacing of 3 ft. c/c, while Inclinometer I-3 was installed in Reinforced Section 2 with an RPP spacing of 4 ft. c/c. Therefore, it is possible that the closer spacing is what can be attributed to the success of Inclinometer I-1 in comparison to Inclinometer I-3.

Figure 4- 8 Comparison at 2.5 ft. depth of Inclinometers I-1 and I-3 at US-287 slope

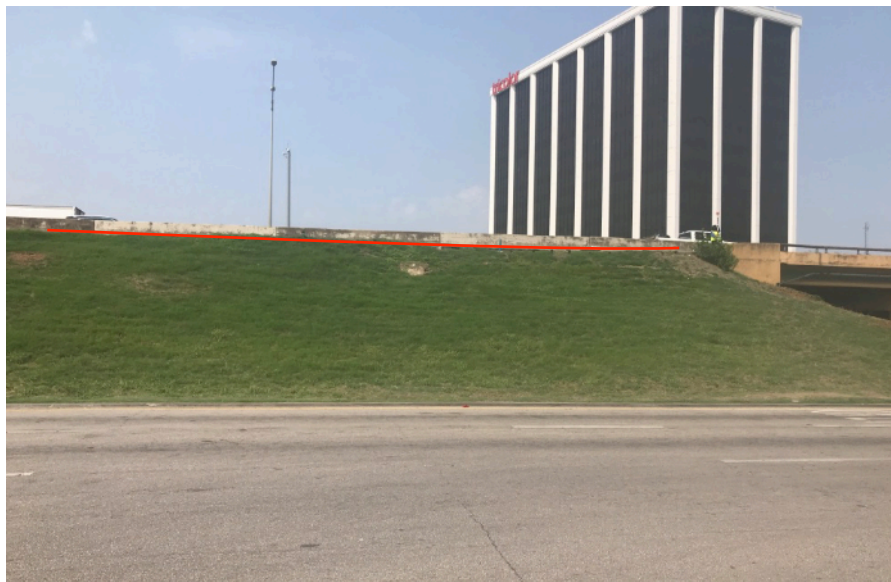
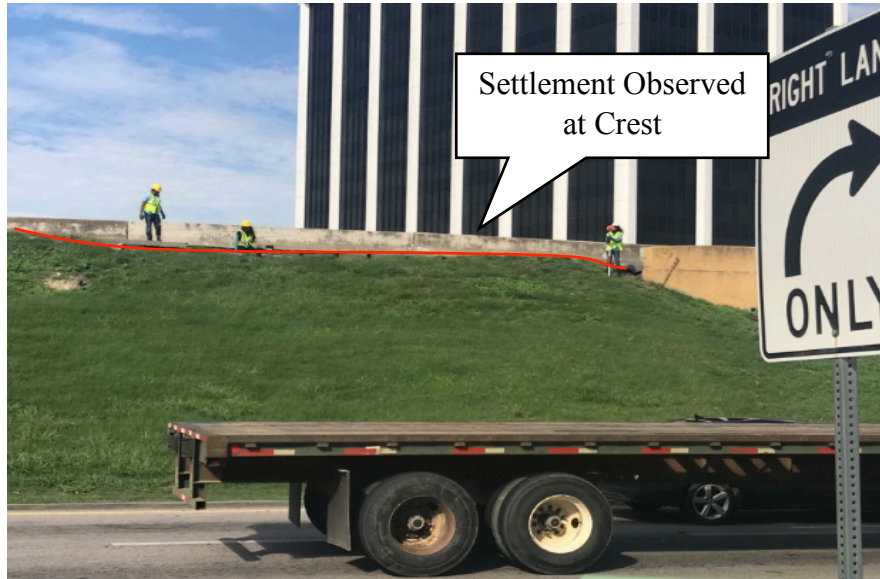
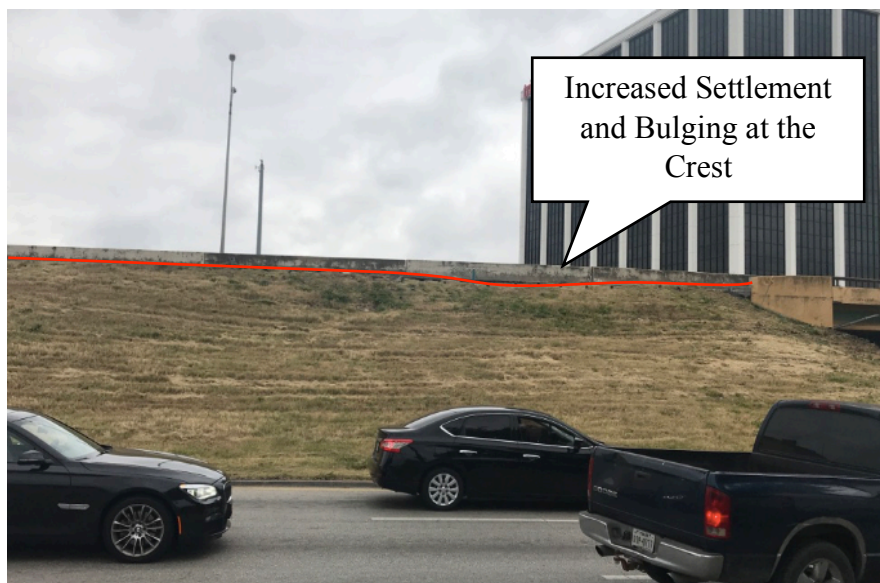
Based on Figure 4-9, the maximum total settlement experienced by the reinforced section of the slope does not exceed 2.65 in. over the 5-year span. Despite October 2018 displaying a trend with incremental settlement from the previous month approaching 0.75 in. at certain locations, it could potentially be related to human error in the input of the height of the total station used. While the maximum settlement experienced each year is around 0.5 in., after prolonged rainfall in the Fall 2018, the egregious crack that was left unsealed further expanded and began to shift. Figure 4-10(a) through (c) displays the settlement and bulging of the slope in particular locations from August 2018 to November 2018.

Figure 4- 10 Gradual settlement experienced at the crest (a) August 2018, (b) September 2018 and (c) November 2018

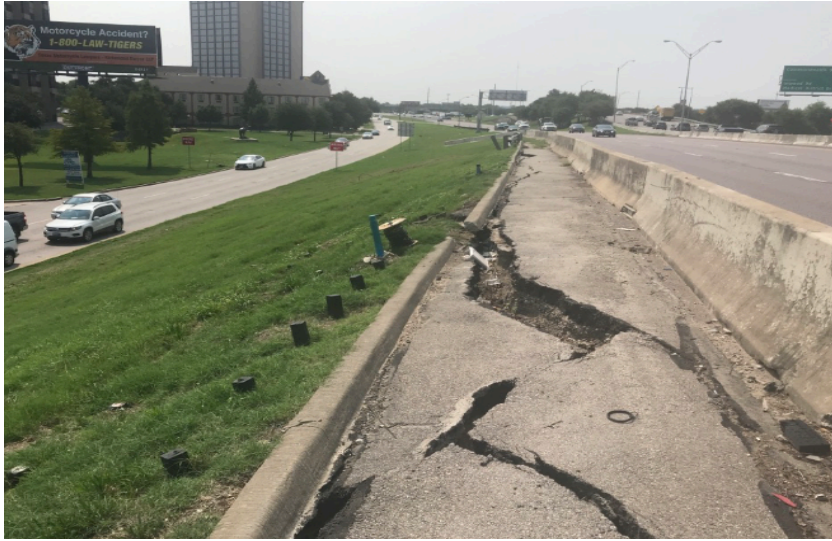
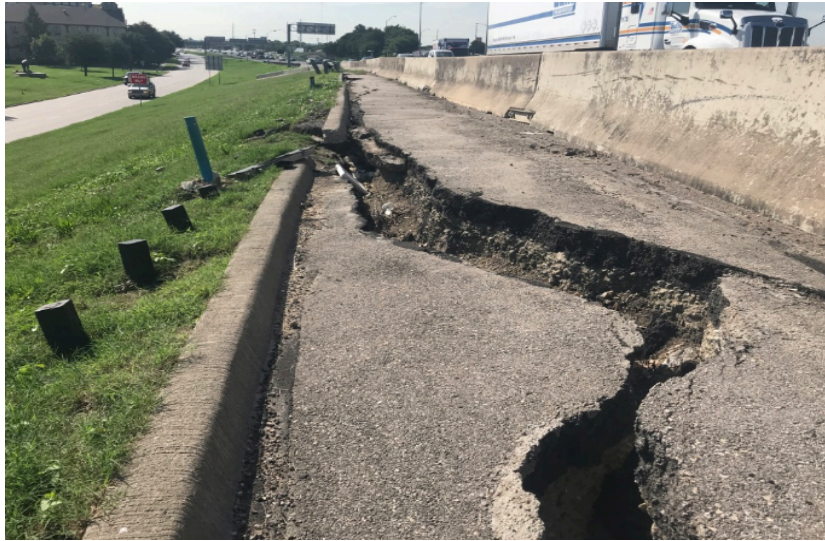
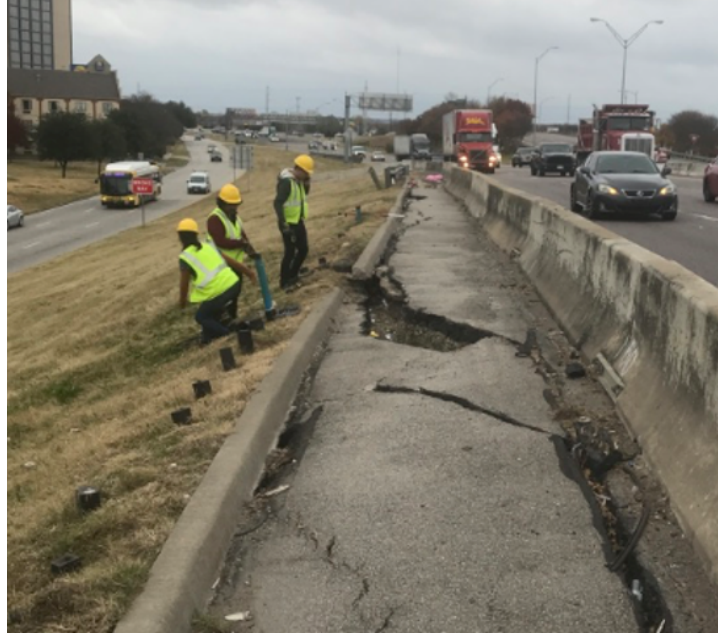
Figure 4- 11 Settlement of shoulder in successive months (a) August 2018, (b) September 2018 and (c) November 2018

The crack that was observed from the beginning of installment of the RPP at the I-35 slope experienced both an increase in width and depth with multiple wetting and drying cycles. In reference to the time frame depicted in Figures 4-11(a) through (c), the Dallas area experienced two distinct rainfall events in which the precipitation was in excess of 13 in. For the months of September and October 2018, the rainfall experienced in the Dallas area was 15.30 in. and 13.39 in., respectively. The recent influx of heavy rainfall, seen in the increase of yearly precipitation in 2018 as compared to previous years in Table 4-4, as well as the degradation of the shoulder crack itself could be linked with the steady increase in settlement measured. With the increase in crack depth and width on the shoulder, it is possible that the amount of runoff that would be experienced on the slope has decreased, with the precipitation infiltrating into the slope by means of the crack acting as a conduit. The potential increase of water in the slope can reduce the shear strength of the soil, causing an increase in the settlement experienced over time.

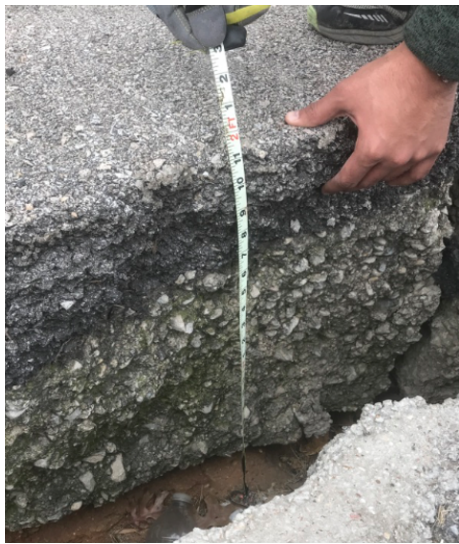
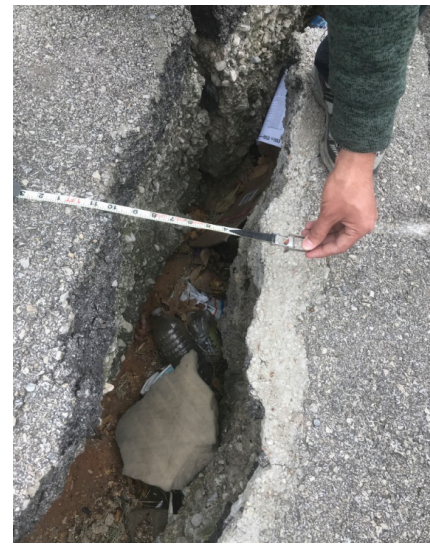
The location of the crack on the shoulder, where the highest settlement was experienced on the slope, is local to the removal of where a drilled shaft was previously located. While more pins were added once removed, voids could have been created leading to increased settlement as well as slight bulging on the slope from continual water infiltration. A depth of nearly 2 ft., reaching the subgrade, expresses the extent of the crack condition and a width of nearly 1 ft. as can be seen in Figure 4-12(a) and (b).

Figure 4- 12 Characteristics of crack on shoulder of I-35 (a) crack 2 ft. depth and (b) crack 1 ft. length

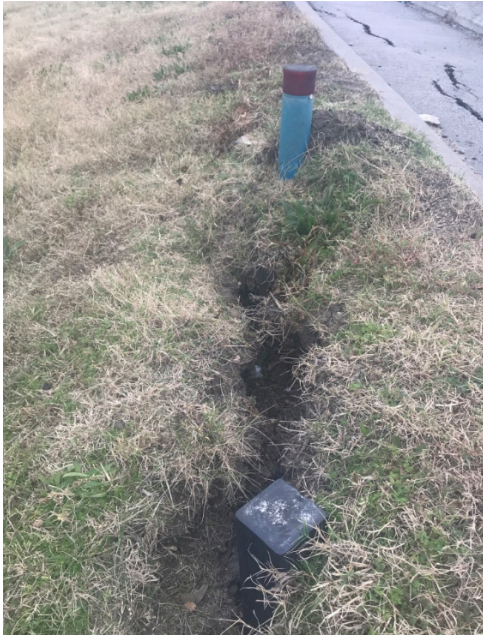
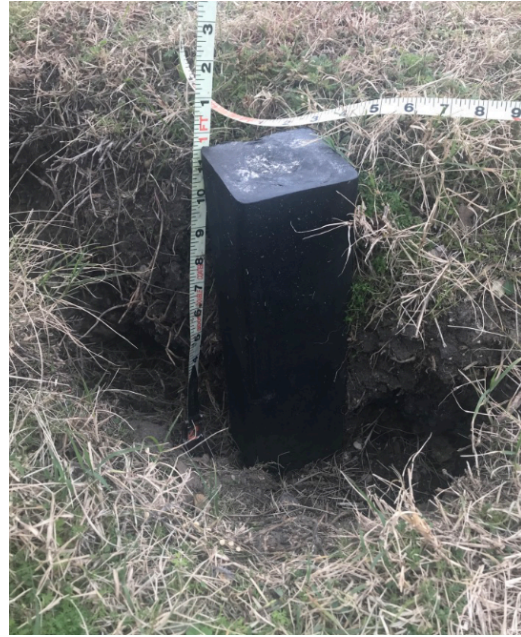
At the location of Inclinometer 2, the soil around local RPP had begun to separate. With loss of soil contact nearly at a foot, the pins are still offering enough resistance against sliding to keep the slope intact. Figure 4-13 shows the condition of the pins relative to Inclinometer 2.

Figure 4- 13 Condition of slope on I-35 displaying (a) loss of contact between RPP, inclinometer and soil and (b) 1 ft. loss of contact soil on RPP

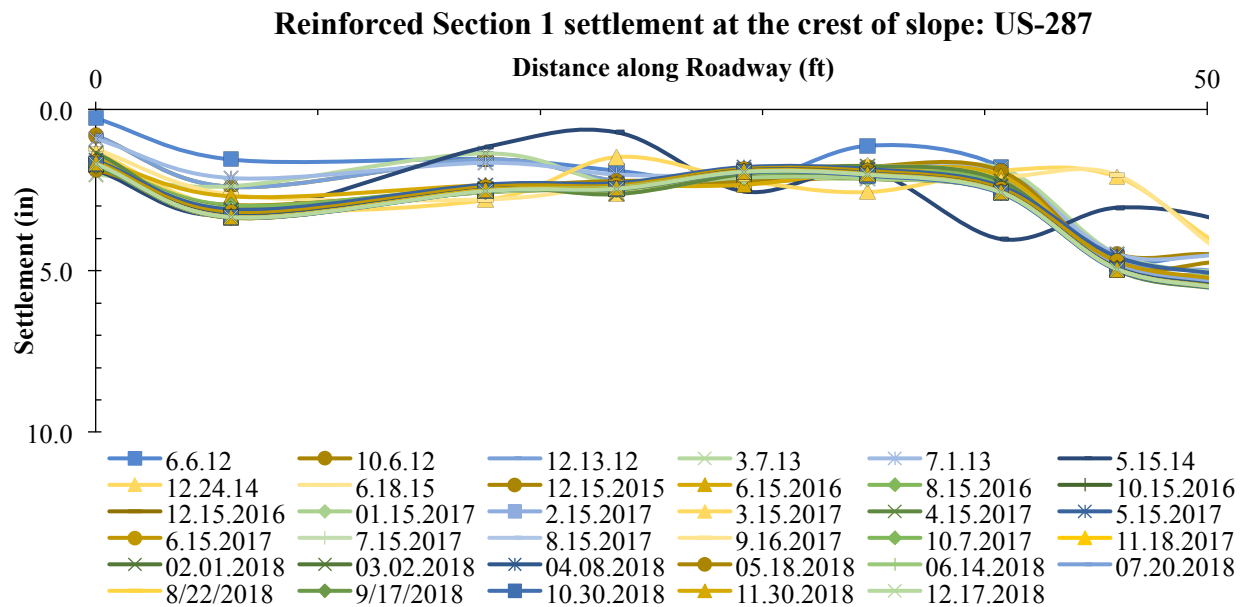
Beginning with Reinforced Section 1, Figure 5-1 displays a larger maximum settlement plot than previously displayed in the performance monitoring section. Approximately 50 ft. in length, Reinforced Section 1 was designed with various combinations of RPP lengths and spacing's. At the crest, however, 10 ft. long RPP were utilized at 3 ft. c/c spacing for the top third of the slope. It should be noted that for Reinforced Section 1, the shoulder cracks observed were not as severe as those present further along the roadway.

Figure 5- 1 Settlement along the crest of US-287 for Reinforced Section 1 (Distance along roadway from 0 ft. - 50 ft.)

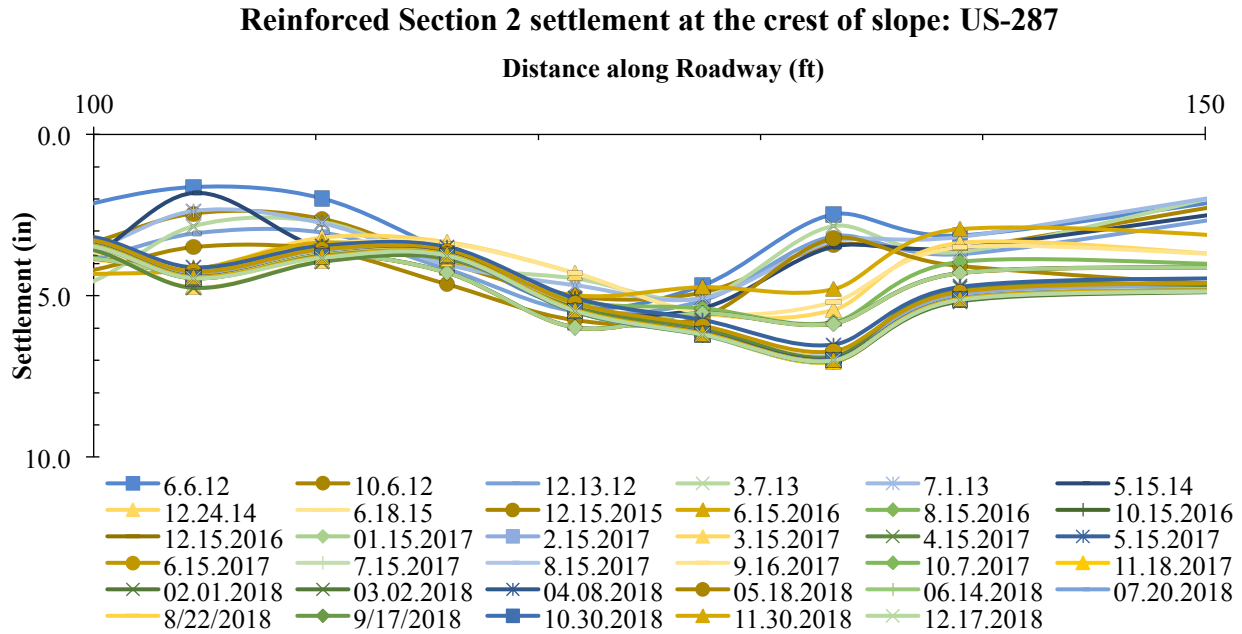
Proceeding to Reinforced Section 2, Figure 5-2 presents the larger settlement plot from the performance monitoring section. Similar to Reinforced Section 1, Reinforced Section 2 was approximately 50 ft. in length. In contrast, however, Reinforced Section 2 possessed a simpler design scheme for the slope section, utilizing only two varying lengths at a constant spacing throughout. At the crest of the slope, 10 ft. long RPP were installed at 4 ft. c/c spacing for the top third of the slope. The shoulder cracking observed at the second reinforced section exhibited cracks far more extensive than those of the first reinforced section.

Figure 5- 2 Settlement along the crest of US-287 for Reinforced Section 2 (Distance along roadway from 100 ft. – 150 ft.)

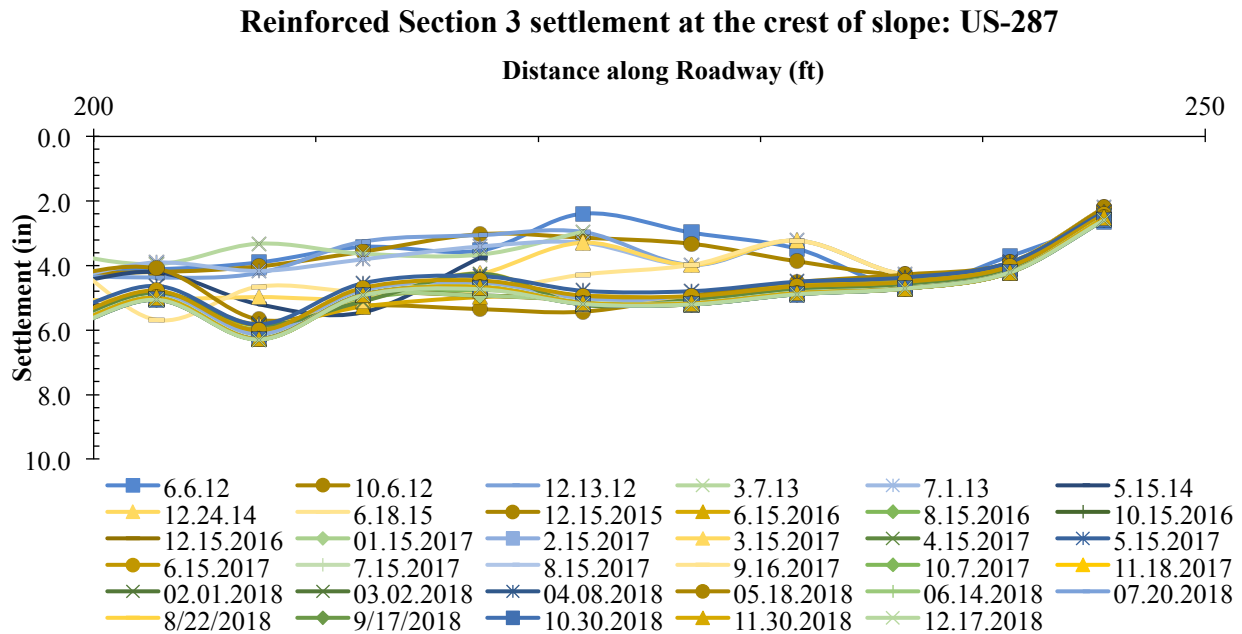
Lastly, Reinforce Section 3 is presented in Figure 5-3. Still approximately 50 ft. in length as both Reinforced Section 1 and 2, Reinforced Section 3 contains a relatively constant reinforcement pattern, utilizing 10 ft. RPP at 4 ft. c/c spacing. At the crest, however, the top two lines of reinforcement are 10 ft. RPP at 3 ft. c/c spacing. The cracks that are observed at the crest of the slope in the third reinforcement location are similar those present in Reinforced Section 2.

Figure 5- 3 Settlement along the crest of US-287 for Reinforced Section 3 (Distance along roadway from 200 ft. – 250 ft.)

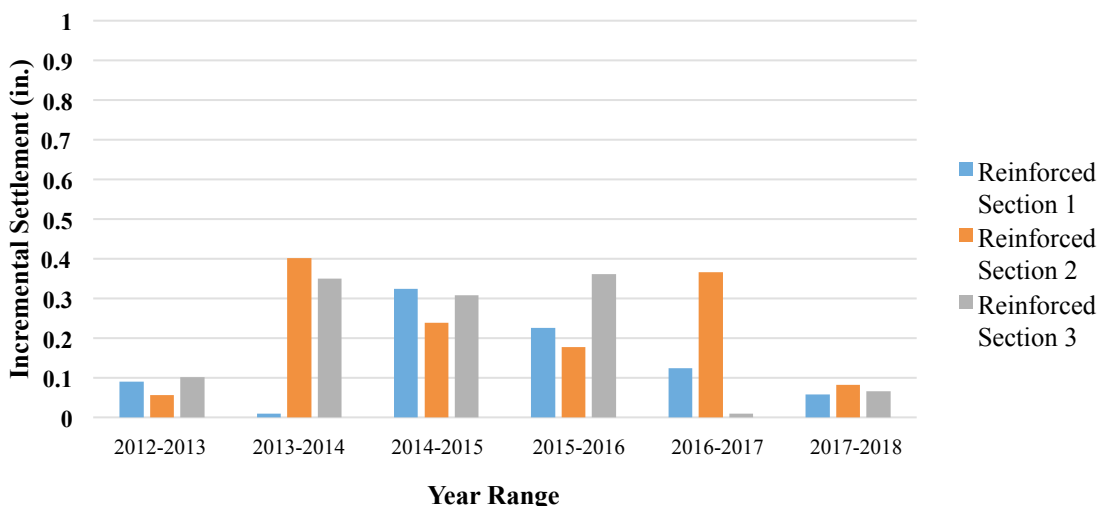
Figure 5- 4 Incremental settlement between reinforced sections of US-287

From both Figure 5-4 and Table 5-1, it can be observed that the incremental settlement experienced in the three sections has generally shown a decrease. While each reinforced section experienced a fluctuation in the general trend, the overall settlement experienced for each of the three sections was not in excess of 2 in. on average for a time span of 7 years of monitoring. Similar to the comparison of the maximum settlements recorded, the order in which the reinforced sections experienced the lowest total incremental settlement was Reinforced Section 1 (0.83 in.), Reinforced Section 3 (1.20 in.) and lastly Reinforced Section 2 (1.33 in.), respectively.

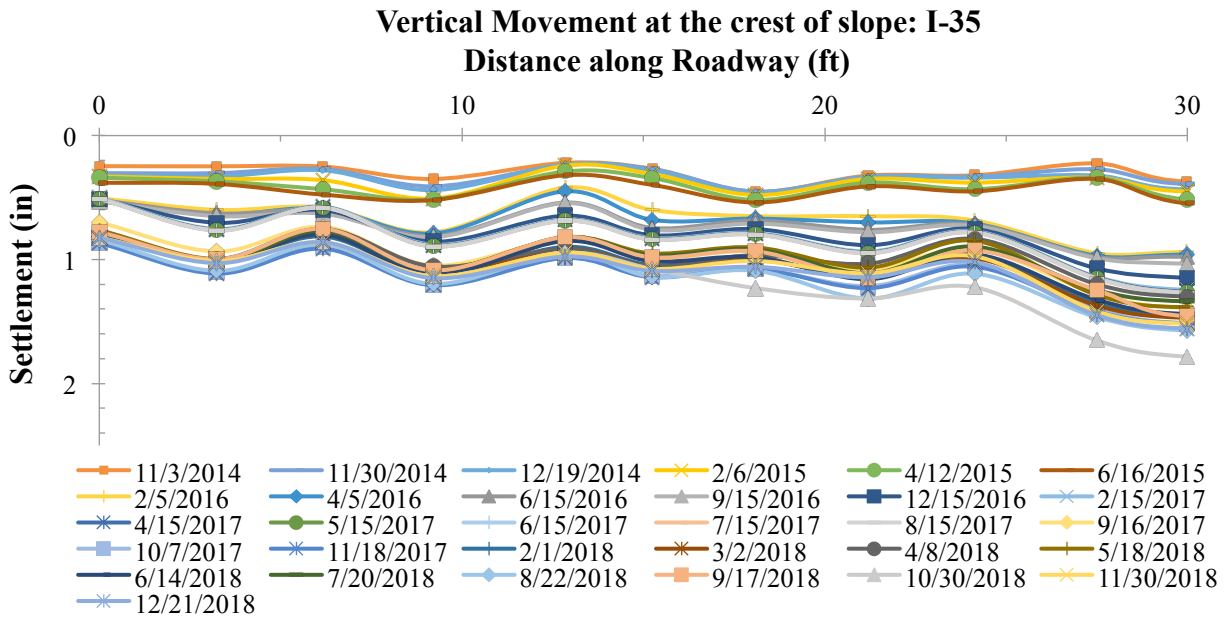
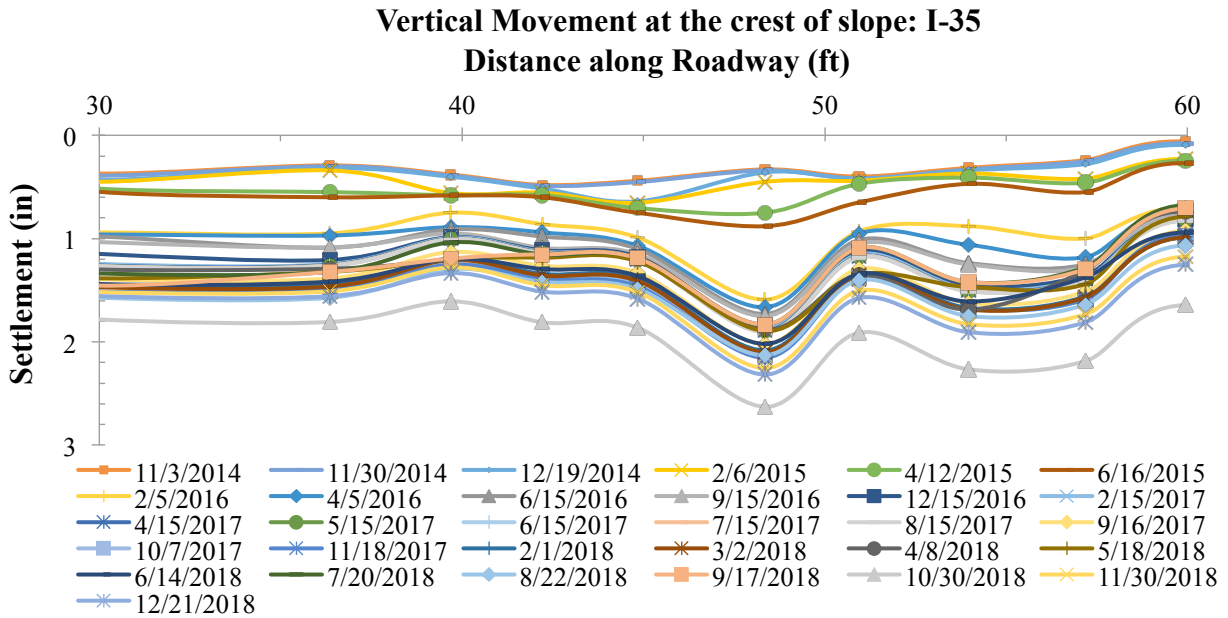
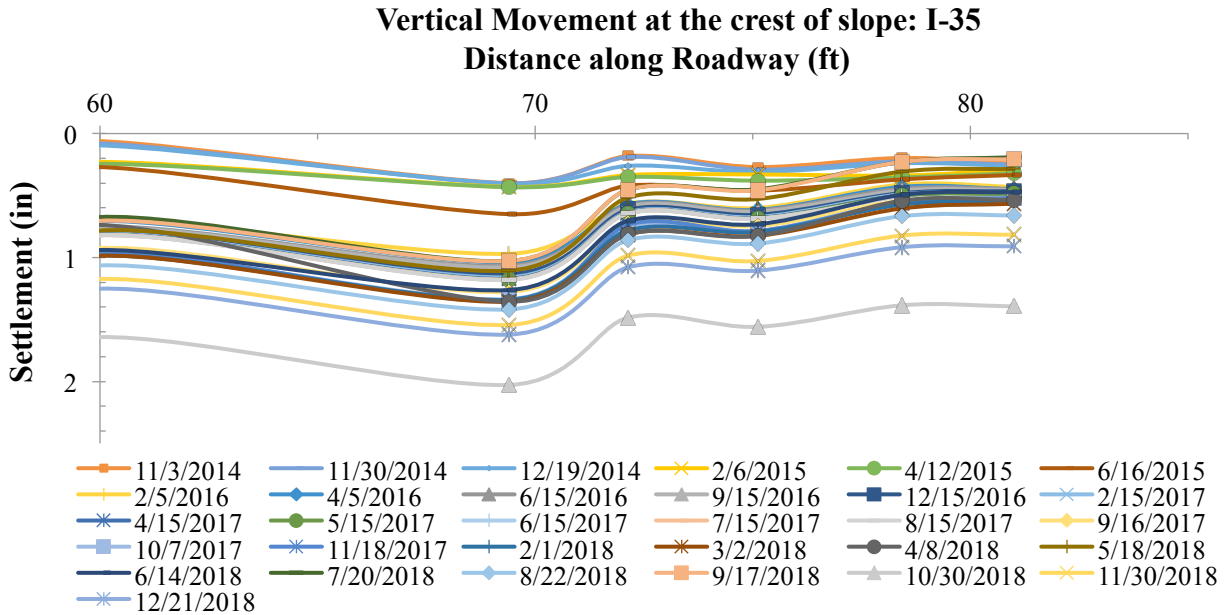
While the I-35 slope was composed of a single reinforcement scheme, it is possible to analyze the slope into three sections also. Broken into sections denoted S1, S2 and S3, Figure 5-6 displays the distance along the roadway associated with each taken section. S1 is the section closest to the bridge abutment, spanning 0 ft. to 30 ft. along the I-35 highway. This section possesses cracks along the shoulder approximately 1 in. in width for the 30 ft. section, with larger cracks becoming prevalent nearing section S2. S2 was denoted as the section 30 ft. to 60 ft. along the roadway and is local to the removal of a drilled shaft in the slope. As previously mentioned, the removal of the drilled shaft potentially could have led to the development of voids in the slope causing additional settlement, this settlement was observed on the crest as the cracks that had previously been present were exacerbated, widening and deepening further into the slope. S3 is the section of the slope furthest from the bridge abutment, spanning a length along the roadway of 60 ft. to approximately 80 ft. For section S3, similar to S1, cracks were prevalent however only approximately 1 in. to 2 in. in width. Figures 5-5 through 5-7 present the three sections individually.

Figure 5- 5 Settlement at crest for I-35 slope Section S1

Figure 5- 6 Settlement at crest for I-35 slope Section S2

Figure 5- 7 Settlement at crest for I-35 slope Section S3

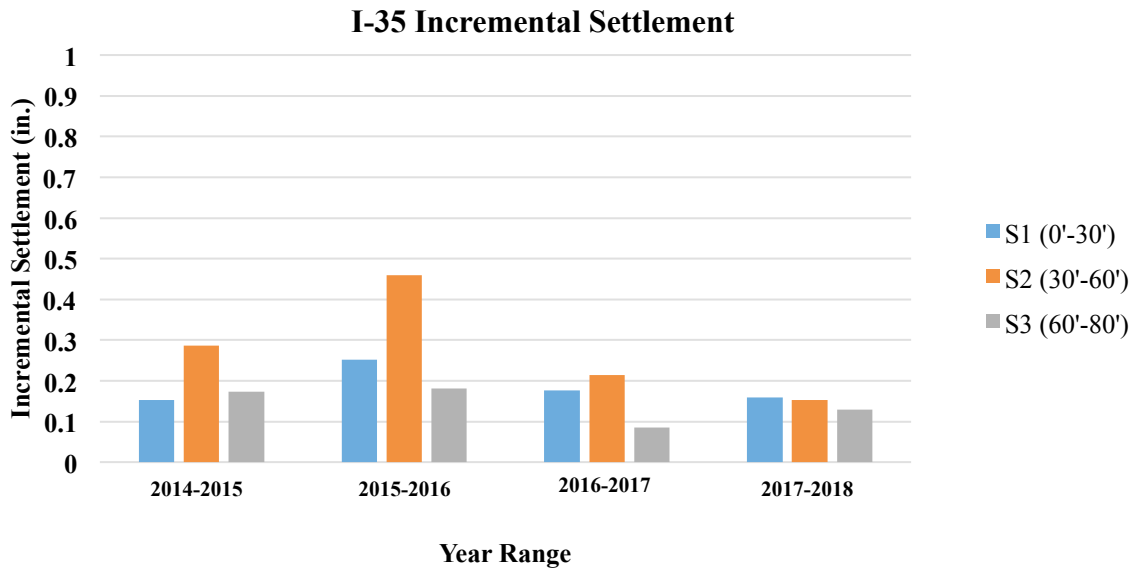
All three of the sections possess a crest reinforcement spacing of 3 ft. c/c, however it is the influence of the crack that is the purpose of the section breaks. Presented in Figure 5-8, Sections S1 and S3 performed similarly in contrast with Section S2. Both Section S1 and S2 contain cracks on the shoulder of the highway, however they are not to the extent of Section S2. From Figure 5-6, the crack can be observed in the total settlement plot occurring approximately around the 45 ft. to 50 ft. length along the roadway section. The removal of a drilled post during the 2015-2016 year transition affected the slopes performance within the section due to the potential voids created after its removal. While the section was reinforced, the potential void and rainwater infiltration could be linked with the cracks worsening. Table 5-6 presents the impact of the removal of the drilled post on the incremental settlement of the reinforced section. The average incremental settlements for sections S1, S2 and S3 are 0.19 in., 0.28 in., and 0.15 in., respectively.

Figure 5- 8 I-35 Incremental settlement

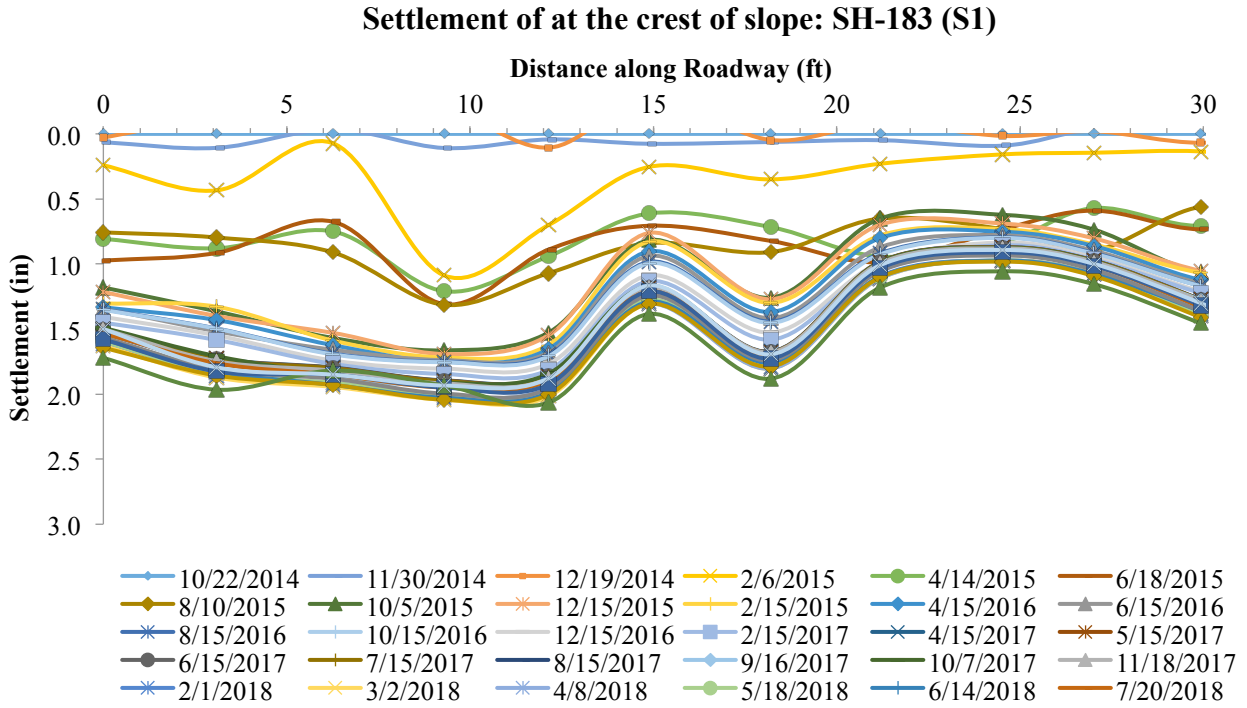
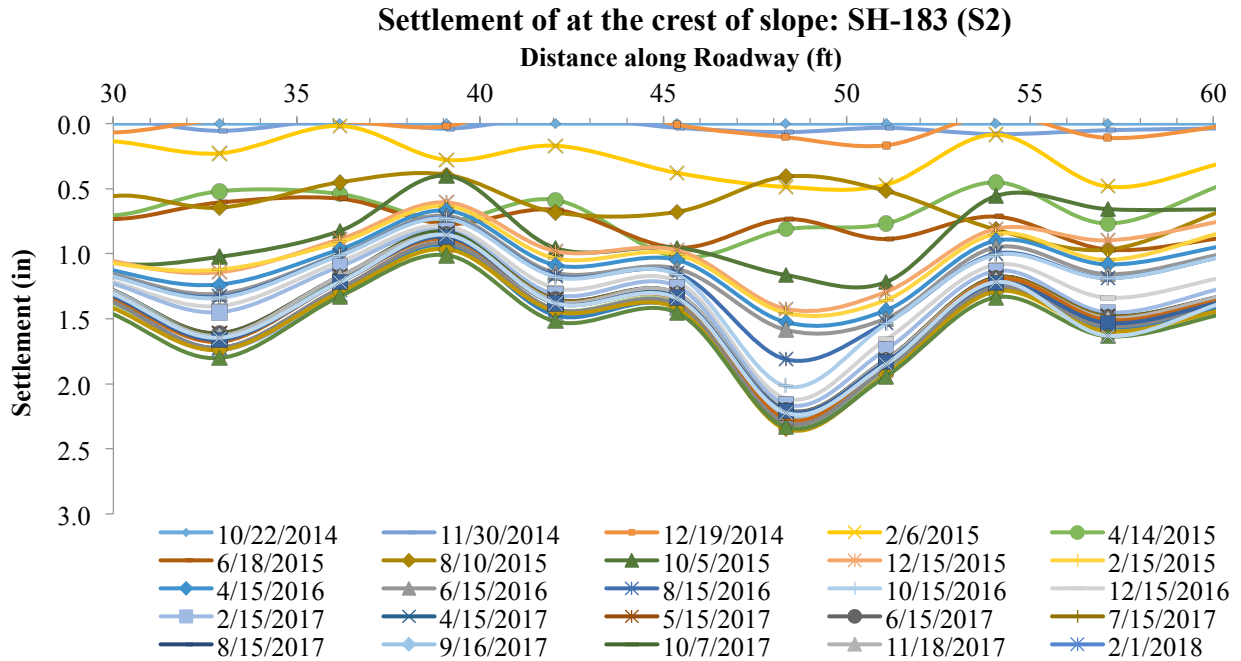
Figure 5- 11 Settlement at the crest of SH-183 slope (S1 Section)

Figure 5- 12 Settlement at the crest of SH-183 slope (S2 Section)

From the graphs presented in Figures 5-11 and 5-12, it can be observed, on average, that the incremental settlement for the two sections performed nearly identical. This is portrayed in Figure 5-13 comparing sections S1 and S2 incremental settlements. From the figure, while the initial adjustment time for the RPP experienced higher measurements of settlement, on average approximately 0.70 in. during 2014 to 2015, the settlement observed decreased over time. After each yearly transition, it can be observed that the incremental settlement is reduced by half, approximately, in the next year transition.

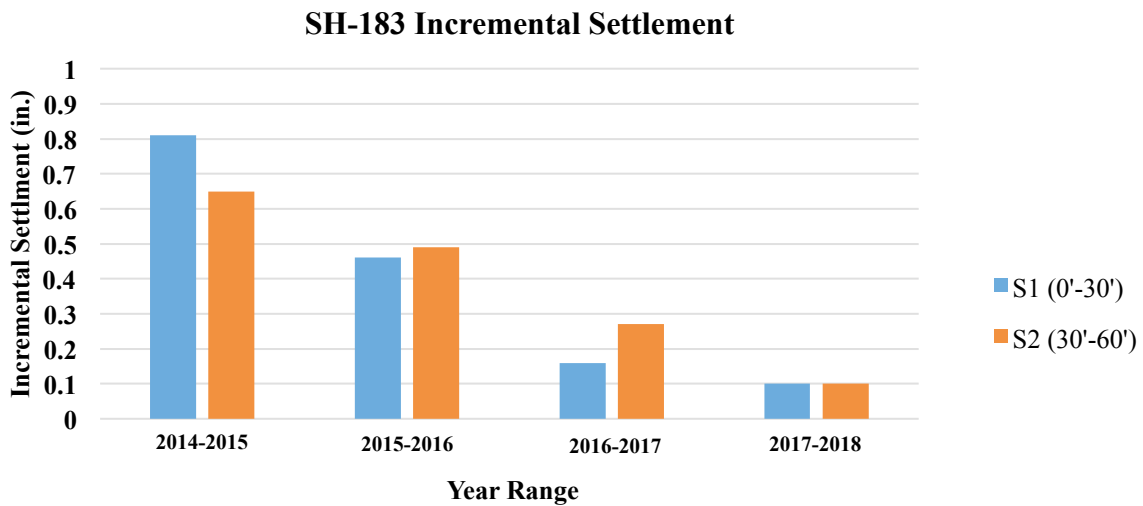
Figure 5- 13 SH-183 incremental settlement
