IN-SERVICE PERFORMANCE EVALUATION OF FIRE AND IMPACT
DAMAGED BRIDGES WITH CFRP LAMINATE STRENGTHENING

SANTOSH TIMILSINA

DOCTOR OF PHILOSOPHY

THE UNIVERSITY OF TEXAS AT ARLINGTON

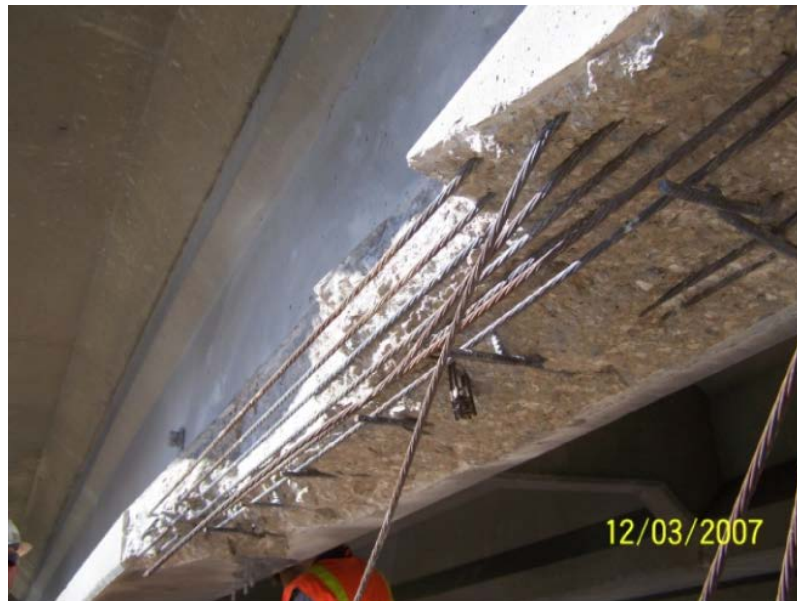
Figure 2-7 Impact-damaged prestressed bridge girder (Kasan et al. 2013)

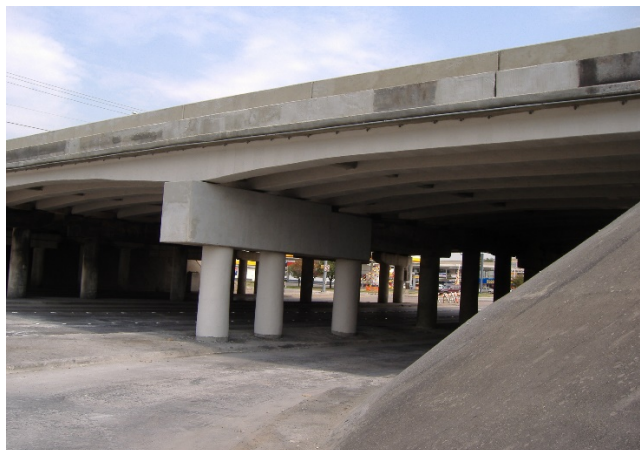
A total of 28.3 m³ (1000 ft³) of loose and unsound concrete was removed during the repair process; significantly higher than initially anticipated. The challenges were in maintaining a parabolic shape of the girder and achieving a smooth finish. 28.3 m³ (1000 ft³) of mortar was sprayed during the repair process and 9.2 m³ (12 cubic yard) concrete was poured. Bearing seats were epoxy injected as jacking up and replacing the bearing pad was not feasible for such long span continuous bridge. The CFRP was saturated using automated saturation to control the amount of epoxy. Pull off tests were performed on the FRP-epoxy-concrete after curing to verify the interfacial bond between the concrete and CFRP. The bond between the concrete

and CFRP was found to be satisfactory as reported in Pallempti et al. 2016. The crew was able to successfully complete the repair process within the stipulated time and the bridge was open to traffic within 47 days after the accident (Figure 3-7).

Figure 3-7 Post- repair MacArthur Bridge

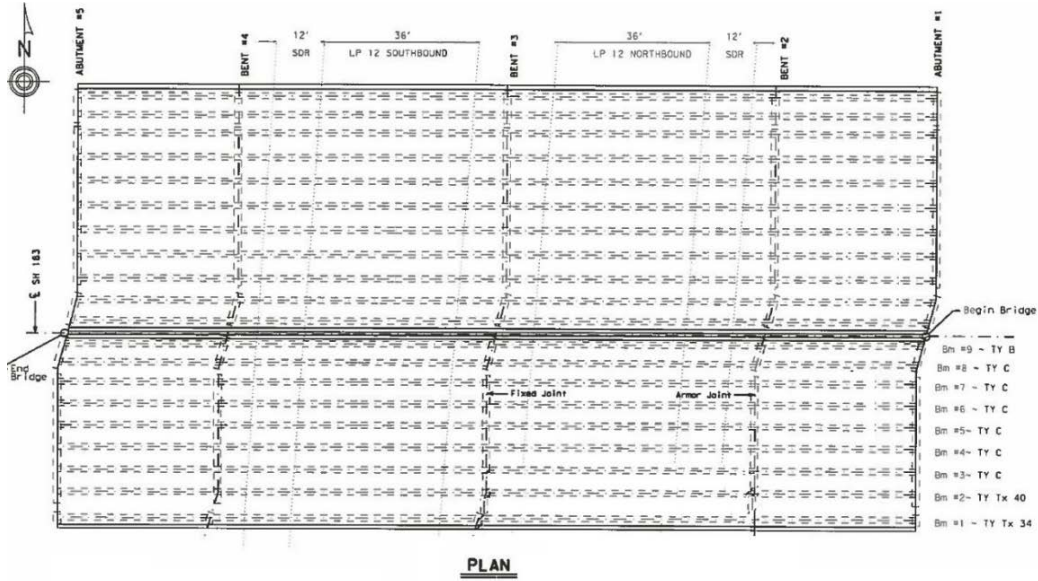
Figure 3-10 Plan view of the bridge

It was decided that the two girders, B1 and B2 had to be completely replaced. Beam B1 was replaced with a Texas Type Tx34 prestressed I-girder and the damaged Beam B2 was replaced with a Texas Type Tx40 prestressed I-girder as shown in Figure 3-10. Beam B3, although suffering from significant section loss and severed strands, was adjudged to be repairable and a repair plan was formulated. Beam B3, which was initially repaired in 2006, had a few strands which were exposed as the result of the collision. Several strands were damaged and needed splicing which was done by using a pre-approved 'Grab-it Cable splice' (Figure 3-14). The splicing and tightening was done such that a tension of at least 107 KN (20,000 lb.) in each 12.5 mm (0.5 in.) strand was guaranteed. The cracks greater than 0.1 mm (0.004 in.) were all injected with high strength epoxy to seal the cracks.

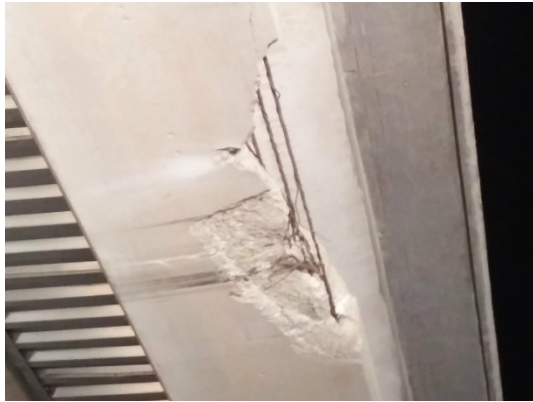
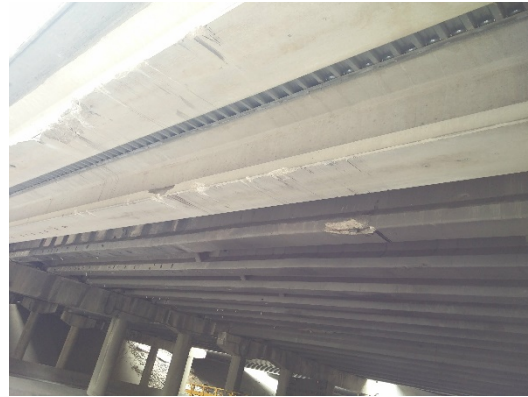
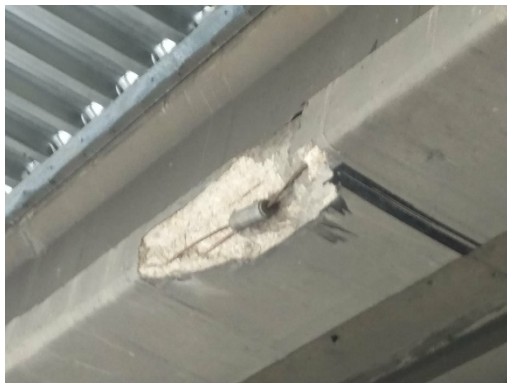
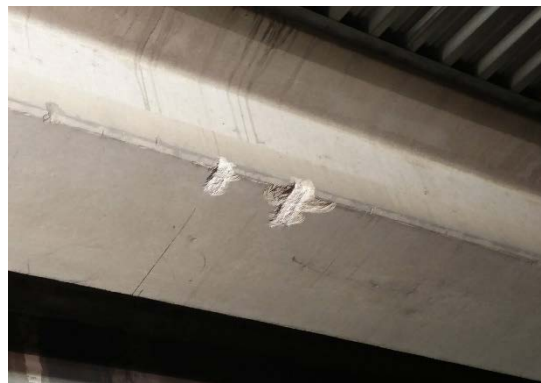
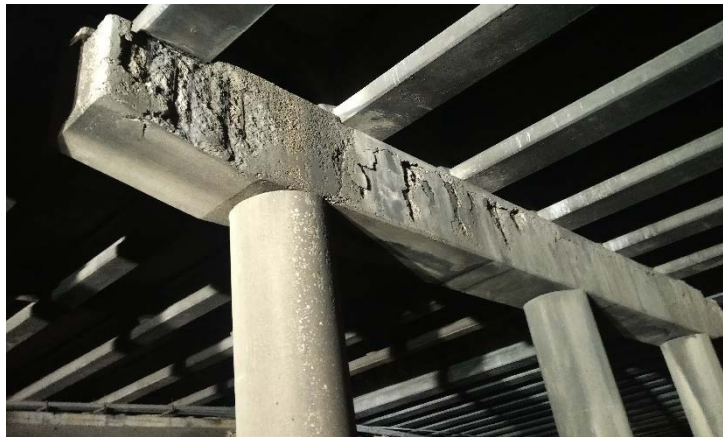
A visual inspection was carried out in June 2017 as part of this study. The bridge was struck by traffic even after the repair and strengthening process as could be seen from the damage in the south exterior girder. The replaced Tx34 girder had severe section loss due to the over height vehicle impact in Span 2 of the EB bridge. The damage could be categorized as severe damage. Several strands of the girder were exposed and three strand was severed [Figure 3-16(a)]. There was some section loss in Beam B2, a replaced Tx40 girder which was also a result of the vehicle hitting the girder [Figure 3-16 (b)]. Beam B3 was also struck and had some loss of the CFRP jacketing [Figure 3-16(c)]. The severed and spliced strand was visible because of loss of concrete section. Scraping of the surface was seen throughout all the girders in Span 2 [Figure 3-16(d)]. There was visible signs of deterioration of the concrete bents in Bent 3 [Figure 3-16(e)]. The deterioration had caused spalling of concrete and corrosion of the rebar. There were some minor hairline cracks on some of the girders. The CFRP did not show any visible signs of debonding or delamination. The FRP seemed well bonded to the substrate concrete and the U-wraps were still intact. The bridge superstructure did not show significant amount of deterioration other than the section loss and damage due to over height vehicle.

Figure 3-16 (a) Loss of concrete exposing strands (b) Bridge bottom showing damage (c) Spliced strands exposed (d) Beam scratched by over height vehicle (e) Bent cap damage

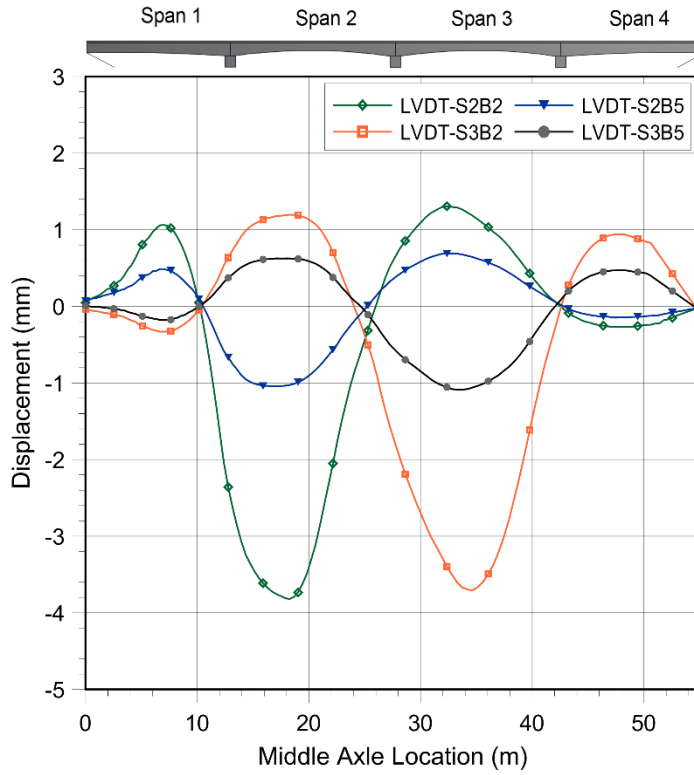
Figure 6-3 Displacement response for Path P1

It can be seen from the graphs that the displacement response of the beam B5 was lower than the displacement of Beam B2. This could be because of the fact that the beams were constructed in two different times. Beam B2 was part of the original construction which had a concrete design compressive strength of 3600 psi. However, Beams B5 and B6 were part of the reconstruction in which the design compressive strength of concrete was 5000 psi. This could be the reason why all the displacements for Beam B5 is lower than the displacement for Beam B2 for all runs.

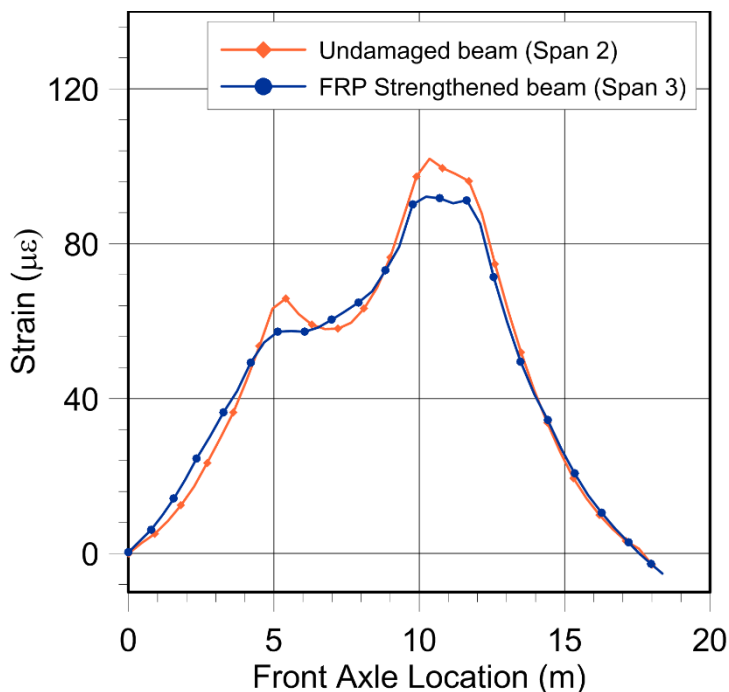
Figure 6-7 Strain comparison between undamaged and FRP strengthened girder

The strain response of the strain gauge was isolated so that the response of the gauge only when the truck entered that span can be considered. The distribution of the strain can be assumed to follow a normal distribution as shown in Figure 6-7. A one tailed hypothesis test was performed to verify the difference in the strain values. The z-test showed that the strain obtained for the undamaged beam was higher than the strain obtained for the CFRP strengthened beam as demonstrated by a Z value of 2.22 when compared to the significance level of 0.05. We can hence conclude with a 95% confidence that the strengthened beam, in Span 3 of the bridge, exhibited a lower strain when compared to the undamaged beam in Span 3 of the bridge. The

damaged beam was exposed to higher thermal effects as a result of fire and subsequently repaired and strengthened with CFRP. The aim of this comparison was to find the effectiveness of the repair procedure, a decade after the strengthening to see the adequacy of the strengthening procedure. The strain in the strengthened beam was lower than the similar undamaged beam, even though the beam had a higher loss in stiffness due to fire. The strain in the strengthened beam was 9% lower than the undamaged beam. This could be because FRP, in addition to the confinement of concrete, prevents the transverse cracks in the bridge from expanding. The bond between the FRP and concrete was still intact during the load test. FRP doesn't only prevent the cracks in the beam from growing, but also prevents new cracks from forming which could be the reason for the decrease. Apart from that, steel reinforcement also loses its load carrying capacity when exposed to thermal effects. The yield strain in steel reinforcement can increase as a result of thermal effect which decreases the moment capacity of the beam. However, a properly designed FRP laminate strengthening system can help alleviate this problem and restore the flexural capacity of the beam.

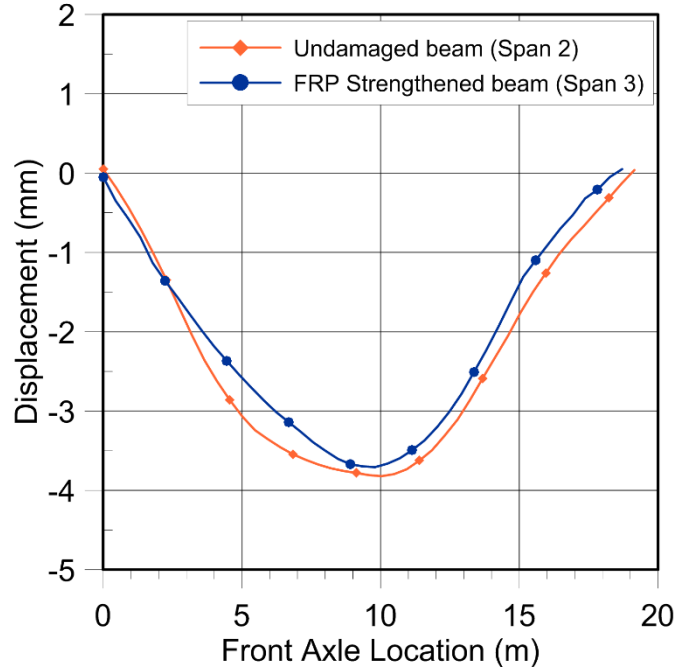
Figure 6-8 Displacement comparison between undamaged and FRP strengthened girder

The deflection observed for the damaged and strengthened girder was 3 % lower than the undamaged girder. There was no significant difference in the deflection response between the two girders which shows the effectiveness of FRP. FRP bond with concrete can increase the stiffness of the concrete in two ways; by providing confinement to the mortar and concrete substrate and increasing the overall elastic stiffness of the beam because of the laminate’s large modulus of Elasticity.

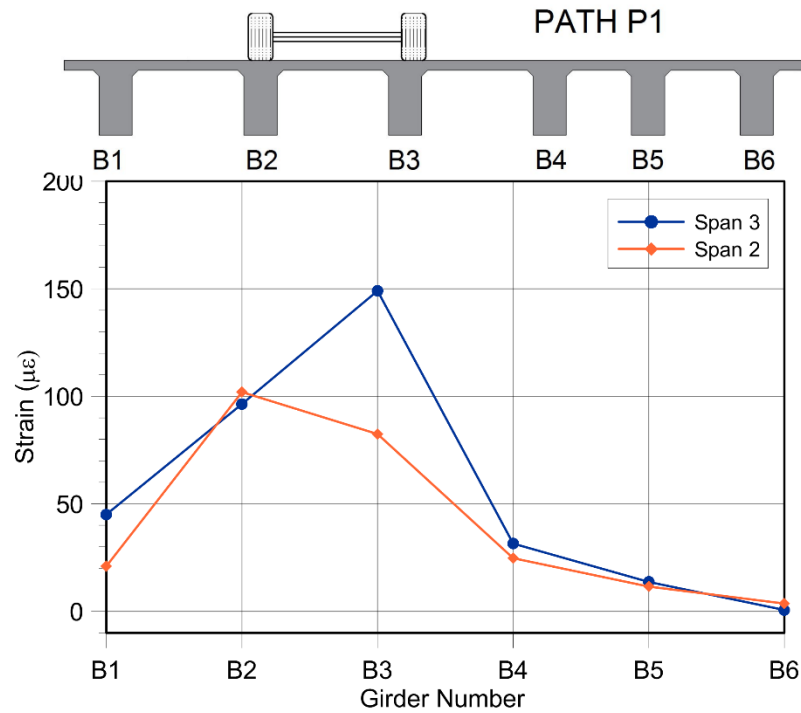
Figure 6-9 Strain comparison between Span 2 and Span 3 (Path P1)

The strain response of the beams in Span 2 was comparable to the strain response of beams in Span 3. It was seen that Span 3 which was most heavily damaged exhibited higher strain than the values for corresponding beams in Span 2, except B2. Beam B2 exhibited lower strain because of the repair and CFRP strengthening. However, Beam B3 was only repaired with mortar and not strengthened with CFRP laminate. There was no visible spalling and section loss in Beam B3 which warranted FRP repair. That could be the reason why no strengthening was done for the beam. However, the beam was exposed to similar thermal effects which could be the reason for the large strain value obtained for beam B3. Another reason for this could be the thermal effects on the reinforcement which can reduce the load carrying capacity of the beam significantly. This large strain response in Beam B4 was verified by other gauges on the same span as well. This

shows that the response was not due to the presence of local crack or deformity, but due to the reduction of overall stiffness of the beam. This can be used to verify that FRP laminate strengthening significantly contributes to the flexural capacity and increases the stiffness of the beam. It could also be concluded that beams which are exposed to thermal effects, however, do not exhibit spalling or section loss, still need to be strengthened with FRP laminate to prevent any microcracks from expanding.

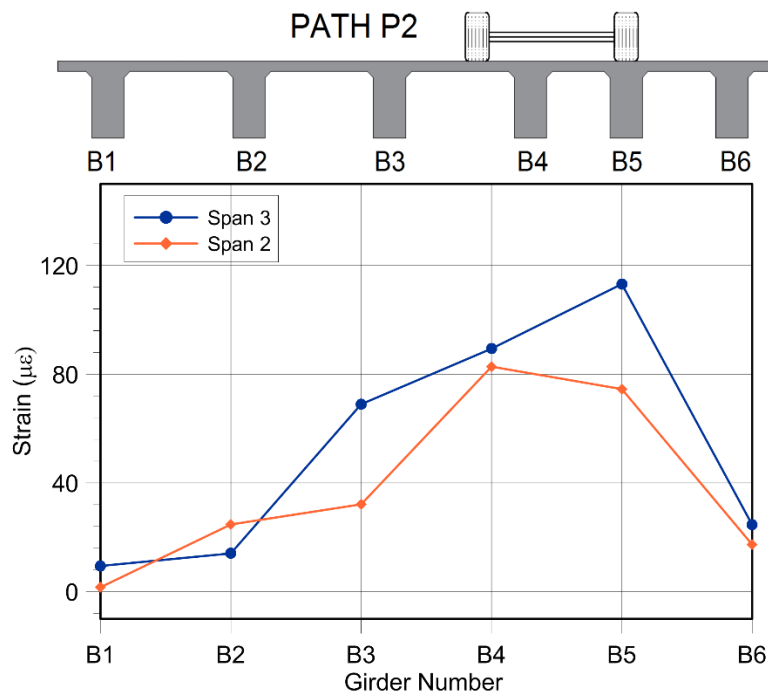
Figure 6-10 Strain comparison between Span 2 and Span 3 (Path P2)

Similar behavior was observed for Beam B3 when the truck was on Path P2. The strain response for Beam B3 was higher for Span 3 when compared with Span 2. Figure 6-10 shows the response of all the girders when the truck is on Path P2. It can be seen that all the beams except Beam B2 exhibited a higher strain for Span 3 when compared with Span 2. This could be because of the thermal effects on the beams and presence of microcracks even after repair. Another reason could be the loss of modulus of elasticity of the steel reinforcement.

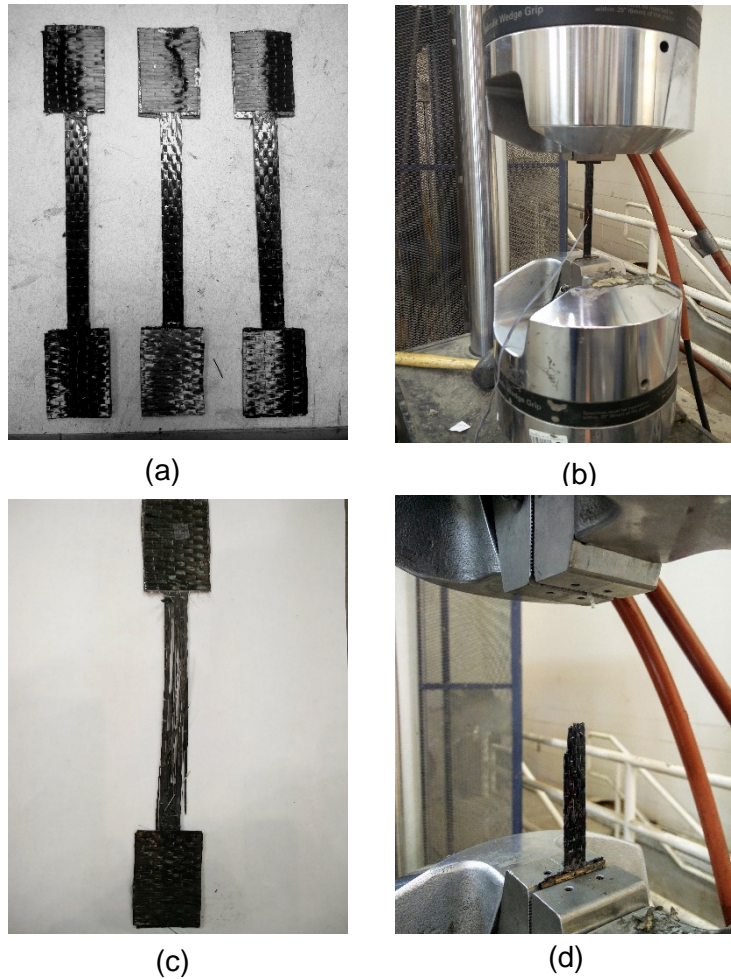
Figure 6-13 Tensile test of FRP laminate (a) Sample preparation (b) Tensile test set up (c) Failure mode (d) Failure mode

A representative FRP sample was collected from the U-wrap of the beam after the load test and five coupon samples were prepared for tensile test. Since, FRP coupons were not tested during the initial application, a new sample of FRP laminate using same fiber and epoxy was created in the lab for comparison purposes. Although the thickness of FRP and the amount of epoxy was aimed to make similar, there was a discrepancy in the thickness of the samples. The lab sample was thicker than the samples obtained from the field. It could be because automated saturation was used during the initial application whereas a roller epoxy application was used during sample preparation for the lab samples. One coupon sample had some concrete on the FRP surface which is why it was discarded during the analysis. Four similar coupons were created from the lab FRP sample. The FRP samples were cut to the suggested dimensions and tabbed using the same CFRP unidirectional fiber material [Figure 6-13 (a)]. Strain gauges were installed on the middle of the FRP sample [Figure 6-13(b)] to obtain the stress strain diagram and eventually the modulus of Elasticity (E) of FRP sample. Tensile test was carried out on the coupon samples according to ASTM D3039 (ASTM, 2014b) to obtain the tensile stress. Figure 6-13(c) and Figure 6-13(d) present the failure modes for two coupon samples.

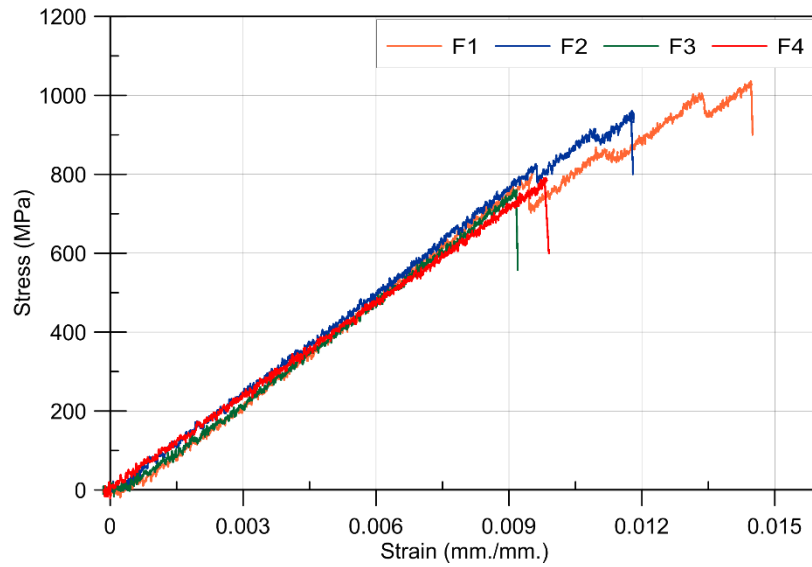
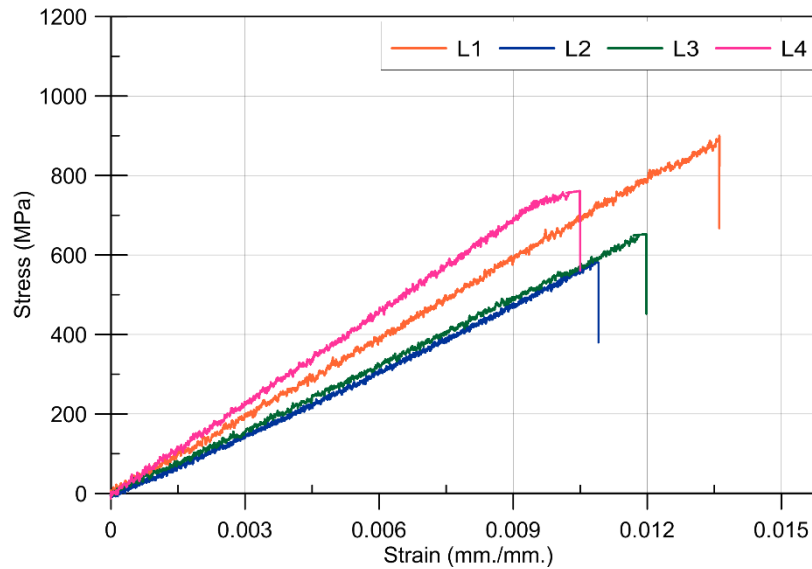
Figure 6-14 Stress strain diagram for FRP coupon samples (a) Field Samples
(b) Lab samples

The failure load, displacement and strain were analyzed and stress-strain diagram for the coupon samples were plotted. Figure 6-14(a) shows the stress-strain diagram for field samples and Figure 6-14(b) shows the stress strain diagram for lab samples. It can be seen that the modulus of elasticity of field samples was similar with slight variability in the fail stress. The lab samples, however, had some variability in the elastic modulus as well as fail stress. The elastic response of the FRP samples is seen to be almost linear until failure.

It can be seen that the field sample had a lower elastic modulus than the lab sample for same thickness. There was a reduction of 13% in the elastic modulus and a reduction of around 21% in the tensile strength of FRP laminate. This reduction can be because of various reasons including wetting and drying, fatigue cycles, change in temperature. This shows that there is reduction in the material properties of FRP laminate when exposed to environmental conditions.

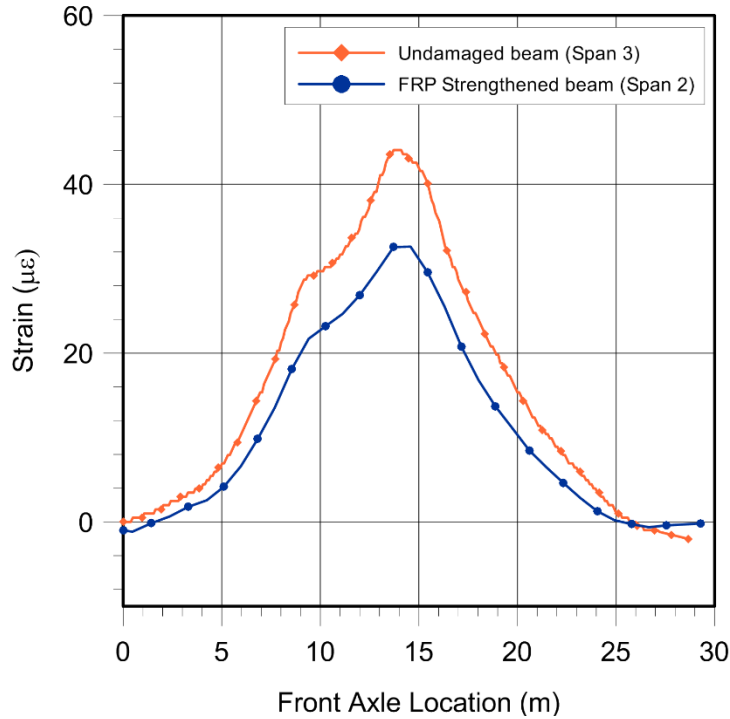
Figure 6-33 Strain comparison between undamaged and FRP strengthened girder

It can be seen that the strengthened girder, in Span 2 of the bridge, exhibited a lower strain when compared to the undamaged girder in Span 3 of the bridge. The damaged girder had cracks and a severed strand which was spliced as part of the repair. The cracks were epoxy injected and the lost section was repaired with mortar. The girder was strengthened for flexure with CFRP laminate and wrapped using transverse U-wraps. A higher strain value would be expected on the damaged girder because of the amount of damage and loss of strands. However, the inverse was seen to be true, which presents the effectiveness of the repair procedure and strengthening technique, in an in-service bridge. The strain in the strengthened girder was 27% lower than the undamaged girder. A z-test was performed on the strain data series for two spans of the bridge. The test showed that the strain was indeed higher as demonstrated by the z value of 2.34 which is higher than 1.96, the critical value for a significance level of 0.05. Hence, it can be said with a 95% accuracy that the strain

obtained from the strengthened girder was lower than the undamaged girder. Although, other factors like deck condition, composite action between the deck and girder and local abnormalities can affect the strain response, it can be safely assumed that the strengthening scheme was able to recover the flexural capacity of the damaged girder.

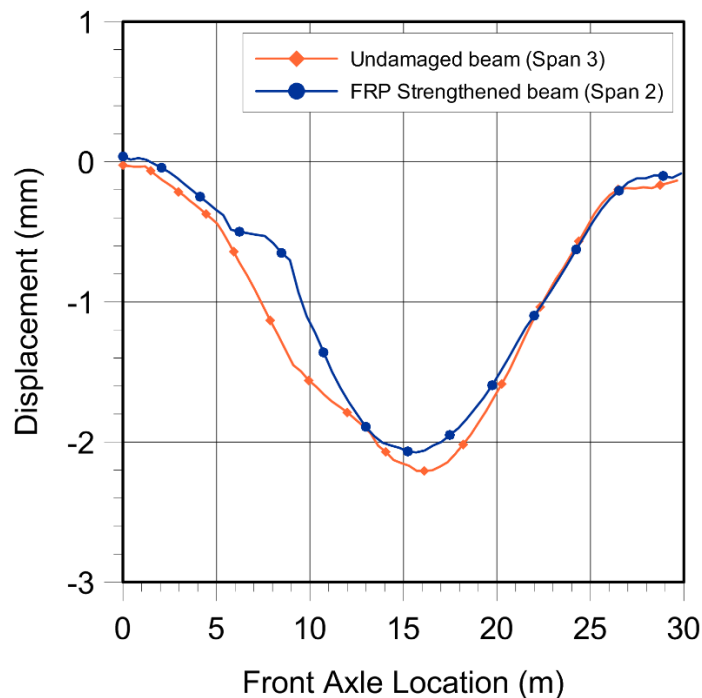
Figure 6-34 Displacement comparison between undamaged and FRP strengthened girder

The deflection observed for the damaged and strengthened girder was 6 % lower than the undamaged girder. This shows that the repair and CFRP application on the damaged girder was successful to recover the elastic stiffness of the bridge

girder. Reduction in displacement also shows that the girder became stiffer due to repair and CFRP application which can be attributed to the brittle nature of CFRP laminate.

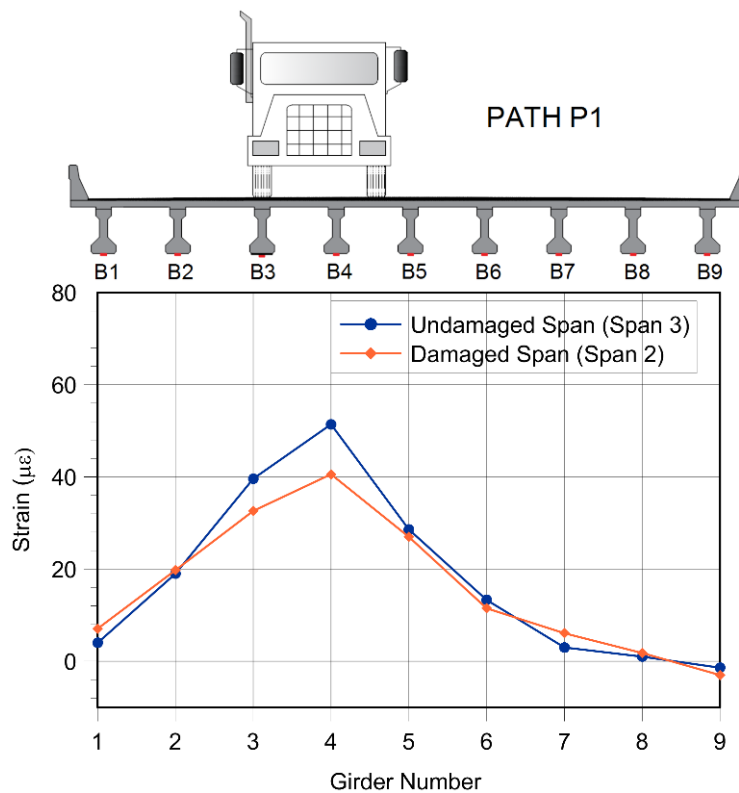
Figure 6-35 Strain comparison for all girders between Span 2 and Span 3

The strain response in two strengthened girders was lower than the undamaged girders. Although the strain response for other bridge girders was almost the same for both the spans, there was a significant difference in the strain values for Beam B3 and B4 which were the girders strengthened with CFRP. This shows that

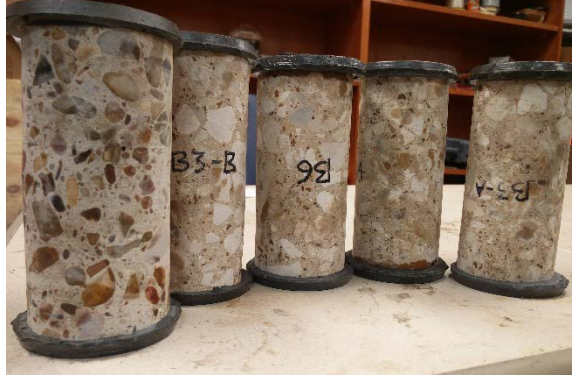
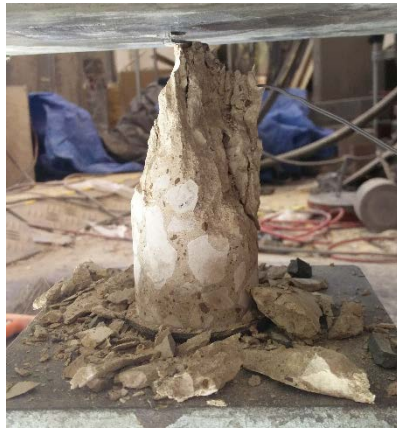
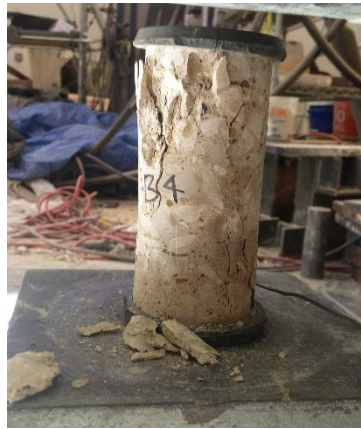
Figure 6-36 (a) Core Samples ready for test (b) Tested core sample
(c) Tested core sample

Five core samples were collected from the web of four different girders in Span 1 of the bridge to obtain the compressive strength of concrete. The concrete cores were all 75 mm (3 in.) in diameter and a length of around 150 mm (6 in.). The web of the girder was the only location of the bridge where the concrete cores could be taken without damaging the strands and reinforcement. The web width for the girders was 175 mm (7 in.) which prevented cores of 100 mm, so as to maintain the length to diameter ratio of around 2 as recommended in ASTM (ASTM C39 2014). The concrete cores were stored in a cool dry place so it did not absorb any moisture. The core samples were cut to the same length and capped using Sulphur capping to make the surface even (Figure 6-36). The samples thus prepared were tested to obtain the compressive strength of concrete using a MTS compression testing machine at a constant rate of around 0.25 ± 0.05 MPa/s (35 ± 7 psi). Strain gauges were attached on two sides of the core sample to get the stress strain response and Elastic modulus of the concrete samples.

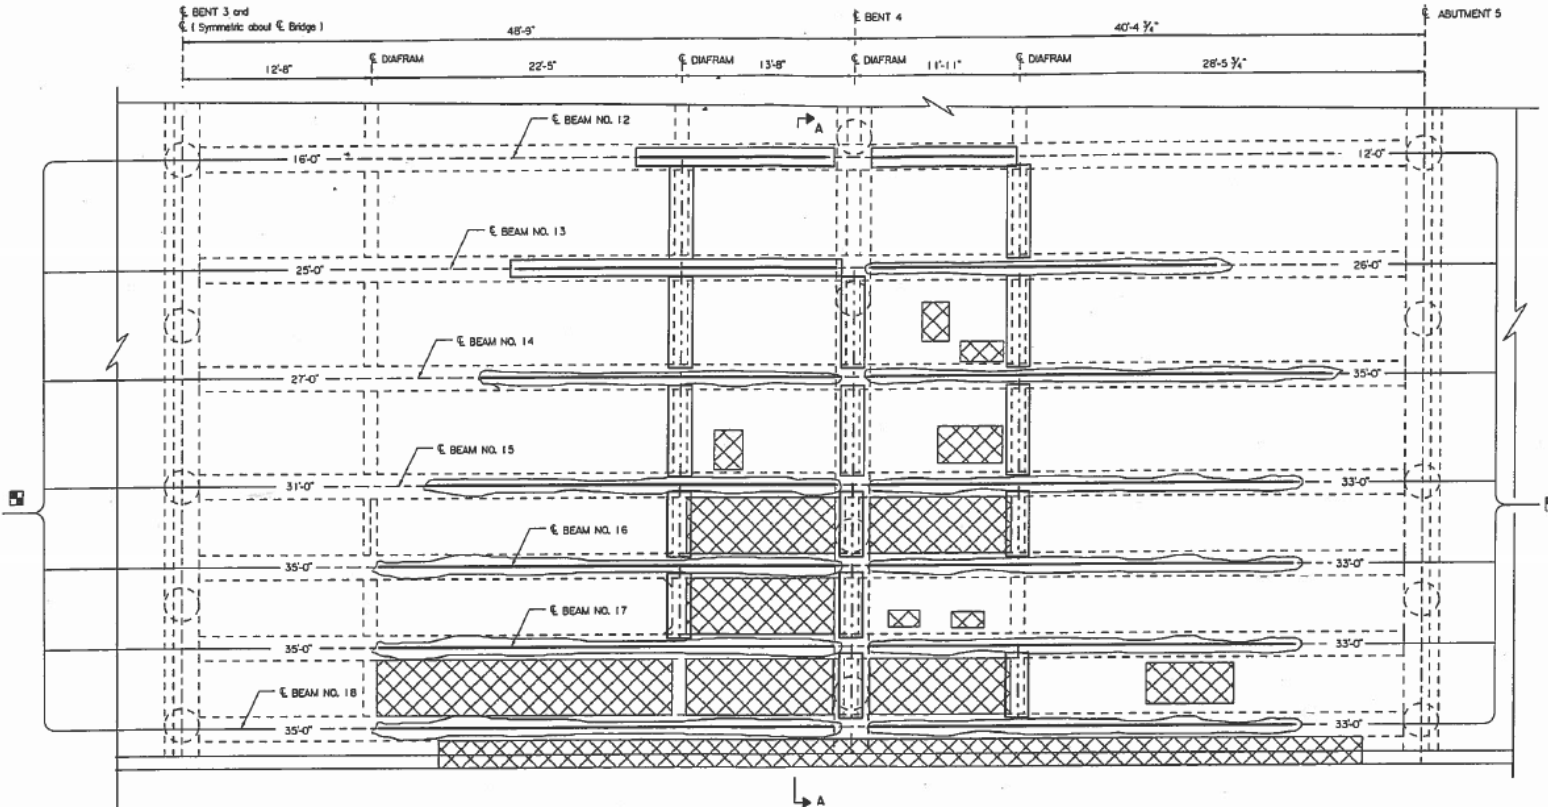
DAMAGE LOCATIONS PLAN

[Symbol] Damaged lengths are Approximate Not able to Measure Exactly

Superstructure Repair Notes:
 Perform superstructure repair work using pneumatically placed concrete in conjunction with the details shown. Perform this work in accordance with Item 423, "Concrete Structure Repair" and Item 431, "Pneumatically Placed Concrete."
 Apply CFRP to designated areas of superstructure in accordance with the details shown and "General Notes for CFRP External Strengthening". See "Superstructure Repair Details", Sheet 3.

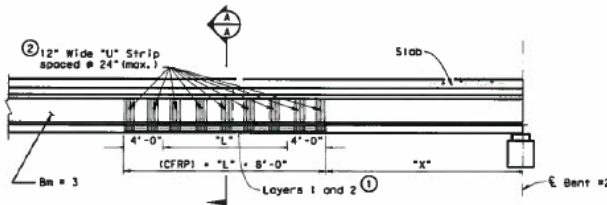
CFRP INSTALLATION AREA - NORTH (EXTERIOR) VIEW

BEAM # 3 CONCRETE & STRAND DAMAGE

Extend CFRP installation area 4'-0" into sound beam on each side of the repaired area. Length of CFRP installation area may increase due to chipping required to expose strand ends.
