INVESTIGATION OF BAMBOO AS
REINFORCEMENT IN CONCRETE

Presented to the Faculty of the Graduate School of
The University of Texas at Arlington in Partial Fulfillment
of the Requirements
for the Degree of

MASTER OF SCIENCE IN CIVIL AND ENVIRONMENTAL ENGINEERING

THE UNIVERSITY OF TEXAS AT ARLINGTON

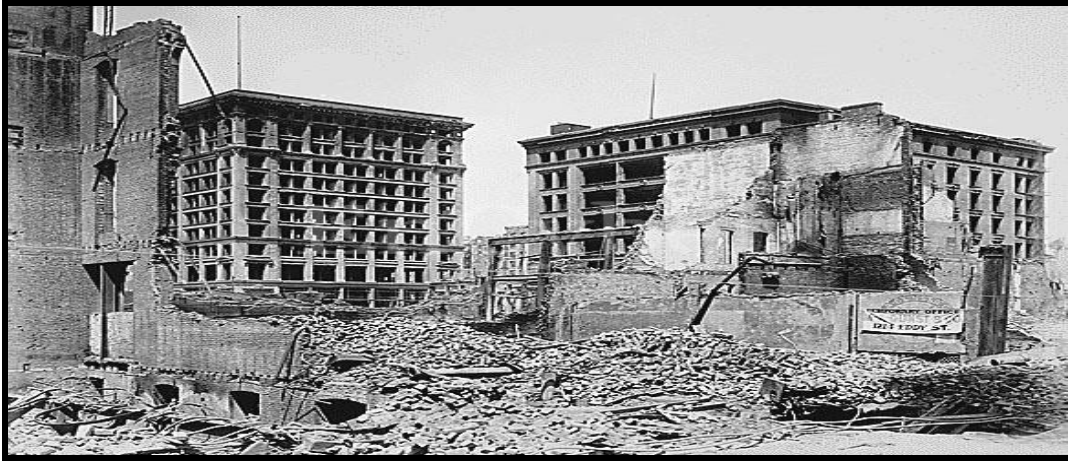
Figure 1.1 Failure of Concrete Building by Earthquake

Unfortunately, structural steel is not easy to find in many countries due to limited natural resources and lack of skilled labor. For the same reasons, use of steel reinforcement in concrete is not widespread. Some buildings in the world have been built of just plain concrete or bricks without steel reinforcement. These buildings typically can not withstand the effects of natural disasters such as earthquakes, hurricanes, and storms. In a few countries, buildings which did not use enough steel have been crumbled by natural disasters such as earthquakes as evident in Figure 1.1.

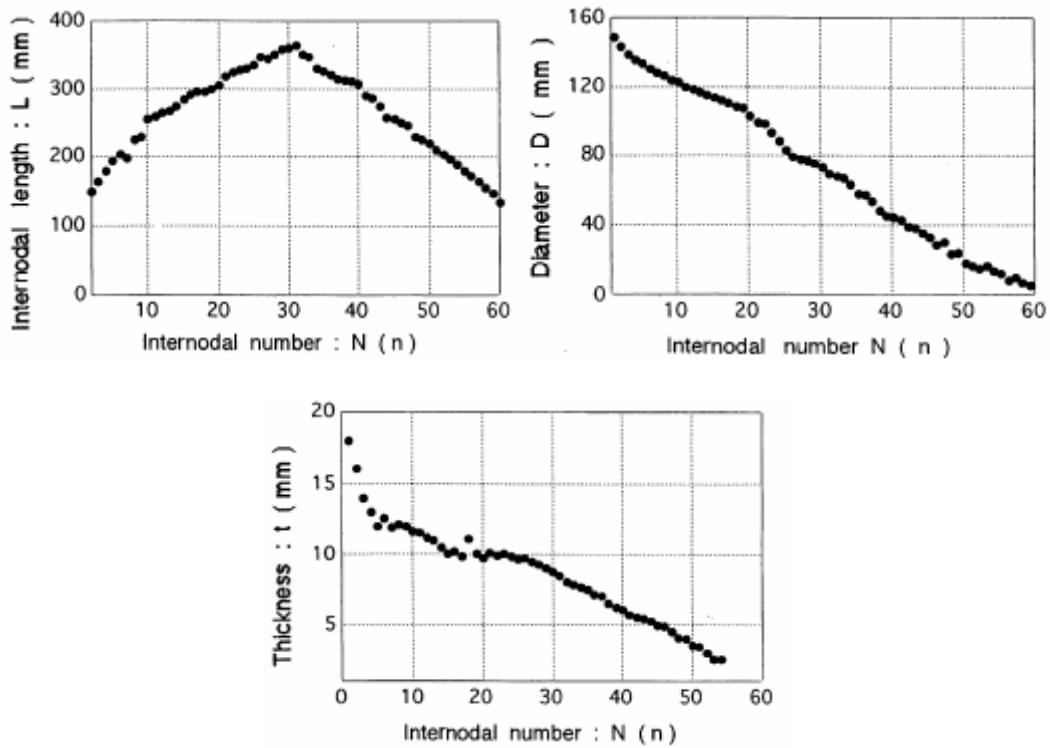
Figure 1.3 Variation of inter-nodal length, diameter and thickness along the whole bamboo culms (Ghavami 1995)

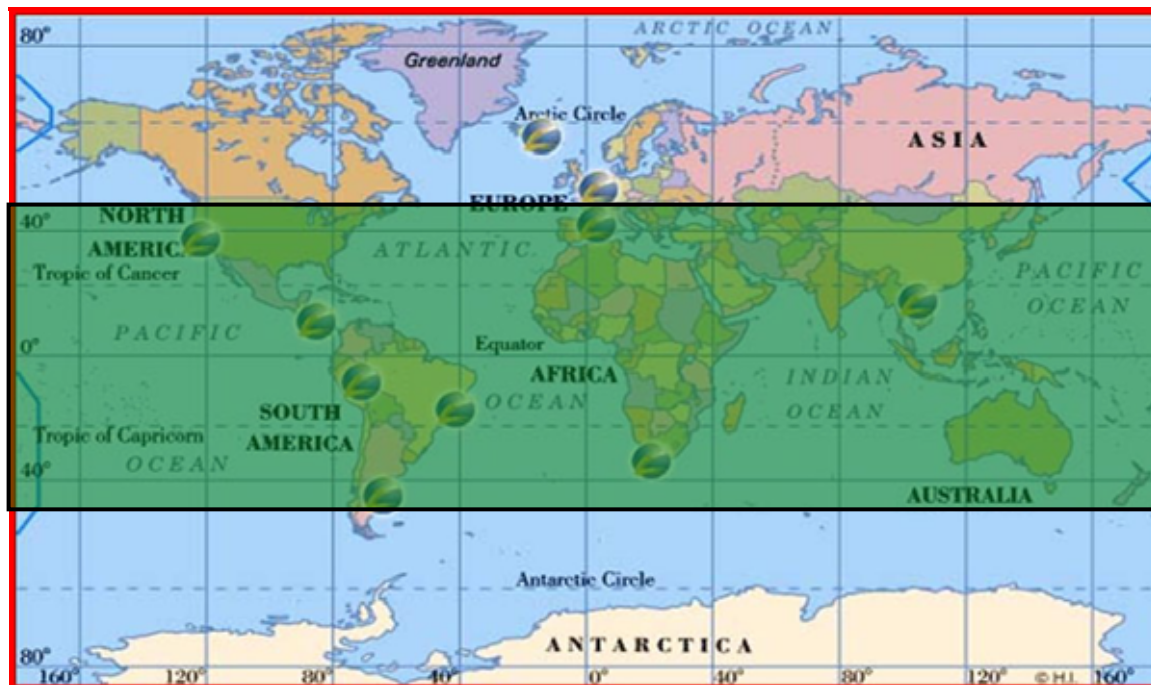
Figure 1.5 Bamboo Distribution around the world

Bamboo is grown in many areas of world and is divided into one thousand-two hundred-fifty kinds of bamboo. Most bamboo can be found in East Asia because of its tropical and subtropical regions. Bamboo use in construction is common in Asian due to factors including economical aspects, lightweight, flexibility, and toughness. When compared to steel's tensile strength, bamboo's value of 54 ksi (370 MPa) is very respectable (Amanda et al. 2001). The middle diagram in Figure 1.5 shows where bamboo is commercially grown.

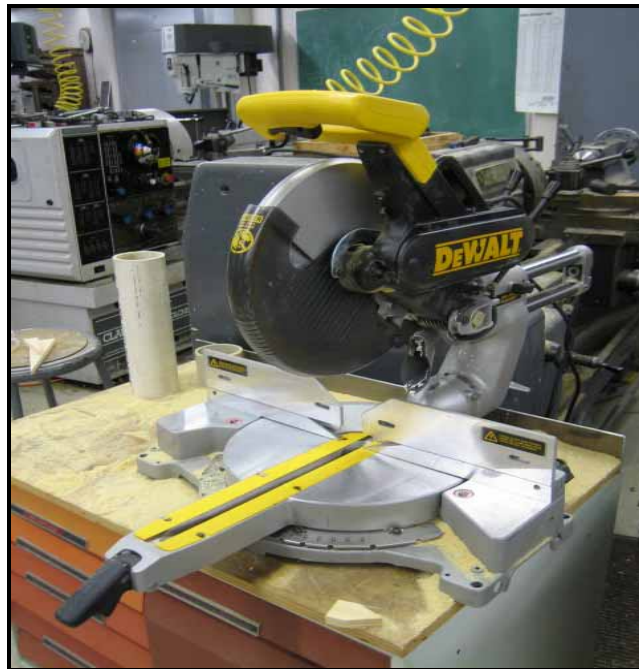
Figure 2.1 A Dewalt Saw

The tensile test was completed using the guidelines listed by ASTM A 390. To make each specimen, it was required to cut suitable sizes for the tensile test due to big diameter (3~5 inch) and long length (9 feet) of bamboo. Basically, the tensile specimen of steel or FRP is fabricated for a length of approximately 10 in (254 mm), so the bamboo is cut into 6 in (152 mm) and 12 in (304 mm) lengths to compare with and without node. Normally, the bamboo rod is typically 10ft (457 cm) in lengths. Thus a saw was required for making the tensile specimen and is shown in Figure 2.1.

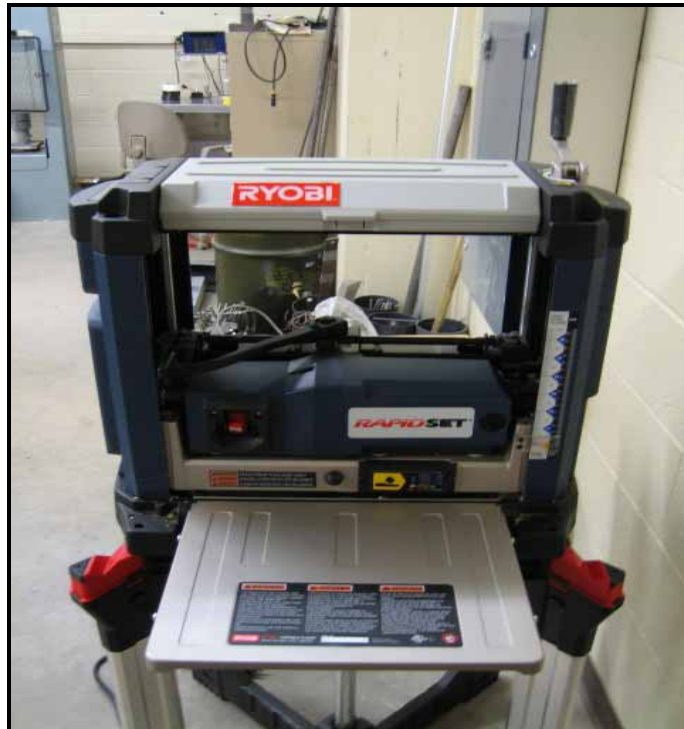
Figure 2.2 Portable Planer

Also, normal bamboo consists of a round surface, so an aluminum tab is required to make a flat surface for attaching the bamboo. Bamboo was cut to the desired length by saw, and it was put onto a planer for making 1/8 in (3.2 mm) thickness of bamboo. The planer can reach the desired thickness and also help to obtain a flat surface. When both sides of a sample are uneven, a surface planer first defines the initial flats surfaces as well as the reverse sides as shown in Figure 2.2.

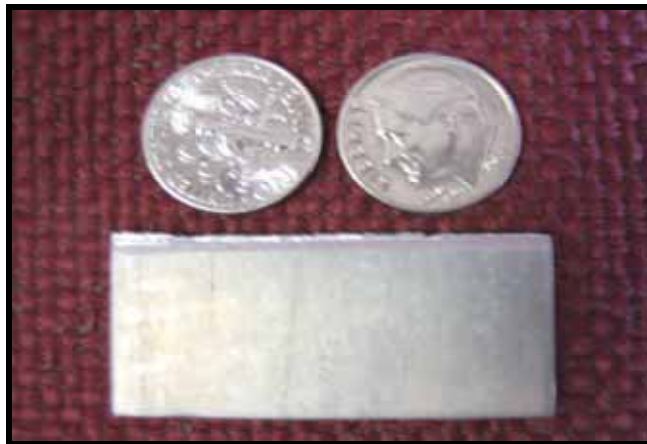
Figure 2.4 Photograph of the Aluminum Tab

the tensile testing machine and this is shown in Figure 2.3. Figure 2.4 shows the size representation of the aluminum tab.

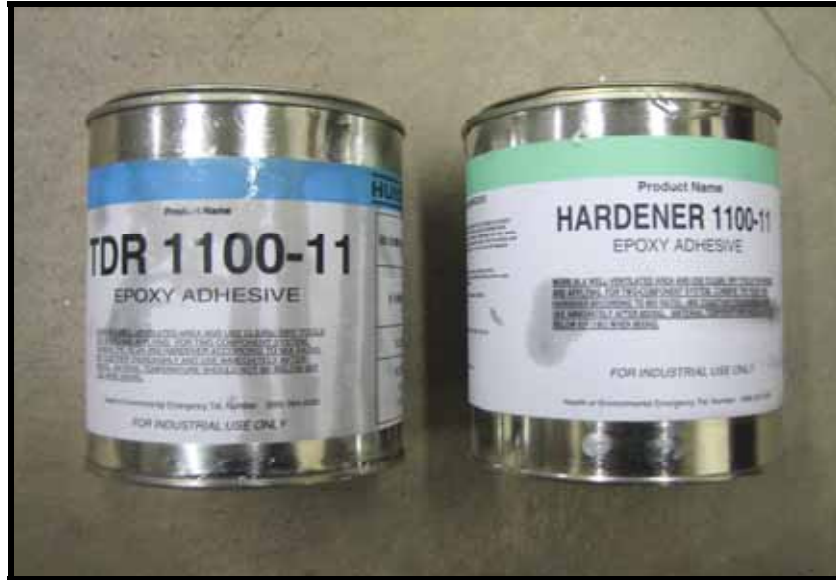
Figure 2.5 Epoxy Adhesive (TDR 1100-11 & HARDENER 1100-11)

The epoxy adhesive, TDR 1100-11 and HARDENER 1100-11, were used to attach the aluminum tabs to the bamboo. Normally, the tensile strength of glue is over 10,000 kgf (98.07 KN), so most glues could not withstand the strength of the tensile machine. Also, most glues lose their bond between aluminum tabs and bamboo, often

causing the grips to be tightened down so strongly that the bamboo could not withstand it. Figure 2.5 shows the epoxy adhesive.

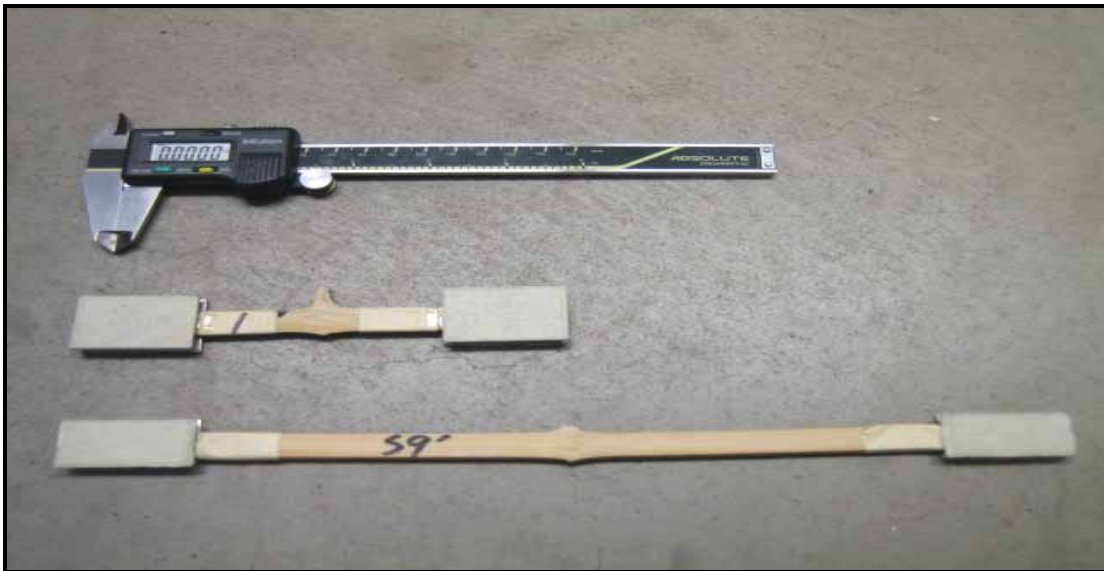
Bamboo Variable	Moso	Solid
Thickness	1/8 in (3.2 mm)	
Node	Yes or No	
Length	6 in (152 mm) or 12 in (305 mm)

Figure 2.6 Diagram of Tensile Sample

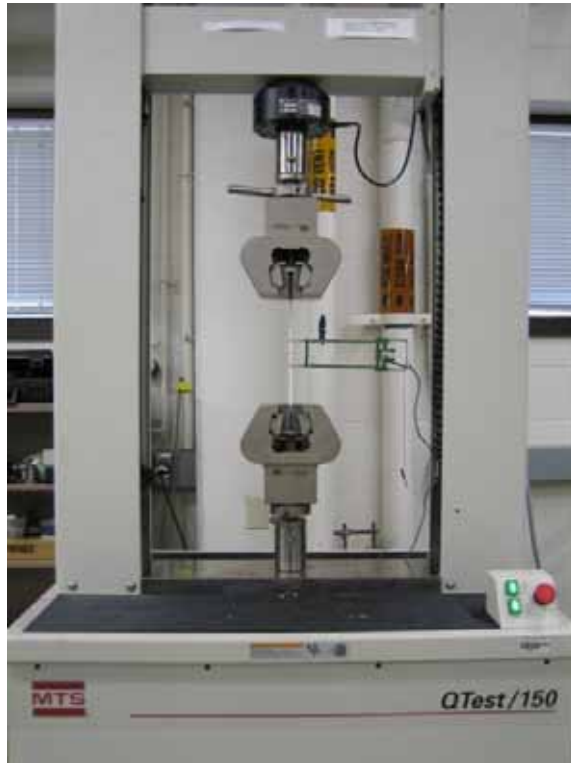
The tensile tests were performed on a MTS QTEST/150 machine testing system with the following components: (1) 100 kip load cell; (2) Grip of MTS QTEST/150; and (3) Extensometer of Epsilon. The MTS QTEST/150 machine is shown in Figure 2.7.

Figure 2.7 MTS QTEST/150

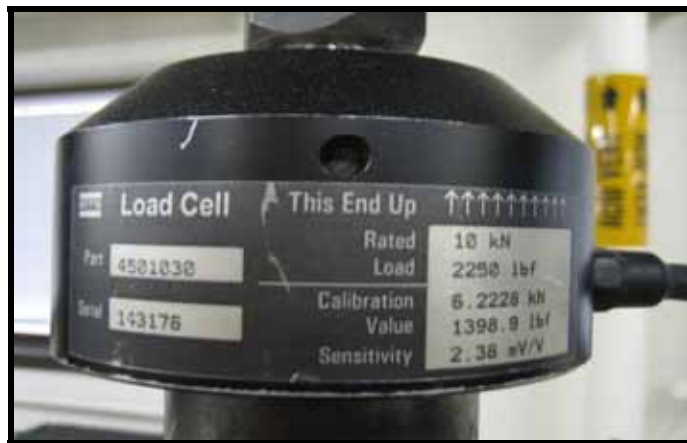
The most important equipment for any weighing conversion into measurable output data is a load cell. It is rated 10 KN (2.3 kips). The picture of the load cell is shown in Figure 2.8.

Figure 2.8 Load Cell

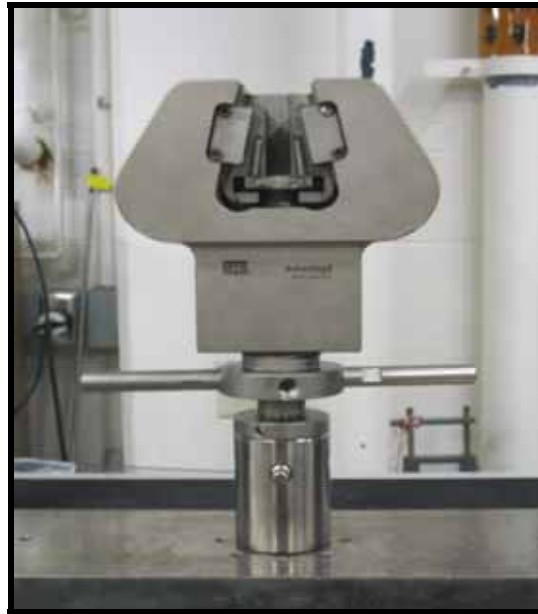
Figure 2.9 shows an enlarged picture of the MTS QTEST/150 grips. It is controlled by hand to tie the specimen, so the bamboo is equipped with aluminum tabs for protecting it from the grip's strength.

Figure 2.9 Grip of MTS QTEST/150

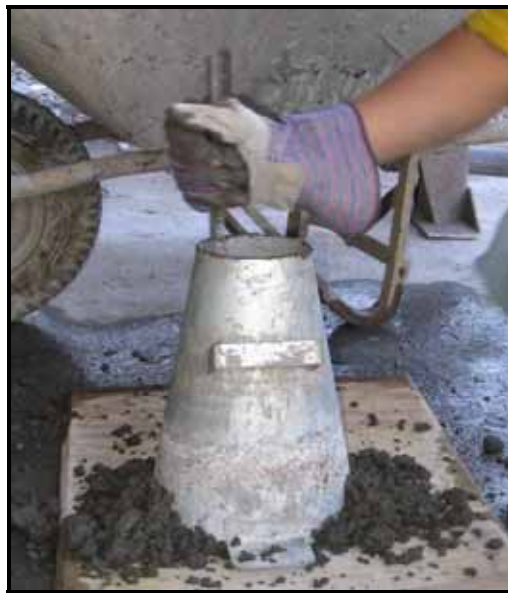
This test suggested a uniform comparison of the batch to batch consistency of the concrete before using the same materials for some tests. Normally, the slump test shows the effective concrete values only for concrete samples having a slump between 1/2 in (13 mm) and 9 in (229 mm) from top of cone (Watkins 2003).

Figure 2.13 Tamping of Slump Test with Rod

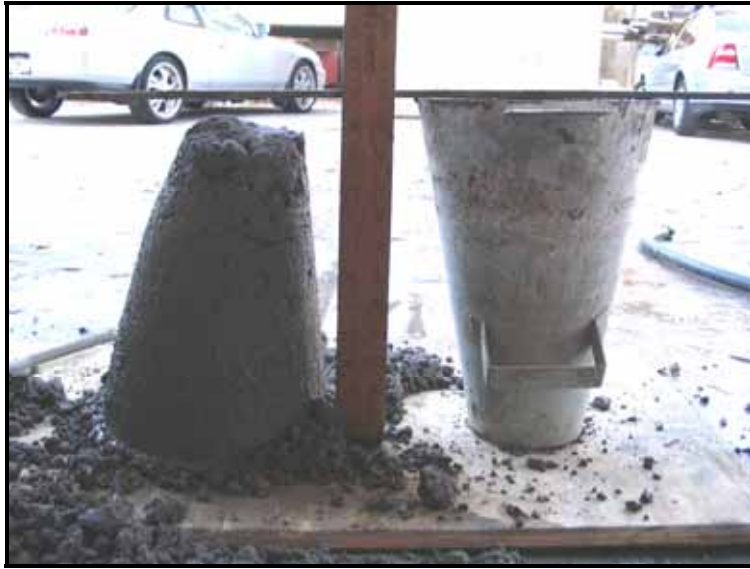
Figure 2.14 Slump Test Result

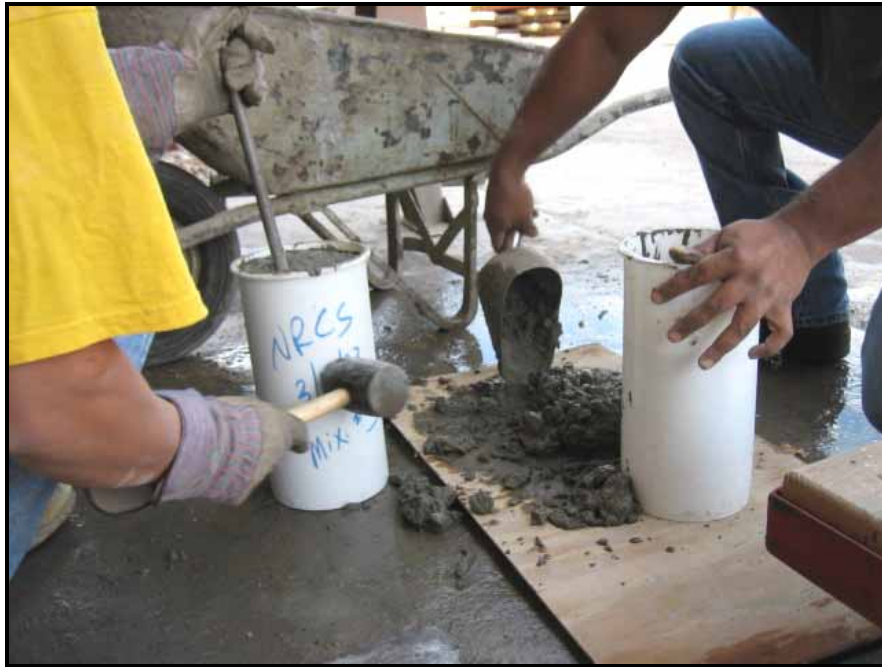
Figure 2.15 Motion of the rod and rubber mallet and pouring concrete

After mixing the concrete in one batch, it was taken to the cylinder. While the concrete was placed into the cylinder, the rod was active and a rubber mallet was acting as a vibration tool hitting the outside of the cylinder to vibrate the concrete into empty spaces because the rod could not adequately pack the concrete into all the spaces present. Figure 2.15 shows the motion of the rod and rubber mallet. Finally, the top of the cylinders were finished off smoothly, and all the bamboo rods were marked two kinds of length, 6 in (152 mm) and 12 in (304 mm), and the concrete cylinders were marked the two points, Center and 1.5 in (38mm) from center. After marking, the bamboo rods were put exact lengths and points on the concrete cylinders.

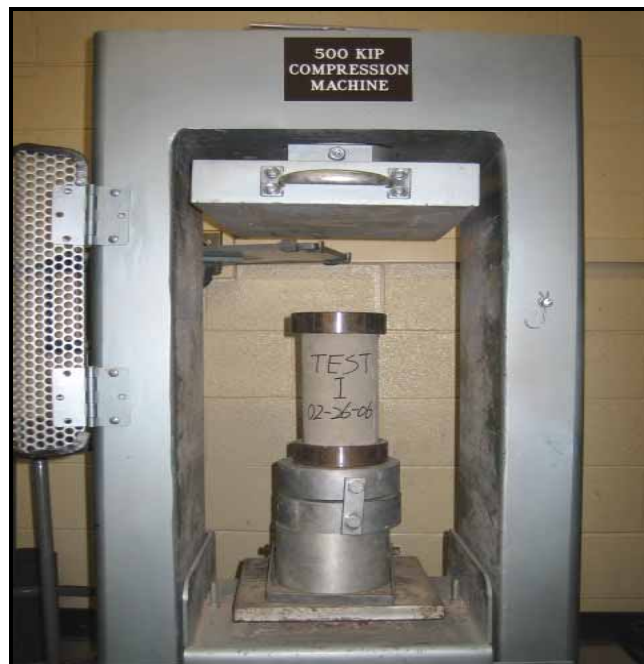
A photograph of a concrete cylinder being loaded in the testing machine is shown in Figure 2.16 and a compression test apparatus with loading value, transmission gear, gauge buster, and output device are shown in Figure 2.17.

Figure 2.16 Compressive Testing

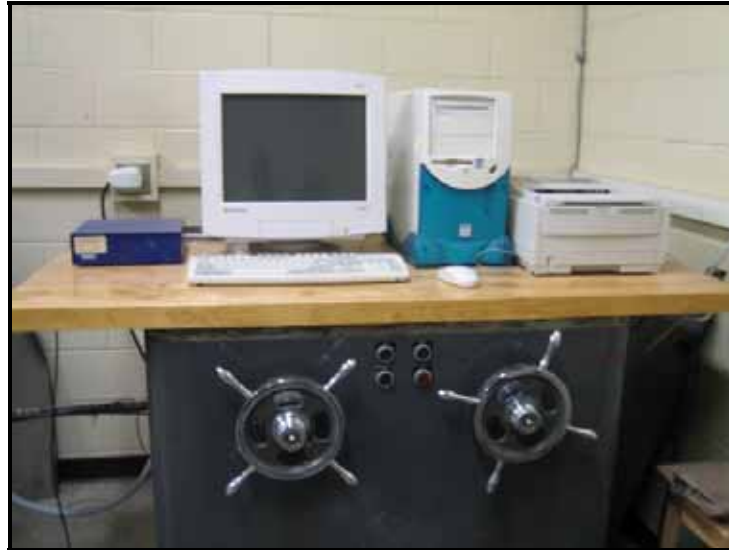
For conveying testing data, a desktop computer with MTESTW software was used to read and store the data and is shown in Figure 2.18. All values were calibrated to zero prior to testing. A calibration factor was computed and a linear slope resulted from a plot of loading data.

Figure 2.18 Data Collection with an Automatic Data Acquisition system

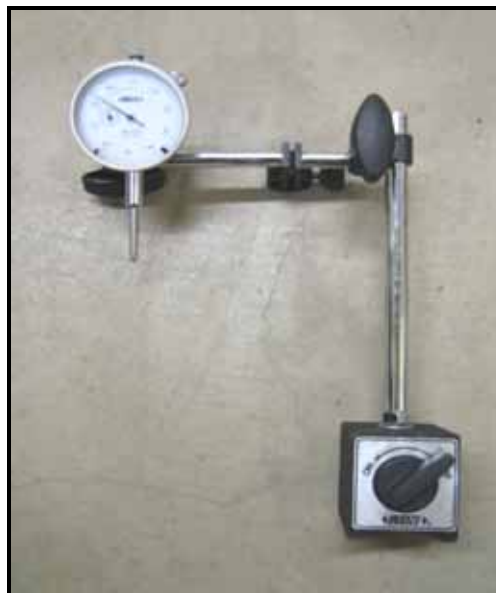
Displacement transducers (DT) were used to measure slip at corresponding displacement throughout the pull-out testing. Two kinds of DT were used. One DT, a dial gauge, was placed above the specimen to measure slippage of the unloaded bamboo through the top of the concrete cylinder as shown in Figure 2.19.

Figure 2.19 Dial Gage

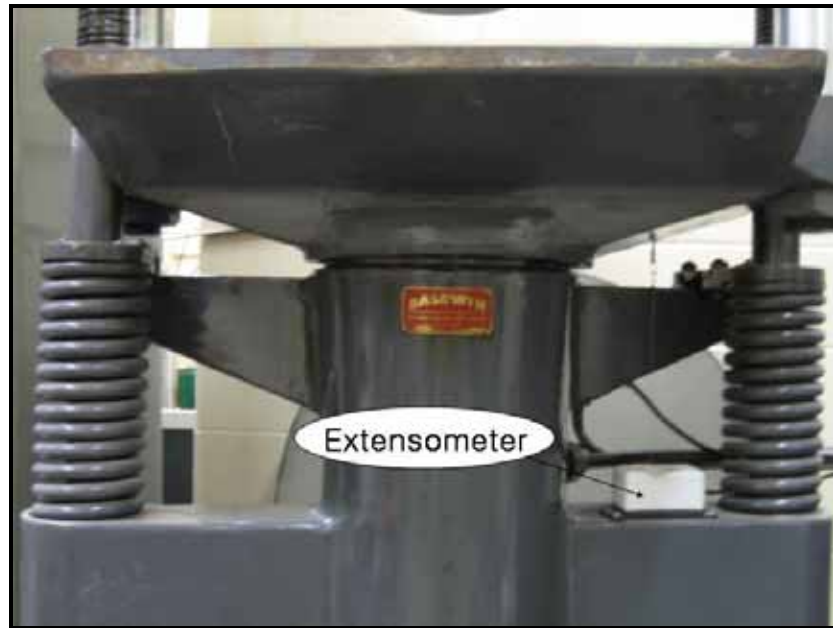
Another DT, an extensometer, was attached to the tensile test machine. It was attached directly to the load plate as shown in Figure 2.20, and measured the elongation.

Figure 2.20 Extensometer

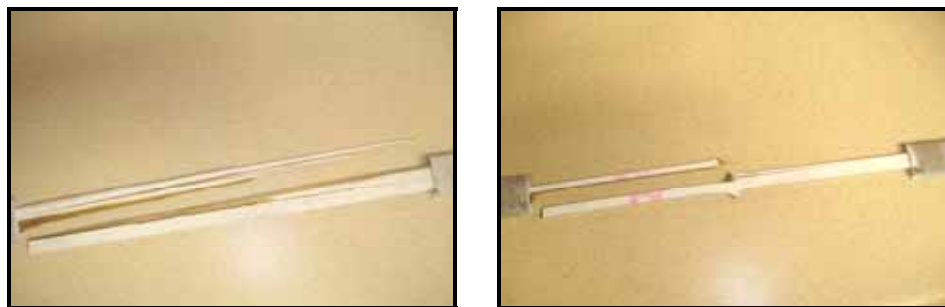
According to a tensile test research of bamboo nodes after, the first result typically observed a splitting failure of bamboo. However, if a node is present, bamboo cracks along the node and then splits, are shown in Figure 3.1 to Figure 3.4. Therefore, the sample with nodes often held a larger load before reaching failure in contrast to those without node.

Figure 3.1 Typical Splitting Failure in Tensile Test – 6 in (152 mm) no node

Figure 3.2 Typical Splitting Failure in Tensile Test – 6 in (152 mm) with node

Figure 3.3 Typical Splitting Failure in Tensile Test – 12 in (304 mm) no node

Figure 3.4 Typical Splitting Failure in Tensile Test – 12 in (304 mm) with node

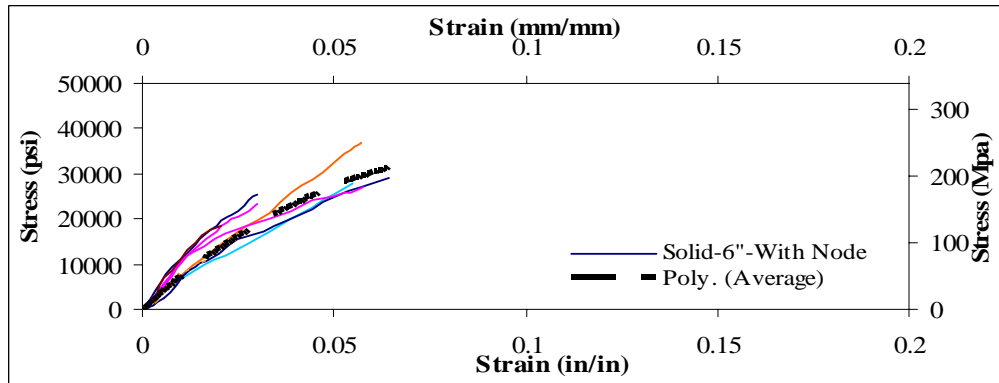
The experimental test results for tensile stress-strain curves are presented Figure 3.11 to 3.22. Figure 3.11 to 3.13 shows the tensile of stress-strain curves for 6 in (152 mm) Solid bamboo with and without node; Figure 3.14 to 3.16 shows the tensile stress-strain curves for 12 in (304 mm) Solid bamboo with and without node; Figure 3.17 to 3.19 shows the tensile stress-strain curves for 6 in (152 mm) Moso bamboo with and without node, Figure 3.20 to 3.22 shows the tensile stress-strain curves for 12 in (304 mm) Moso bamboo with and without node.

Figure 3.11 Stress-Strain Curve for samples no node
Solid Bamboo 1/8 in (3.2 mm) Thickness, 6 in (152 mm) Length

Figure 3.12 Stress-Strain Curve for samples with node
Solid Bamboo 1/8 in (3.2 mm) Thickness, 6 (152 mm) Length

Figure 3.13 Stress-Strain Curve of Solid 6 in sample no node & with node

In the other case; node present, the maximum stress was 37 ksi (256 Mpa) which was occurred several parallel cracks and broken at the node, and the minimum stress was 18 ksi (127 Mpa) which was cut clearly at the node. Table 3.2 shows those test results and Figure 3.12 shows the equation (3.2) which is

Table 3.1 and 3.2 shows the collected data of the 6 in (152 mm) Solid bamboos with and without nodes. According to the results of the test, the specimen with node has failure which occurred with high stress, 37 ksi (256 Mpa) and high strain value, 0.06in/in (mm/mm). Also, two data could not be retrieved due to computer problems in the all Solid bamboo with 1/ 8 in (3.2 mm) in thickness and 6 in (152 mm) in length.

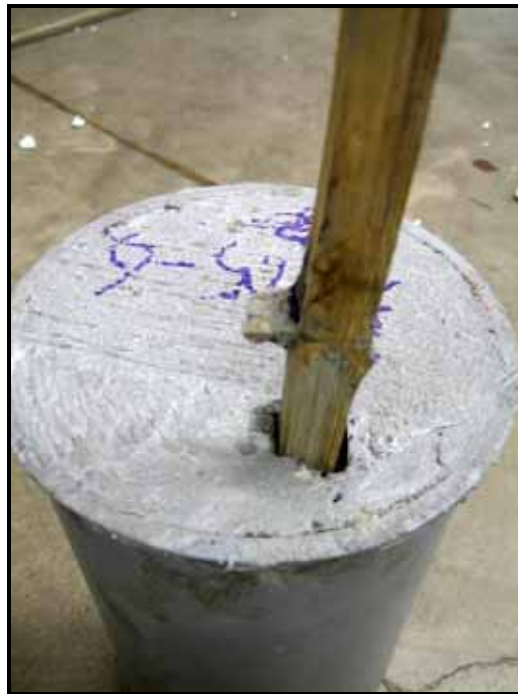
In the test results, the failures of most bamboo occurred at the interface between the reinforcing bamboo and the surrounding concrete which is shown in Figure 3.24. While the bamboo slipped out of the concrete, the bamboo was broken at the grip which is shown in Figure 3.25. The final bond strength was dictated by the shear strength of the concrete and the geometrical properties of the bamboo.

Figure 3.24 Pullout Failure Specimen

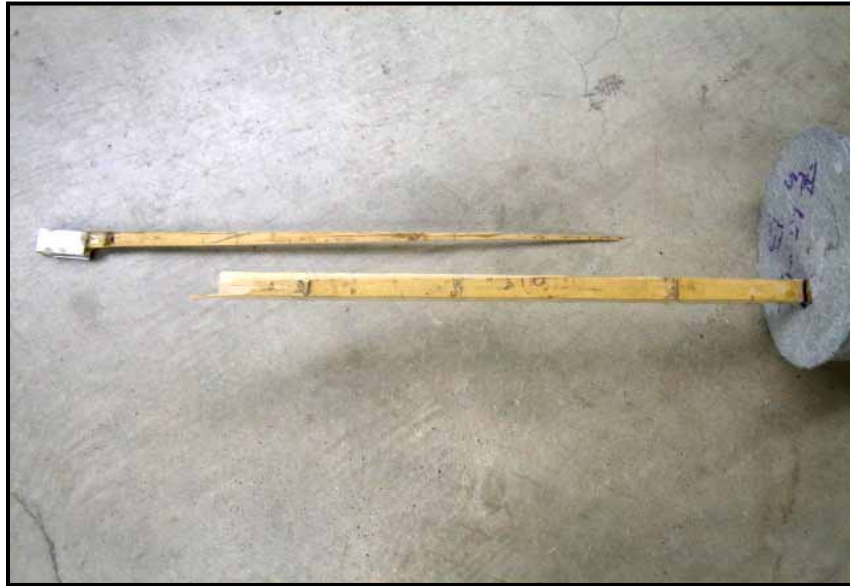
Figure 3.25 The Grip Failure of Pullout Test

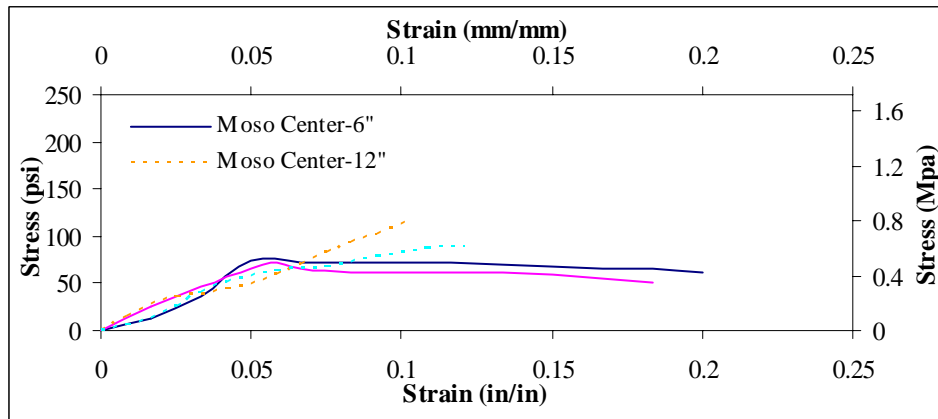
Normally, the concrete cracking can be observed in pullout testing of reinforce steel bars and FRP (Fiber Reinforcement Plastic), but bamboos show smooth slipping without any cracking of concrete. Also, no damage was observed to the bamboo after the pullout tests.

Figure 3.27 Bond Stress-Slip Behavior for Solid Bamboo - 1.5 in (152 mm) from Edge

Figure 3.28 Bond Stress-Slip Behavior for Solid Bamboo - Center

Figure 3.29 Bond Stress-Slip Behavior for combined Solid Bamboo test geometry

Figure 3.30 Bond Stress-Slip Behavior for Moso Bamboo - 1.5 in (38 mm) from Edge

Figure 3.31 Bond Stress-Slip Behavior for Moso Bamboo - Center

Figure 3.32 Bond Stress-Slip Behavior for combined Moso Bamboo test geometry
